## Open Eye Home Inspections LLC

### Property Inspection Report

Inspection date: **Monday, July 1, 2024**

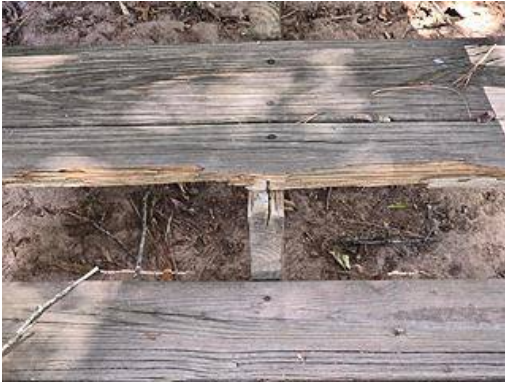
Photo 4-1

One or more treads at exterior stairs were deteriorated. This is a potential fall hazard. Recommend that a qualified person repair as necessary.

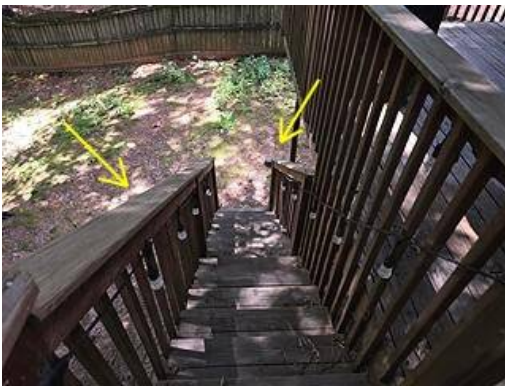
Photo 5-1

Handrails at one or more flights of stairs were wobbly. This is a safety hazard. Recommend that a qualified person repair as necessary.

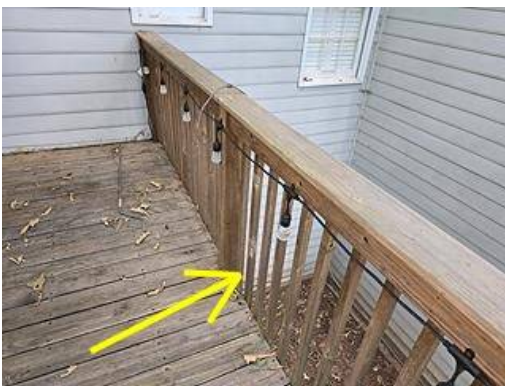
Photo 6-1

Guardrails at one or more locations with drop-offs higher than 30 inches were wobbly, and pose a fall hazard. Recommend that a qualified person repair guardrails as necessary.

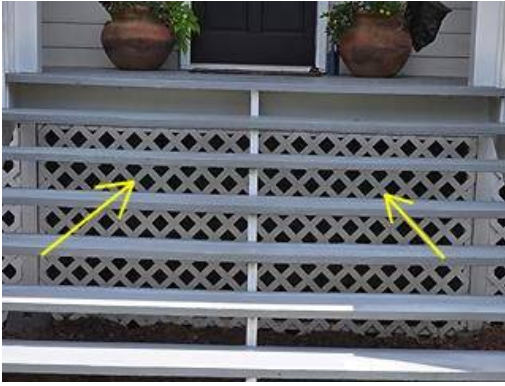
Photo 7-1

The front steps need more stringers to support the stair treads. Recommend having a qualified contractor evaluate and make any necessary repairs.

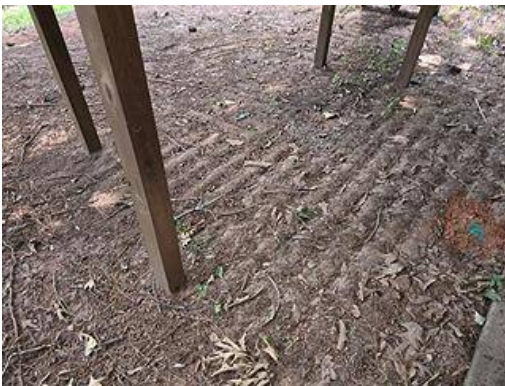
Photo 8-1

This deck is not considered safe by today's standards. The 4x4 posts are too small and in contact with the soil. The deck frame is single board band instead of double. One post is bowed. Recommend having a qualified contractor evaluate and make any necessary repairs.

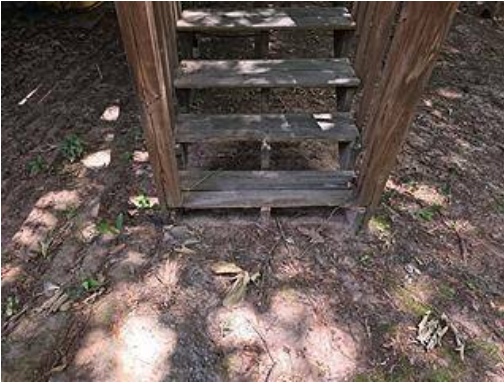
Photo 9-1

Soil was in contact with or close to wooden stairs at one or more locations. This is a conducive condition for wood-destroying organisms. Soil should be graded and/or removed so no wood-soil contact is present, if possible. Otherwise, installing products such as borate-based Impel rods may help to prevent infestation and damage. For more information, visit: <https://www.reporthost.com/?IMPEL>

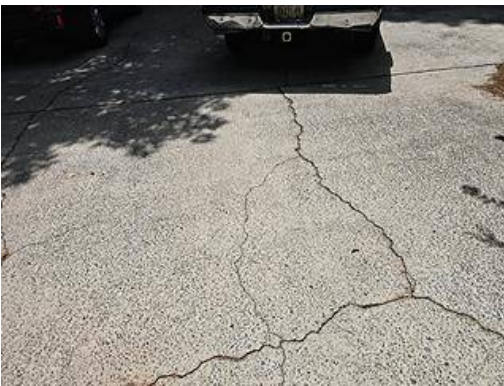
Photo 10-1

10) **i** Minor deterioration (e.g. cracks, holes, settlement, heaving) was found in the driveway, but no trip hazards were found. The client may wish to have repairs made for cosmetic reasons.

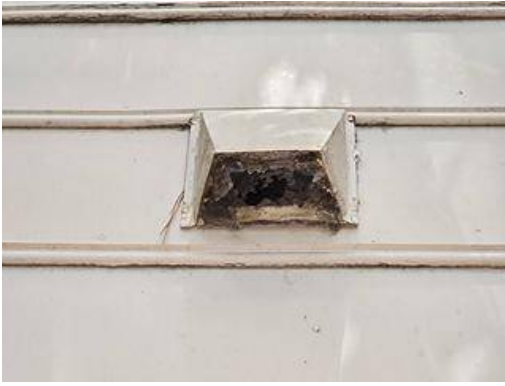
Photo 11-1

11) **+** **i** The clothes dryer exhaust duct appeared to need cleaning. Significant amounts of lint build-up were visible and may reduce air flow. This is a fire hazard. Recommend that a qualified person clean this duct now and as necessary in the future. Some chimney sweeps or heating/cooling duct cleaners perform this service. For more information, visit:

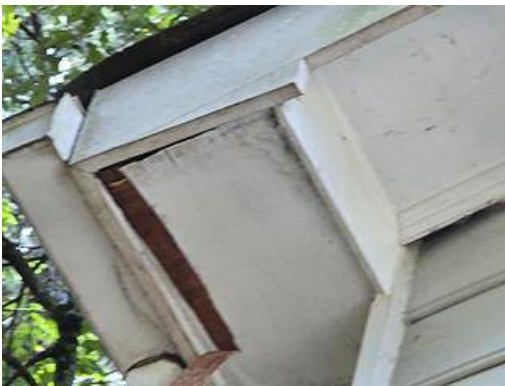
Photo 12-1

Soffit boards are sagging or damaged in one or more areas. Recommend having a qualified contractor evaluate and make any necessary repairs.

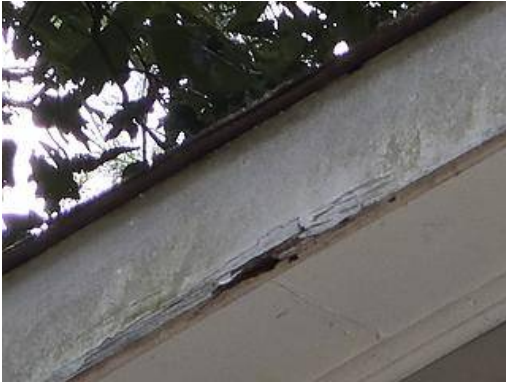
Photo 13-1

Fascia boards are damaged in one or more areas. Recommend having a qualified contractor evaluate and make any necessary repairs.

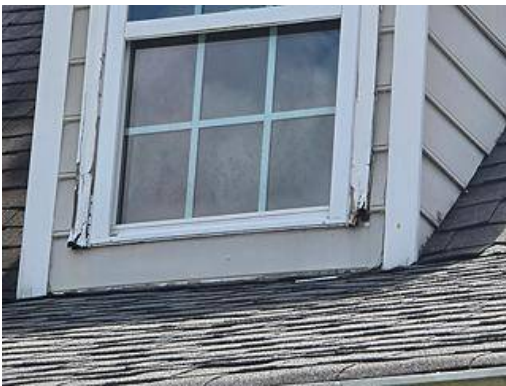
Photo 14-1

Some sections of siding and/or trim were deteriorated. Recommend that a qualified person repair, replace or install siding or trim as necessary.

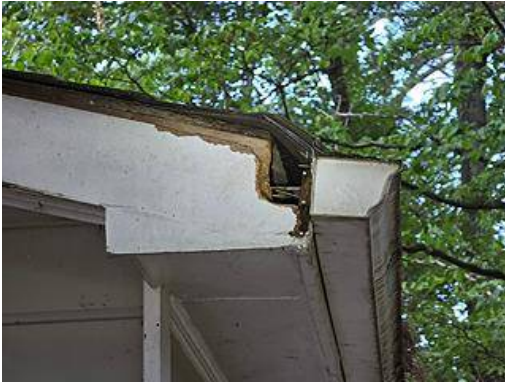
Photo 15-1

Potential rodent entry points were noticed at one or more areas of the exterior. Rodents can enter gaps of 1/2 inch or more. Recommend having a qualified contractor evaluate and make all necessary repairs.

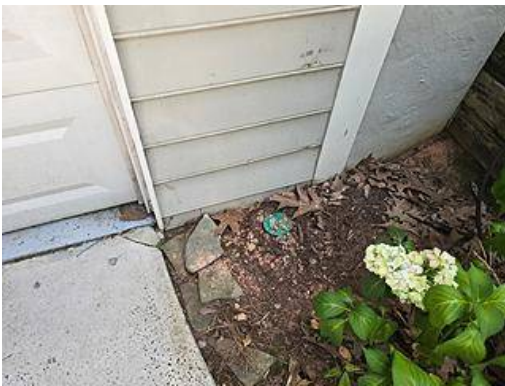
Photo 17-1

Soil was in contact with or less than 6 inches from siding or trim. Regardless of what material is used for siding, it should not be in contact with the soil. If made of wood, siding or trim will eventually rot. For other materials, ground or surface water can infiltrate siding or trim and cause damage to the wall structure. Wood-destroying insects are likely to infest and damage the wall structure. This is a conducive condition for wood-destroying organisms. Recommend grading or removing soil as necessary to maintain a 6-inch clearance. Note that damage from fungal rot and/or insects may be found when soil is removed, and repairs may be necessary.

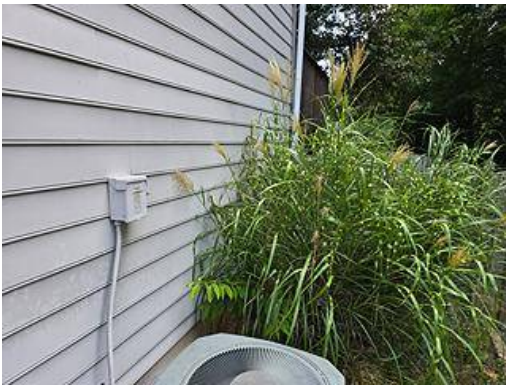
Photo 18-1

Vegetation such as trees, shrubs and/or vines was in contact with or close to the building exterior. Vegetation can serve as a pathway for wood-destroying insects and can retain moisture against the exterior after it rains. This is a conducive condition for wood-destroying organisms. Recommend pruning, moving or removing vegetation as necessary to maintain at least 6 inches of space between it and the building exterior. A 1-foot clearance is better.

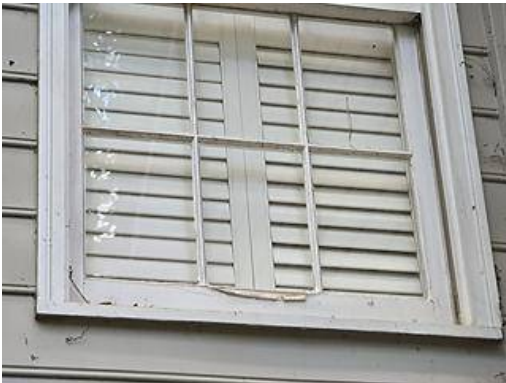
Photo 19-1

19) 🛠️ The paint or stain finish in some areas was failing (e.g. peeling, faded, worn, thinning). Siding and trim with a failing finish can be damaged by moisture. Recommend that a qualified contractor prep (e.g. clean, scrape, sand, prime, caulk) and repaint or restain the building exterior where necessary and per standard building practices. Any repairs needed to the siding or trim should be made prior to this.

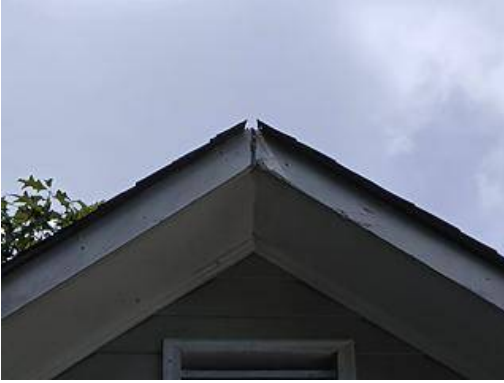
Photo 21-1

Some composition shingles were damaged. Leaks can occur as a result. This is a conducive condition for wood-destroying organisms. Recommend that a qualified contractor repair as necessary. For example, by replacing shingles.

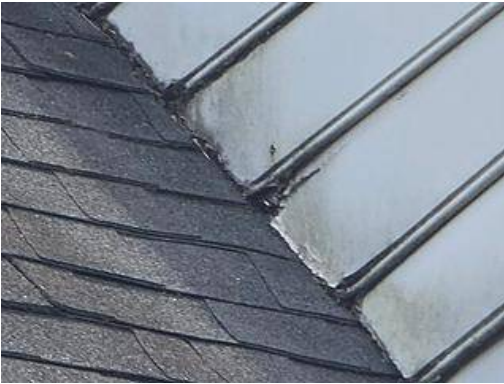
Photo 22-1

The siding on one or more exterior walls was in contact with or too close to roof surfaces below. This is a conducive condition for wood-destroying organisms. There should be a gap of 1 1/2 to 2 inches between a roof surface and siding above. The gap is meant to prevent water from wicking up into the bottom edge of the siding and causing fungal rot, or damaging the siding. There may also be inadequate space for additional layers of roofing materials in the future. Recommend that a qualified contractor repair per standard building practices. For example, by trimming the siding.

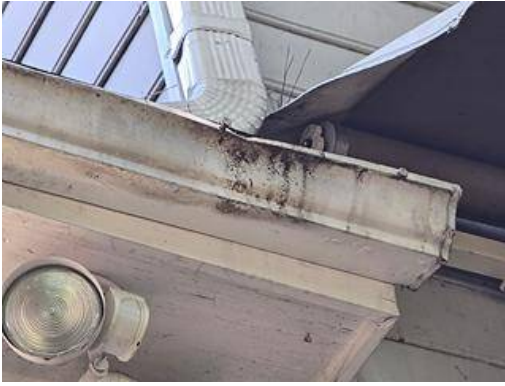
Photo 23-1

One or more gutters were damaged. Rainwater can come in contact with the building exterior or accumulate around the building foundation as a result. This is a conducive condition for wood-destroying organisms. Recommend that a qualified person repair as necessary.

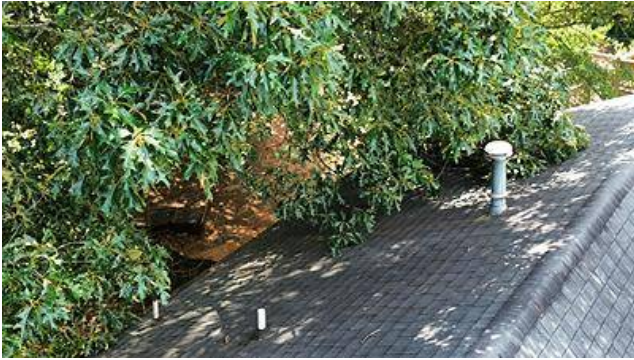
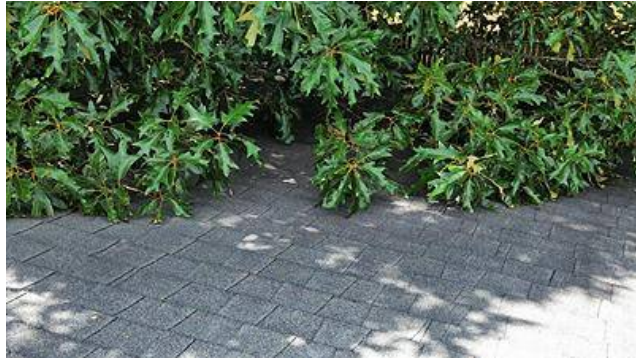
Vegetation such as trees, shrubs, and/or vines overhung the roof surface or were in contact with the roof edge. Organic debris such as leaves or needles are likely to accumulate in gutters and on the roof surface. Gutters can overflow and cause water to come in contact with the building exterior or water can accumulate around the foundation. This is a conducive condition for wood-destroying organisms. Vegetation in contact with the roof can damage the roof surface and/or the roof drainage system. Recommend pruning vegetation so as to not be in contact with the roof and to not overhang the roof surface. If vegetation is too tall then it should be pruned at least 10 feet above the roof surface.

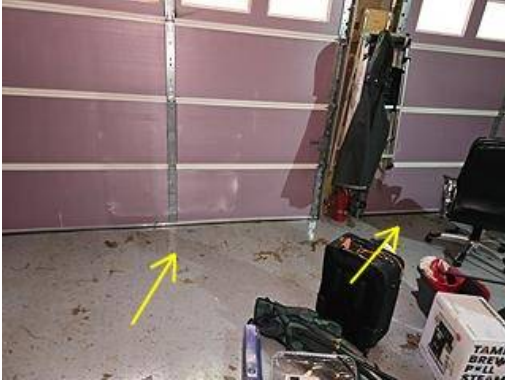
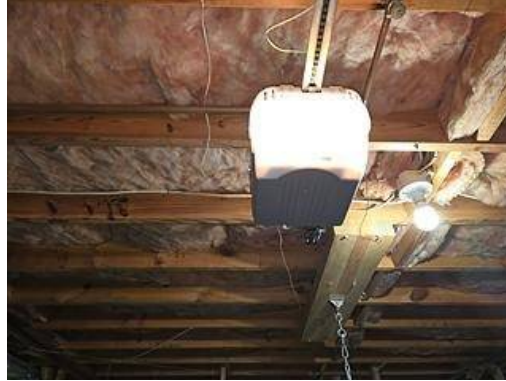
The auto-reverse mechanism on one or more automatic openers for garage vehicle doors was inoperable. This is a potential safety hazard. A qualified contractor should evaluate and repair as necessary. For more information on garage door safety issues, visit:

Photo 29-2 THE CONTROLS FOR THIS ADJUSTMENT ARE LOCATED ON THE OPENER.

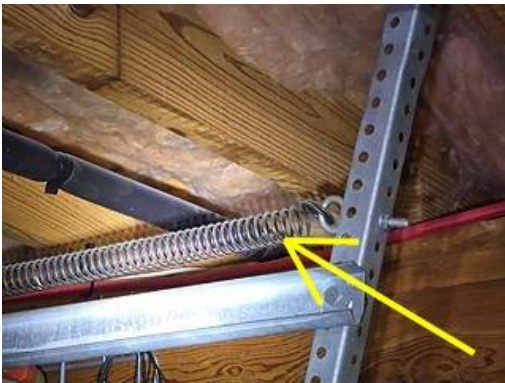
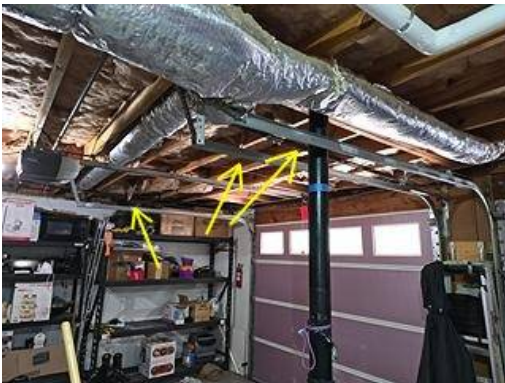
30) 🛠️ One or more extension springs supporting garage vehicle doors had no safety containment cables installed. These cables prevent injury to people located nearby when springs eventually break. This is a potential safety hazard. Recommend that a qualified contractor install cables where missing per standard building practices. For more information, visit:

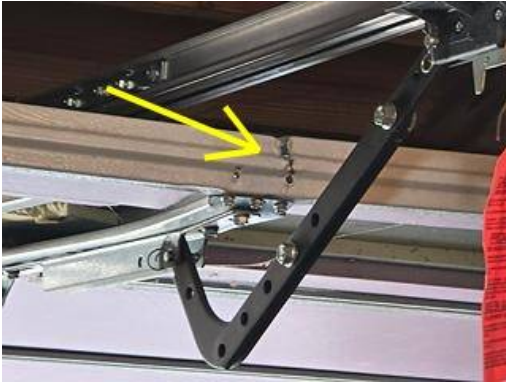
Photo 31-1

31) 🛠️ The right side garage vehicle door is damaged at the top. Recommend having a qualified contractor evaluate and make any necessary repairs.

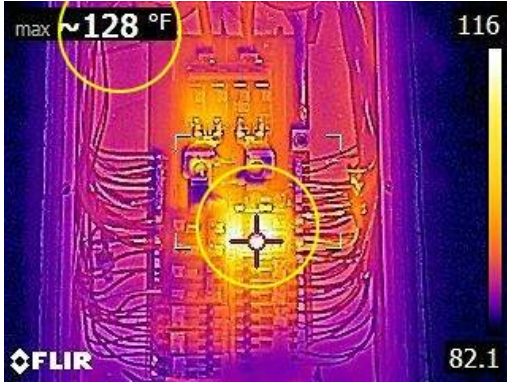
Photo 37-1

The infrared scan of the electrical panel showed an elevated temperature on the A/C breaker. Recommend having a

qualified electrician evaluate and make any necessary repairs.

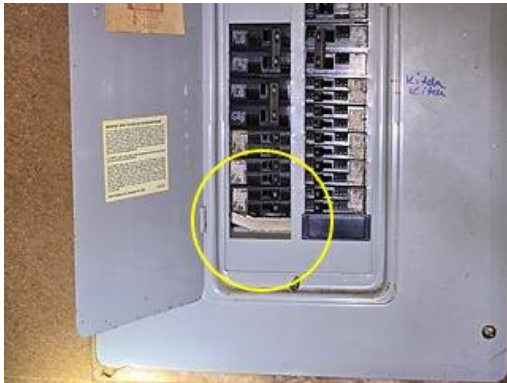
Photo 39-1

One or more slots where circuit breakers are normally installed were open in panel(s) #. Energized equipment was exposed and is a shock hazard. Recommend that a qualified person install closure covers where missing.

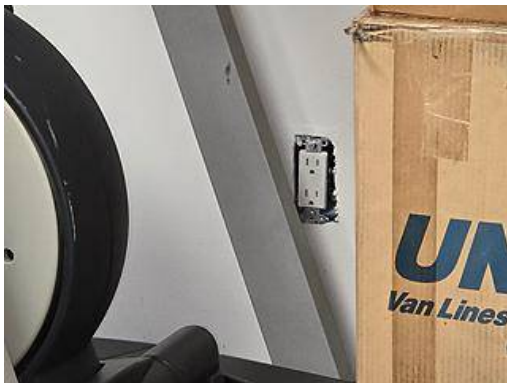
Photo 40-1

One or more cover plates for switches, receptacles or junction boxes were missing or broken. These plates are intended to contain fire and prevent electric shock from occurring due to exposed wires. Recommend that a qualified person install cover plates where necessary.

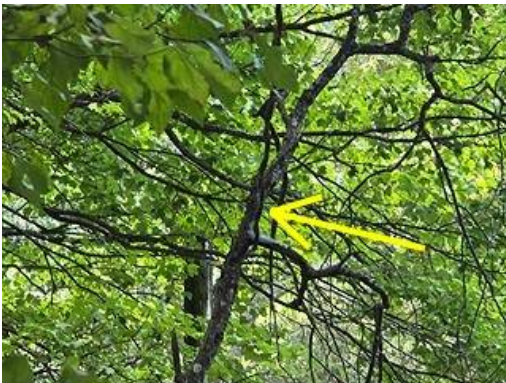
Photo 42-1

The service drop wires were in contact with trees or vegetation. This can result in damage to wiring insulation or broken wires during high winds. Recommend pruning trees or vegetation as necessary. The utility company may prune trees at no charge.

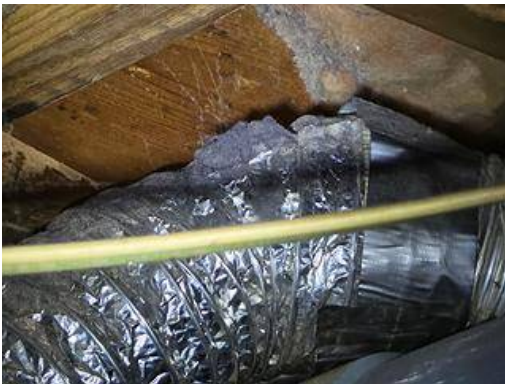
Photo 45-1

The clothes dryer's flexible exhaust duct was routed through a wall, building substructure or attic. This type of duct is easily damaged, prone to clogging and not suitable for this purpose. Clothes dryers may overheat. This is a potential fire hazard. It is acceptable for a short length of corrugated, semi-rigid metal duct (not accordion flex-duct) be used between the dryer and the wall or floor fitting, but duct runs through walls, building substructures and attics should be made of rigid metal, and wrapped in R-4 insulation if routed through an unheated space. Recommend that a qualified person replace ducting per standard building practices.

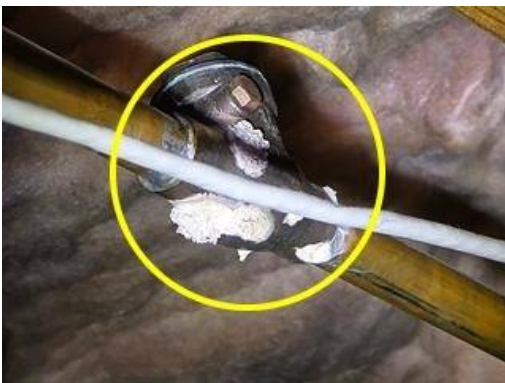
Significant corrosion was found in some water supply pipes or fittings. Leaks can occur as a result. Recommend that a qualified plumber evaluate and replace components as necessary.

Photo 46-1 THIS IS THE CHECK VALVE ABOVE THE WATER HEATER.

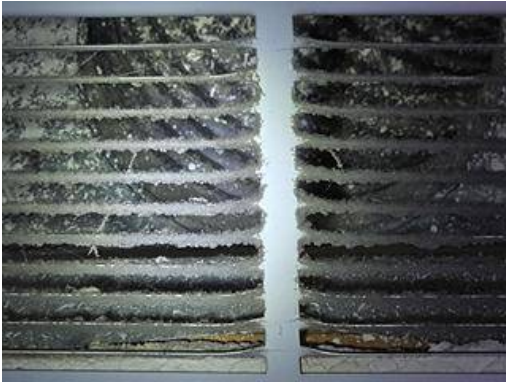
Photo 54-1

54) **+🔧** Significant amounts of debris, dirt and/or dust were visible in one or more sections of supply and/or return air ducts for the heating or cooling system. This can be a health hazard, especially for those with allergies or respiratory problems. The Environmental Protection Agency (EPA) recommends considering having ducts professionally cleaned when "ducts are clogged with excessive amounts of dust and debris and/or particles are actually released into the home from your supply registers." At a minimum, the visible debris should be thoroughly cleaned. Recommend that a qualified contractor clean the ducts. For more information on duct cleaning in relation to indoor air quality, visit:

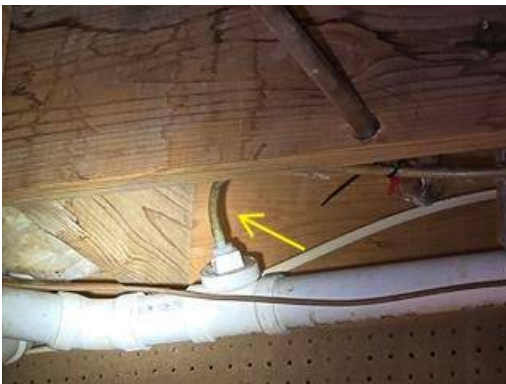
Photo 55-1

The air handler's primary condensate drain line was routed into a plumbing drain pipe. Such drain lines should terminate in surface waterways (e.g. a floor drain or outside). Recommend that a qualified HVAC contractor repair per standard building practices.

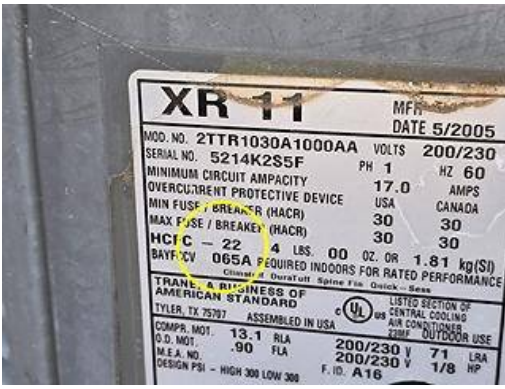
Photo 57-1

This a/c unit appears to use R-22 refrigerant. R22 is being phased out worldwide because of its harmful effects on the ozone layer. The U.S. Environmental Protection Agency (EPA) has set January 1, 2020 as the date when R22 is banned from production and importation in the United States. After that date, R22 cannot be manufactured in the U.S. and it cannot be imported. When this system fails it will need to be replaced with a condenser using the current 410-A refrigerant.

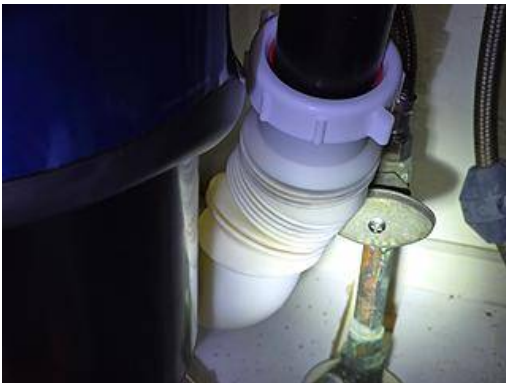
Photo 64-1

Ribbed, flexible drain pipe was used at the sink. This type of drain pipe accumulates debris more easily than smooth wall pipe and is more likely to clog. Recommend that a qualified plumber replace flexible piping with standard plumbing components (smooth wall pipe) to prevent clogged drains.

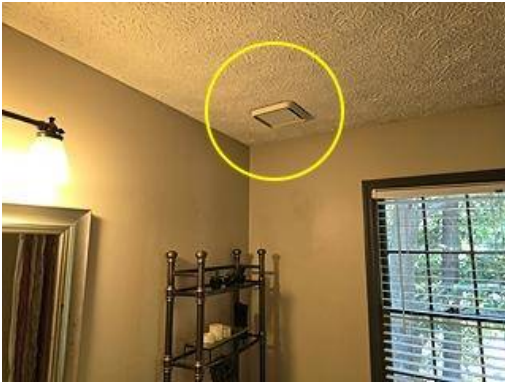
Photo 72-1

The exhaust fan at the upstairs hallway bathroom was weak or slow. Moisture may accumulate and result in mold, bacteria or fungal growth. Recommend that a qualified person clean, repair or replace fans as necessary.

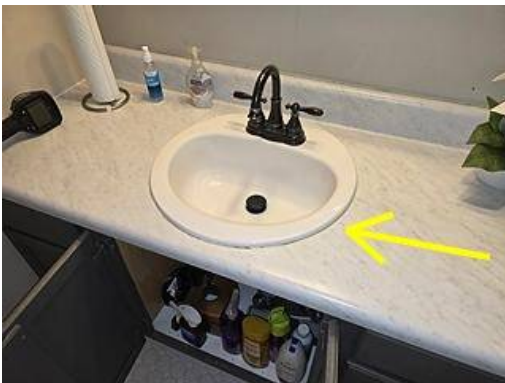
Photo 73-1

The bathroom sink is loose in the upstairs hallway bathroom. Recommend having a qualified contractor evaluate and make any necessary repairs.

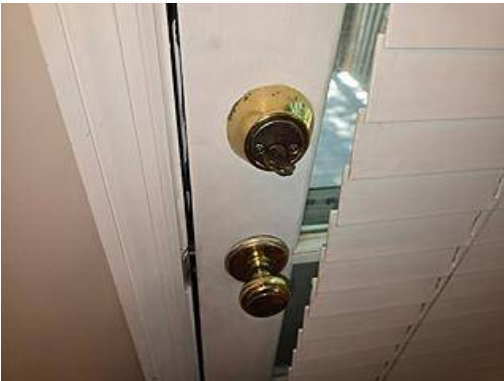
Photo 76-1

One or more interior doors had a keyed lockset or deadbolt installed. This is a safety hazard for small children in the event that they lock themselves in the room, do not know how to unlock the door, and the key is not available. Recommend that a qualified person replace keyed locksets and/or deadbolts with "privacy" locksets (no key required) as necessary.

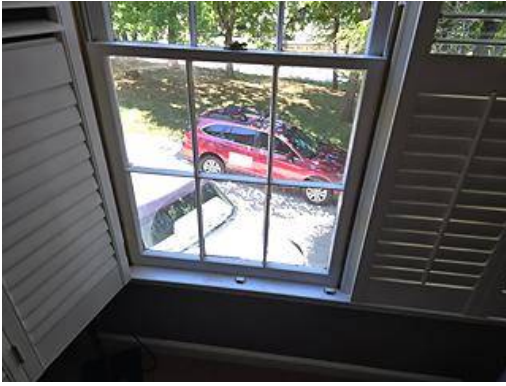
Photo 77-1

One or more windows that were designed to open and close were stuck shut. Recommend that a qualified person repair windows as necessary so they open and close easily.

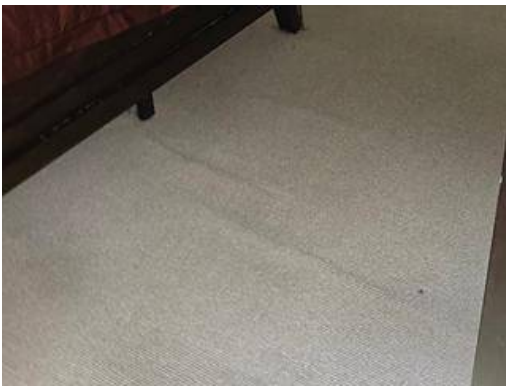
Photo 78-1

78) 🧰 Carpeting in one or more areas was loose. Recommend that a qualified contractor repair as necessary. For example, by stretching or replacing carpeting.

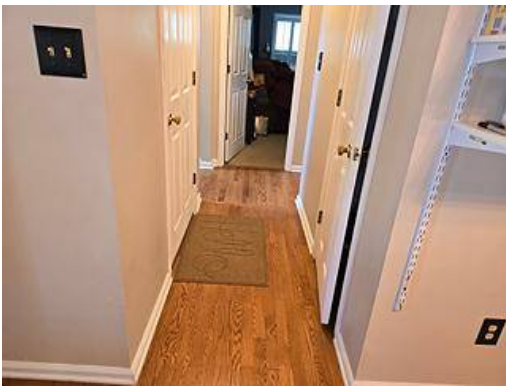
Photo 79-1

79) 🧰 Floors in one or more areas were not level. This can be caused by foundation settlement or movement of the foundation, posts and/or beams. No structural concerns were found at the time of the inspection. This is not unusual in older homes. Recommend having a qualified contractor evaluate and make any necessary repairs.

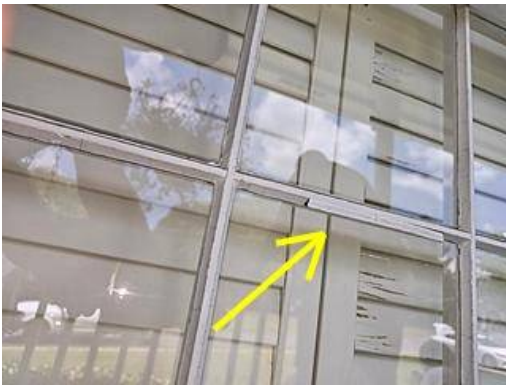
Photo 80-1

80) 🧰 The glazing compound or caulk that holds glass panes in one or more windows was deteriorated and/or substandard. Air and/or water can leak through windows, and wood window frames are prone to rot. This is a conducive condition for wood-destroying organisms. Recommend that a qualified person replace glazing compound as necessary. For more information, visit: <https://www.reporhost.com/?PUTTY>
