## Open Eye Home Inspections LLC

### Property New Home Final Inspection Report

Client(s): **Sample Report 3**

Inspection date: **Thursday, January 26, 2023**

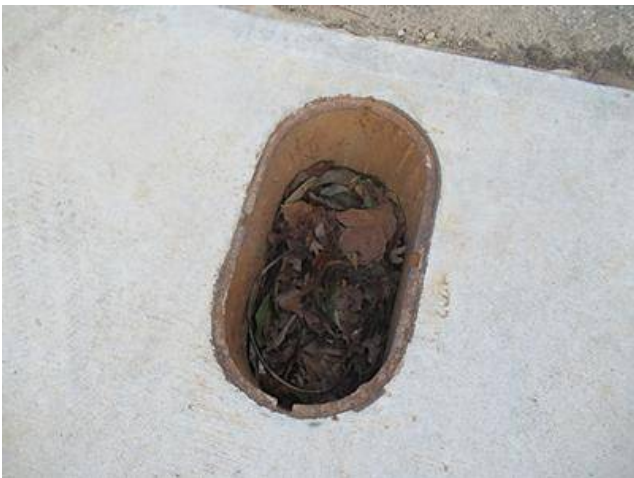
Photo 5-1

The metal sewer cleanout or meter cover in the driveway, was missing at the time of the inspection. Recommend having the builder evaluate and make any necessary repairs or replacement.

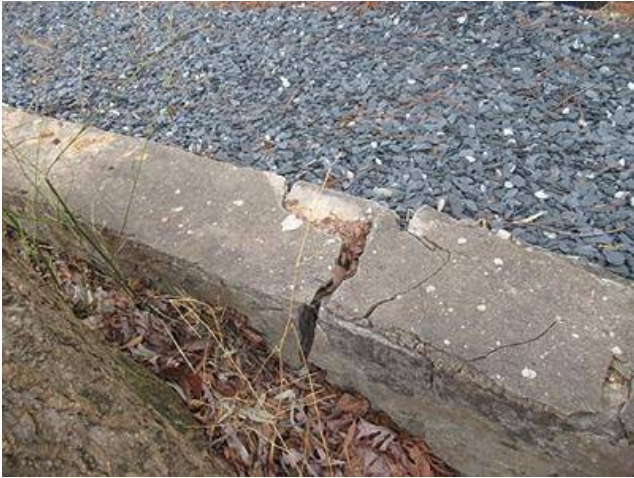
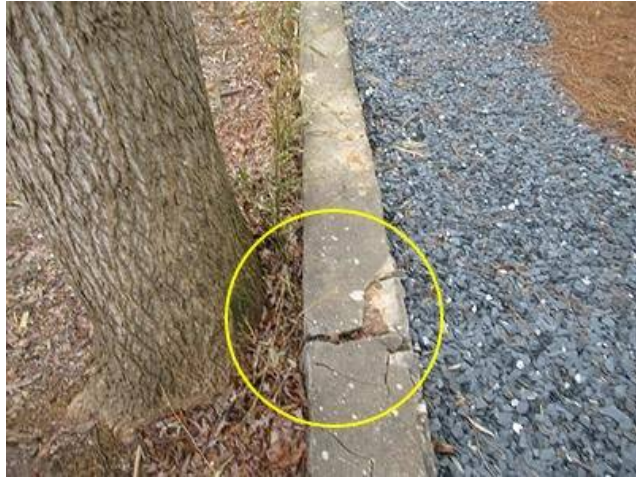
Photo 6-1

Significant cracks, deterioration, leaning and/or bowing were found in one or more retaining walls at the edge of the property on the right side. Recommend having the builder evaluate and make any necessary repairs.

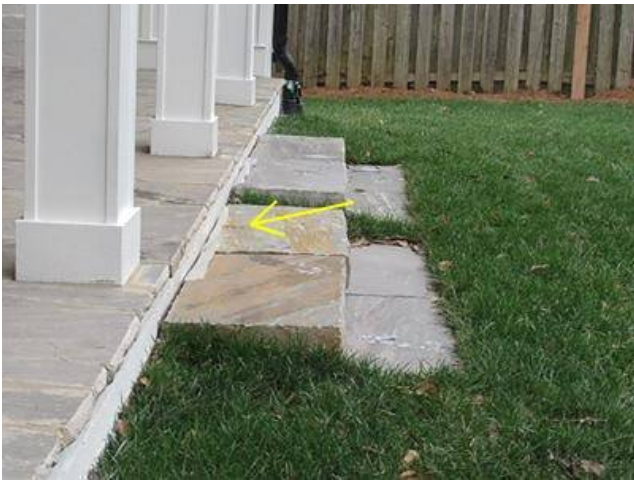
Photo 7-1

- 
- 7) 🛠️ The stairs at the back patio slope towards the patio. Recommend having the builder evaluate and make any necessary repairs.

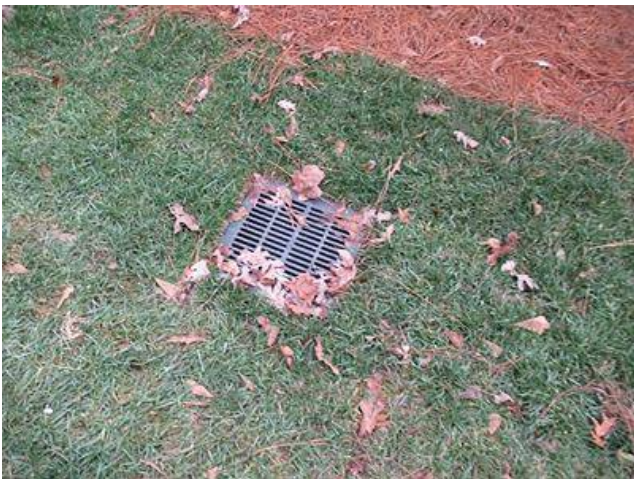
Photo 8-1

- 
- 8) 🔍📍📌 Drains were noticed in the yard. Recommend monitoring these drains to keep them clear from debris.

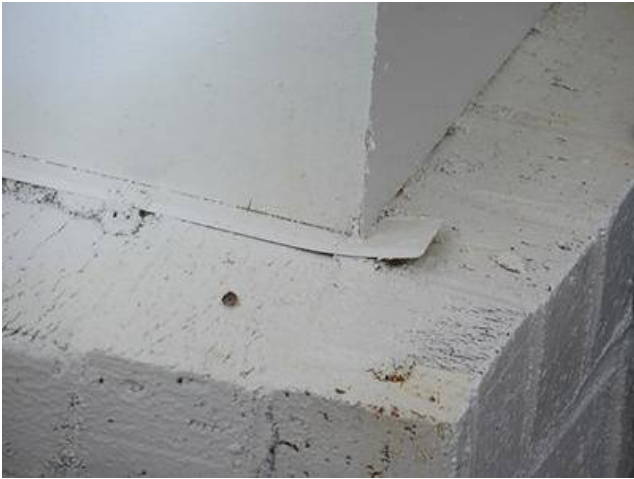
Photo 9-1

The brick ledge flashing is missing one or more areas around the structure. SEE CAPTIONS BELOW PHOTOS FOR LOCATIONS. Recommend having the builder evaluate and install flashing where missing.

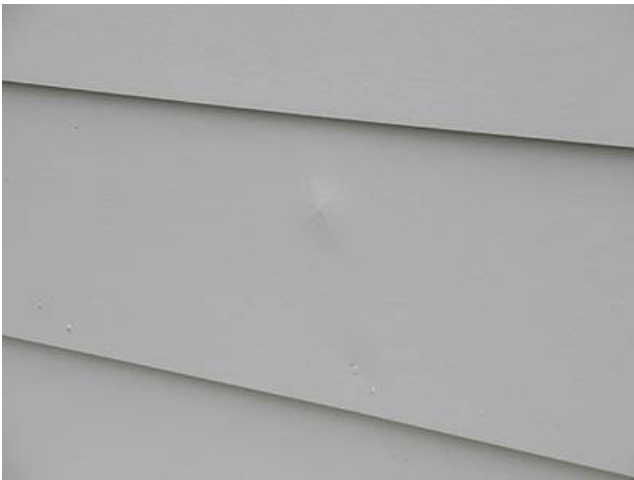
**Photo 10-1**

One piece of siding on the right side of the structure, has a noticeable protrusion in the siding board. Recommend having the builder evaluate and make any necessary repairs or replacement.

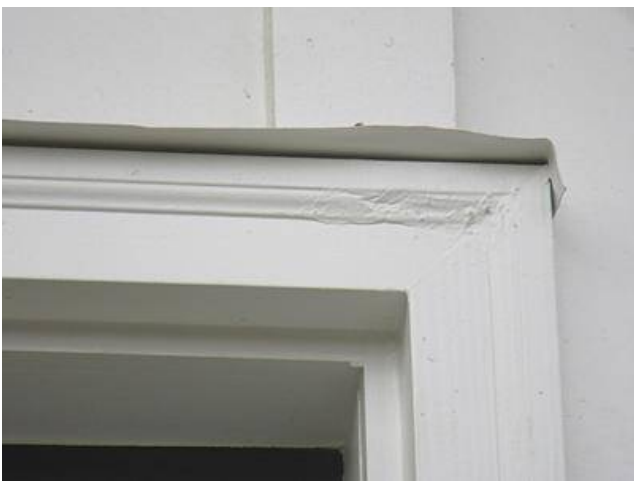
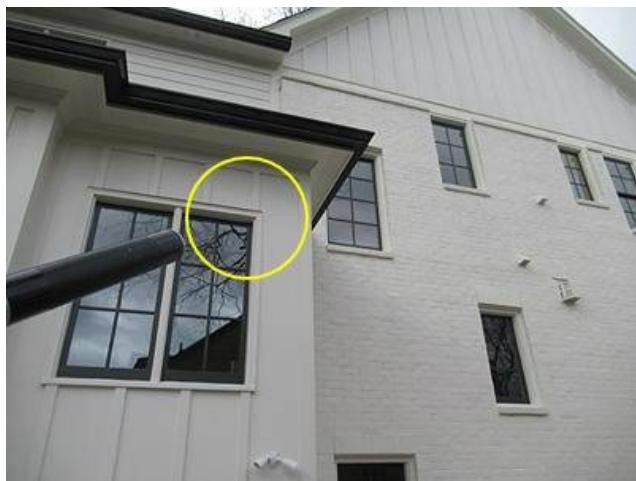
**Photo 11-1**

Trim above one window on the left side of the house is damaged. Recommend having the builder evaluate and make any necessary repairs or replacement.

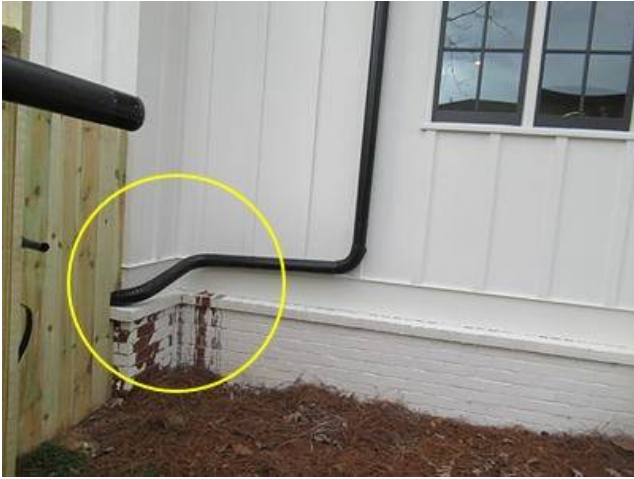
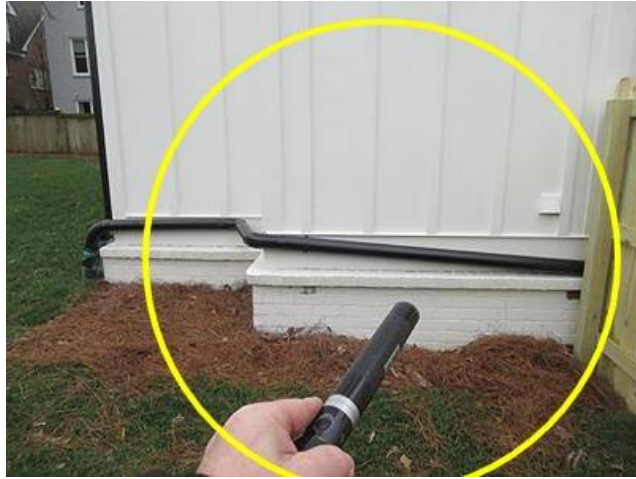
Photo 12-1

- 12) 🛠️ The horizontal downspout run on the left side of the house, tapers down and then up. This will not allow the water to flow correctly to the end of the downspout and will likely cause the water to come out at the downspout connections. Recommend having the builder evaluate and make any necessary repairs.

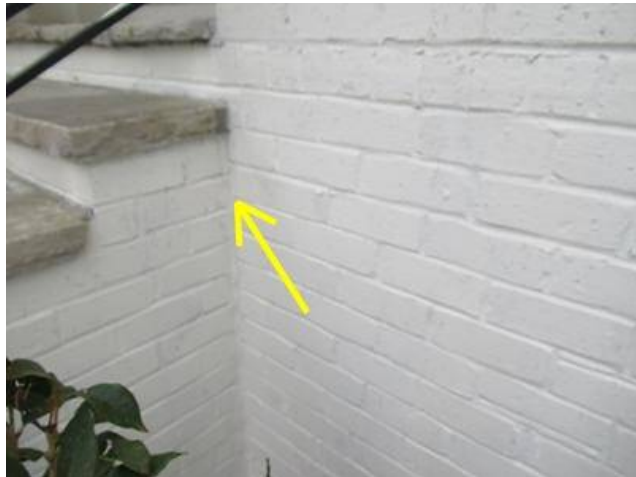
Photo 13-2

- 13) 🔍📍 One or more minor cracks were noticed in the brick veneer. These do not appear to be a structural concern. However, it is recommended to have a qualified contractor evaluate and repoint the mortar as necessary.

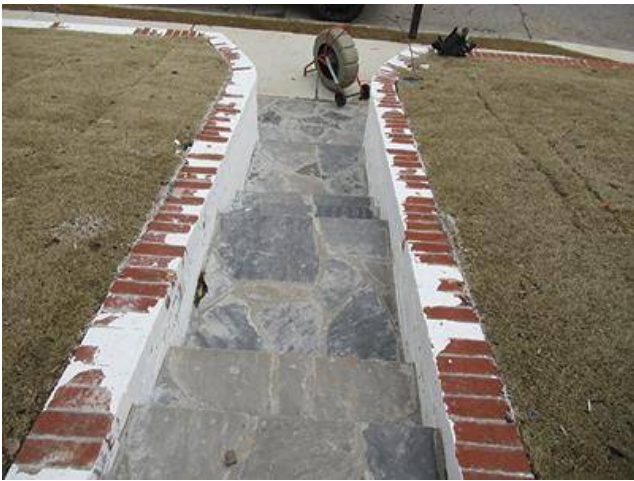
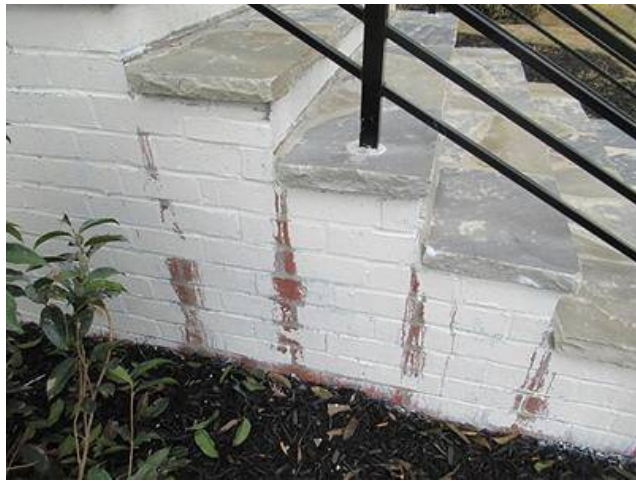
Photo 14-1

- 14) 🛠️ Paint has washed off the brick in some areas. Recommend having the builder evaluate and make any necessary repairs.

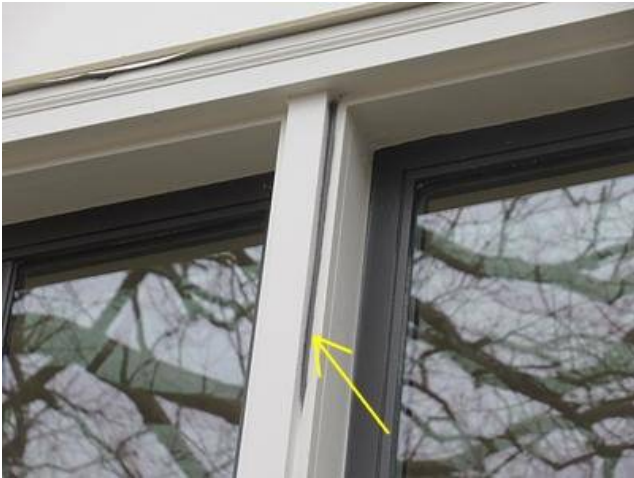
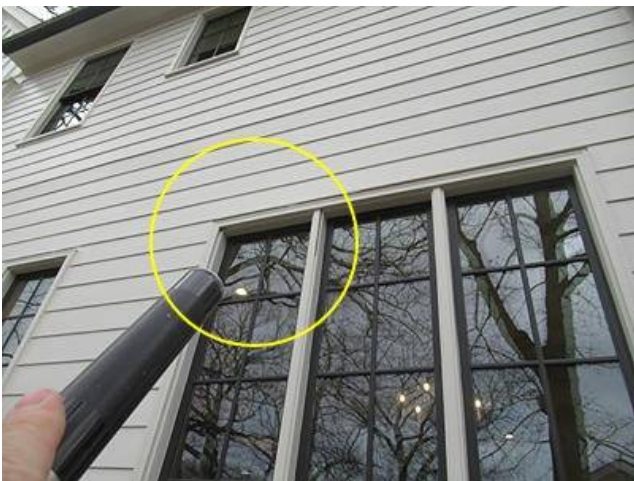
Photo 15-1

15) 🪛 Paint is missing at one or more pieces of window trim on the right side of the structure. Recommend having the builder evaluate and make any necessary repairs.

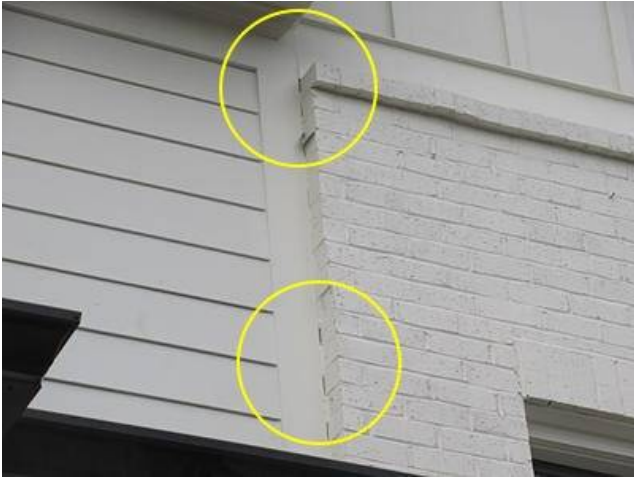
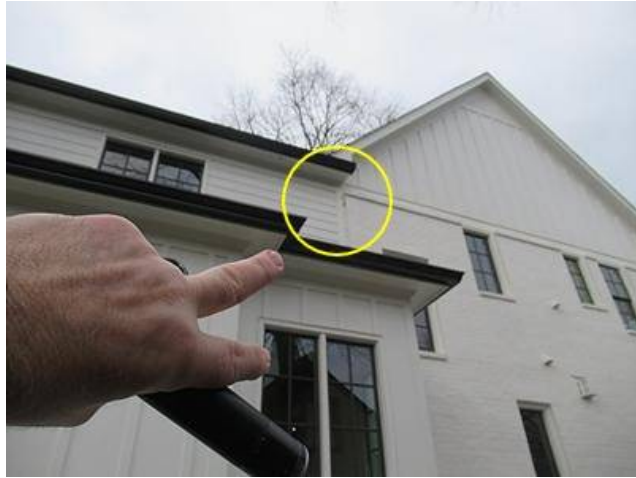
Photo 16-1

16) 🪛 Caulk is missing at one window frame on the left side of the house. Recommend having the builder evaluate and make any necessary repairs.

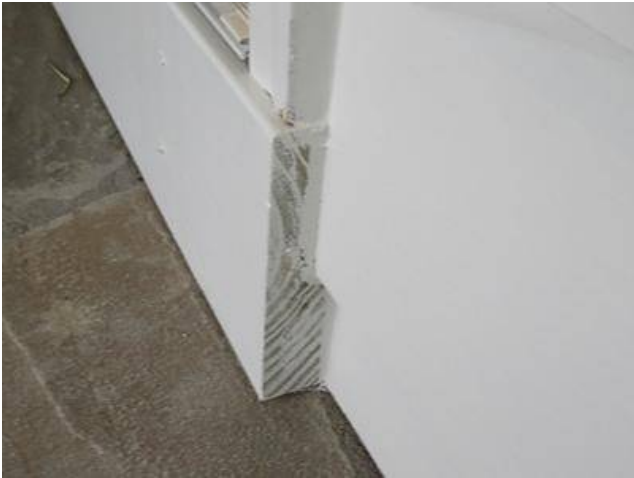
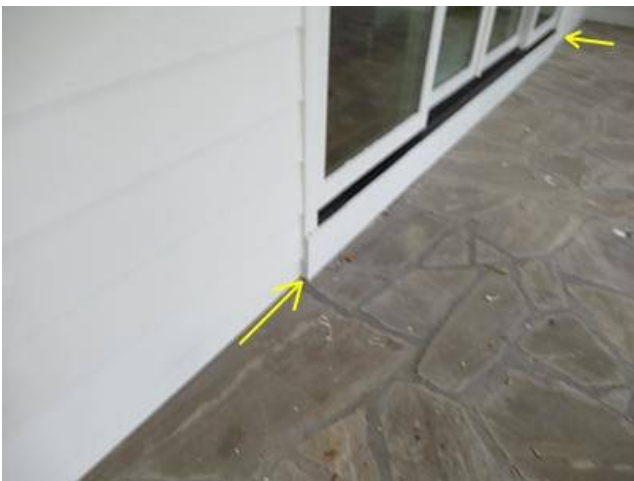
Photo 17-1

17) 🛠️ The ends of the threshold boards under the exterior doors were not painted on the ends. Recommend having the builder evaluate and make any necessary repairs.

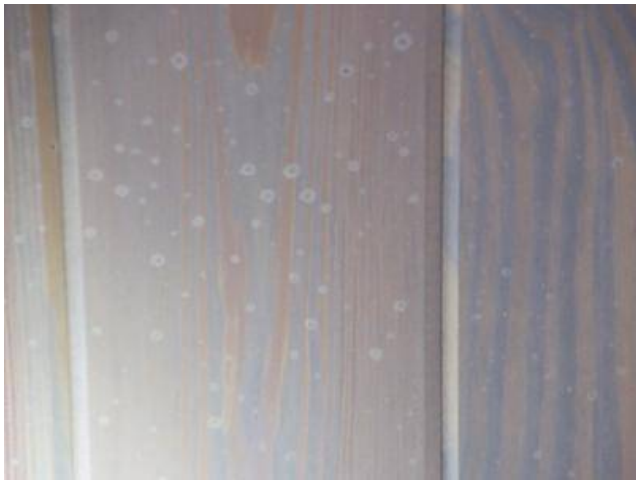
Photo 18-1

18) 🛠️ Paint splatter was noticed on the patio ceiling in one area. Recommend having the builder evaluate and make any necessary repairs.

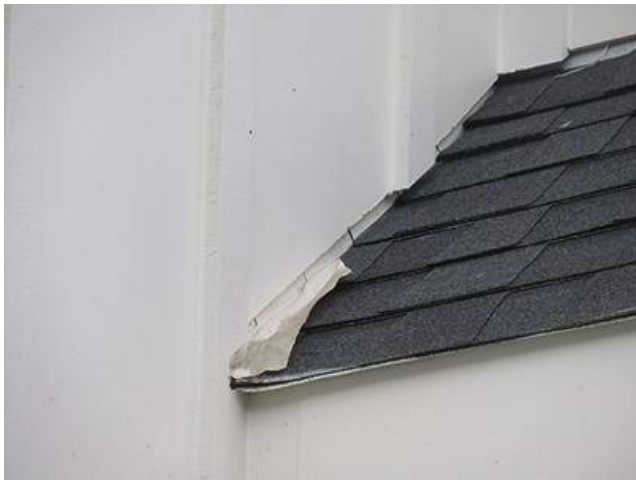
Photo 19-1

Painters tape was noticed above the chimney box on the left side of the structure and at the back of the structure by the patio. Recommend having the builder evaluate and make any necessary repairs.

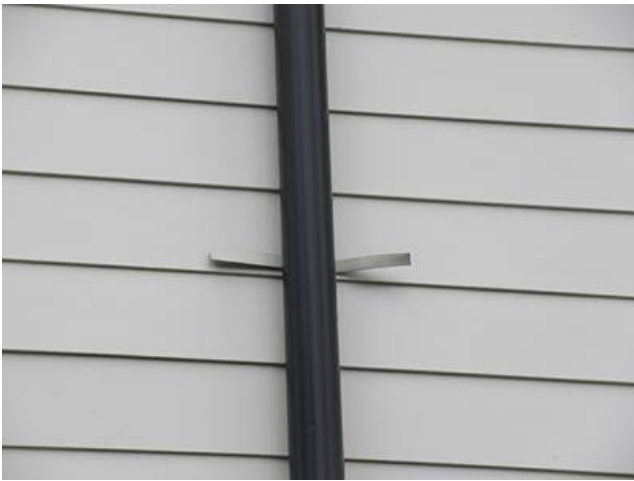
Photo 20-1

The strap at one downspout at the back of the house, is not secured. Recommend having the builder evaluate and make any necessary repairs.

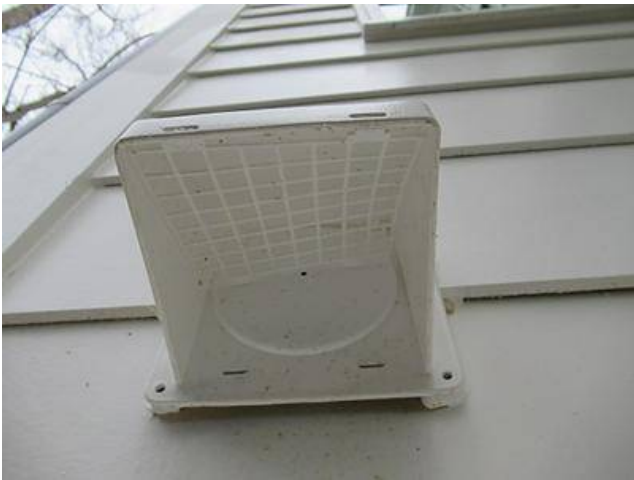
Photo 21-1

21) 🛠️ The grill in one exhaust vent at the back right side of the structure is blocking the flapper. Recommend having the builder evaluate and make any necessary repairs.

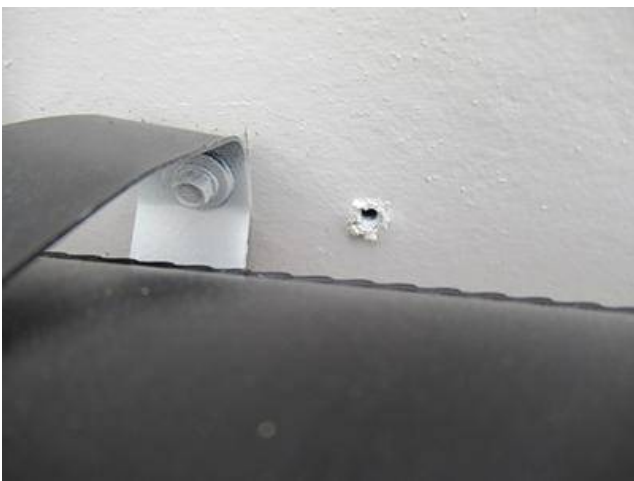
Photo 22-1

22) 🛠️ There is a hole in the siding by the horizontal downspout run on the left side of the house. Recommend having the builder evaluate and make any necessary repairs.

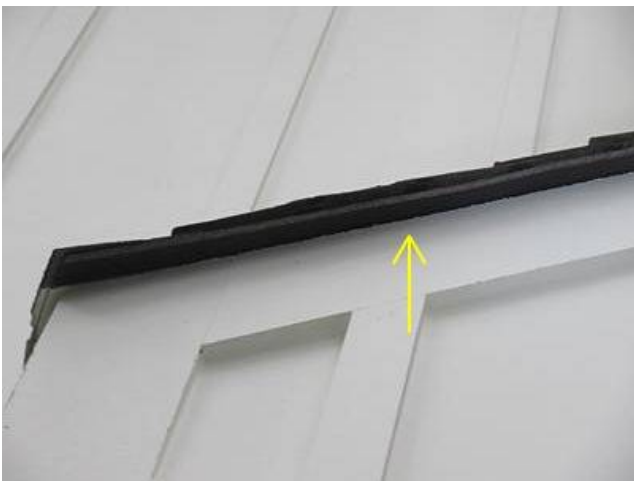
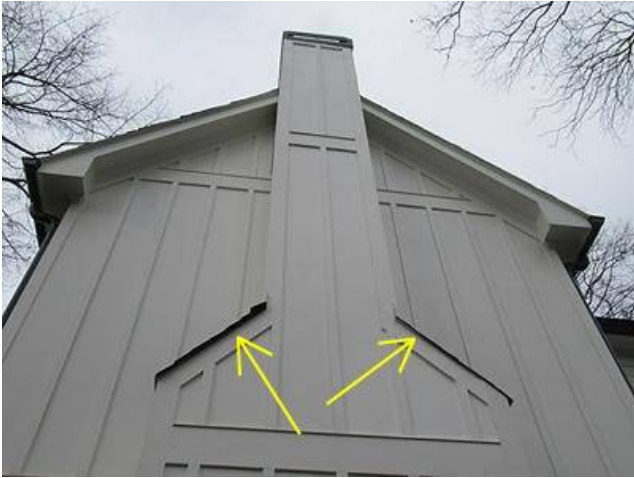
Photo 25-1

25) 🛠️ The drip edge is missing at the roof on the chimney box at the left side of the structure. Recommend having the builder evaluate and make any necessary repairs.

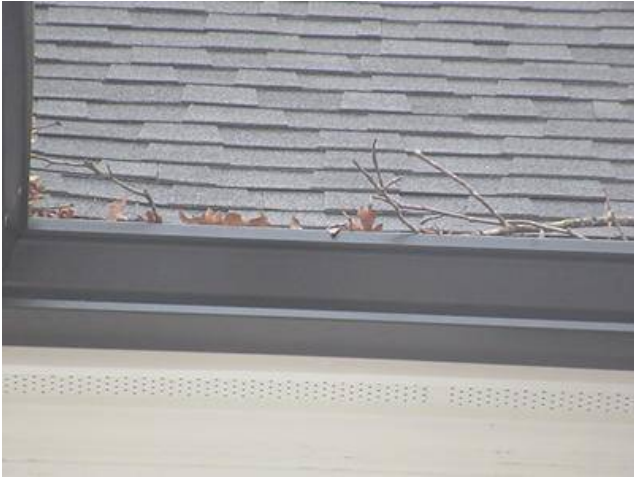
Photo 28-1

28) 🧹 Significant amounts of debris such as leaves, needles, seeds, etc. have accumulated on the roof surface. Water may not flow easily off the roof, and can enter gaps in the roof surface. Leaks can occur as a result. This is a conducive condition for wood-destroying organisms. Recommend cleaning debris from the roof surface now and as necessary in the future.

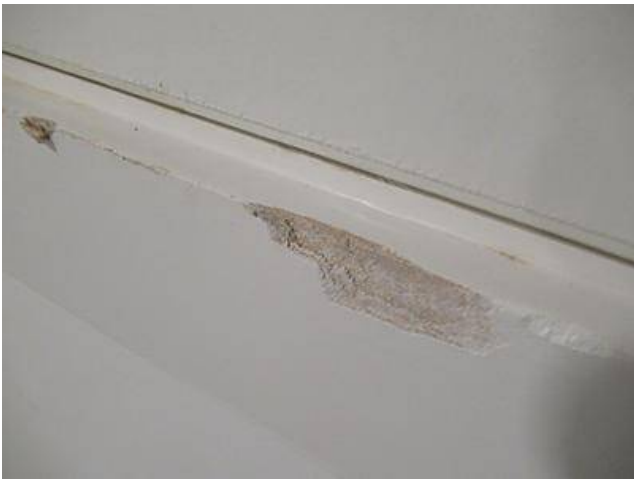
Photo 32-1

The trim at the front cubby hatch in the garage is damaged. Recommend having the builder evaluate and make any necessary repairs or replacement.

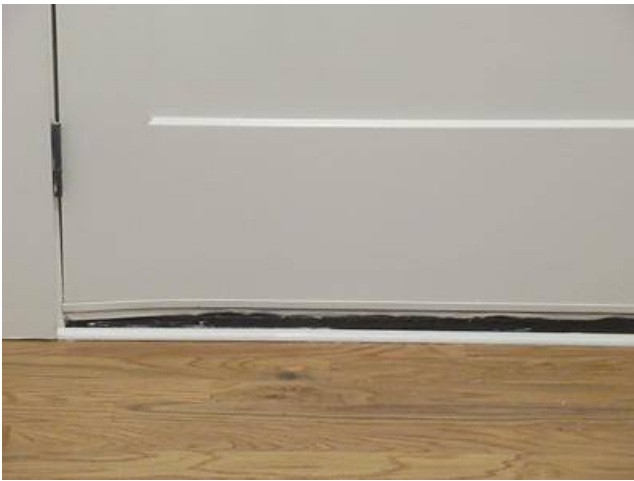
Photo 33-1

The door gasket at the bottom of the garage door is crooked or damaged. Recommend having the builder evaluate and make any necessary repairs.

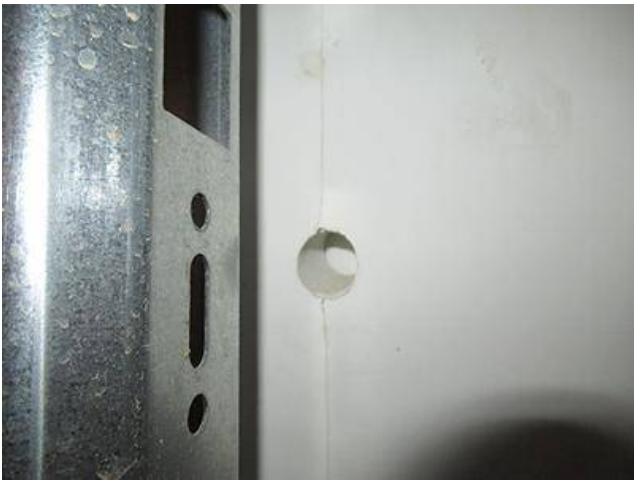
Photo 34-1

There is a hole in the garage door frame board on the right side if facing from inside the garage. Recommend having the builder evaluate and make any necessary repairs.

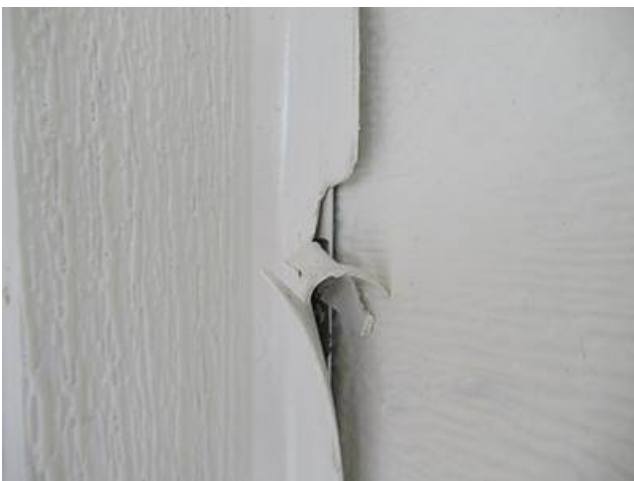
Photo 35-1

The weatherstripping at the left side of the garage door is damaged in one area. Recommend having the builder evaluate and make any necessary repairs.

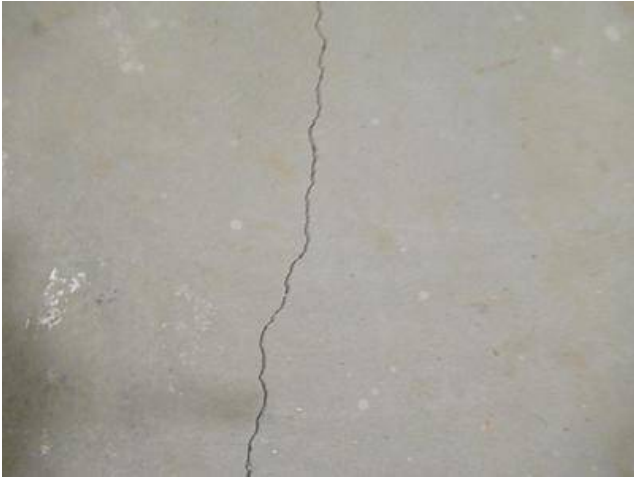
Photo 38-1

Minor cracks were found in the concrete slab floor. These are common and appeared to be only a cosmetic issue.

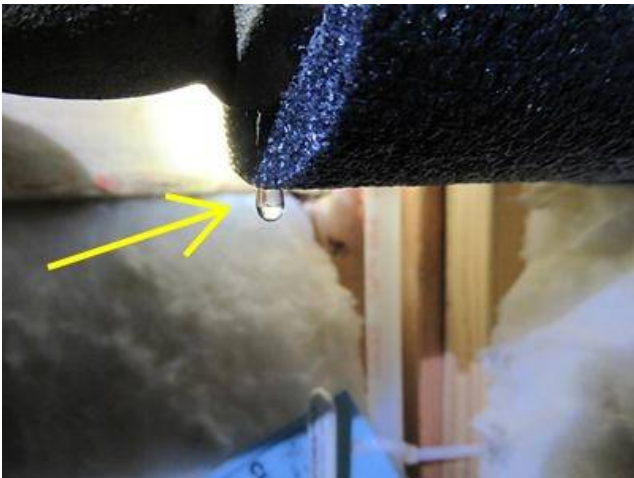
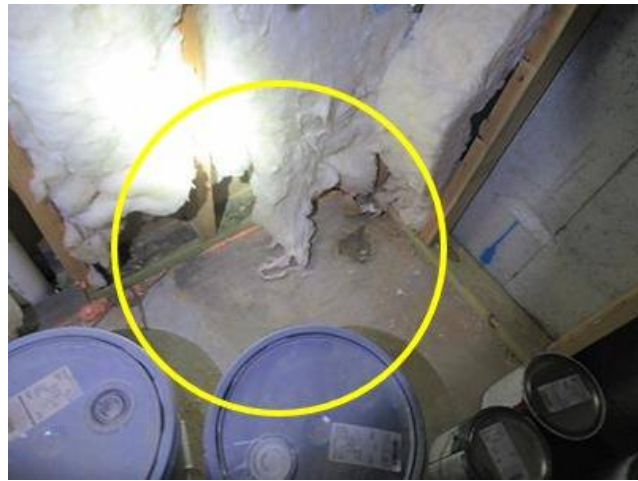
Photo 39-1

There appears to be a leak at one pipe connection for the tankless water heater. Recommend having the builder evaluate and make any necessary repairs.

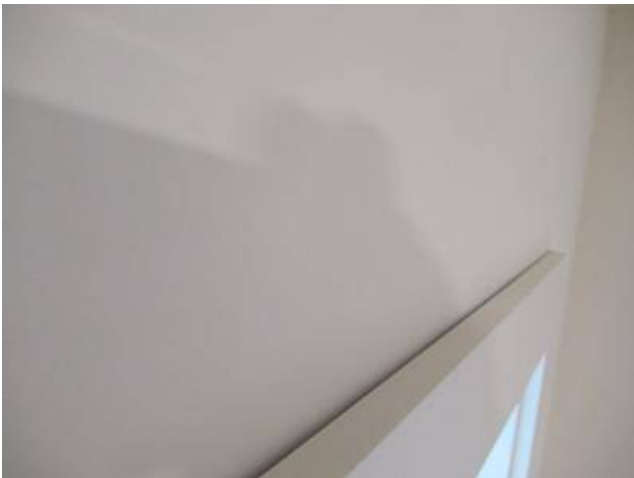
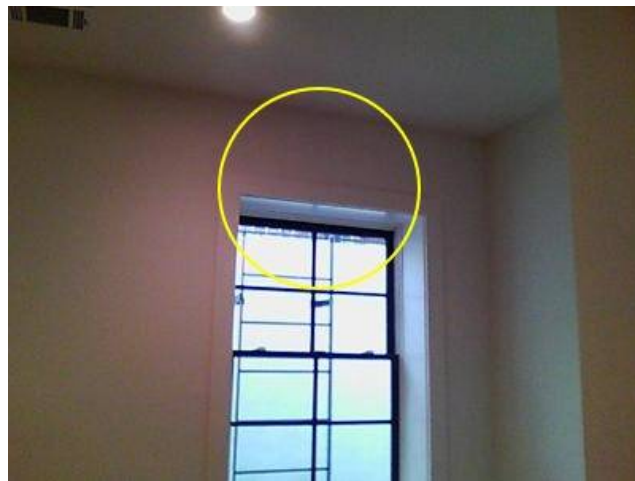
Photo 40-1

40) 🛠️ There is a gap, missing caulk, at the trim above the window in the basement bedroom. The infrared scan showed a temperature anomaly indicating cool air in this area. Recommend having the builder evaluate and make any necessary repairs.

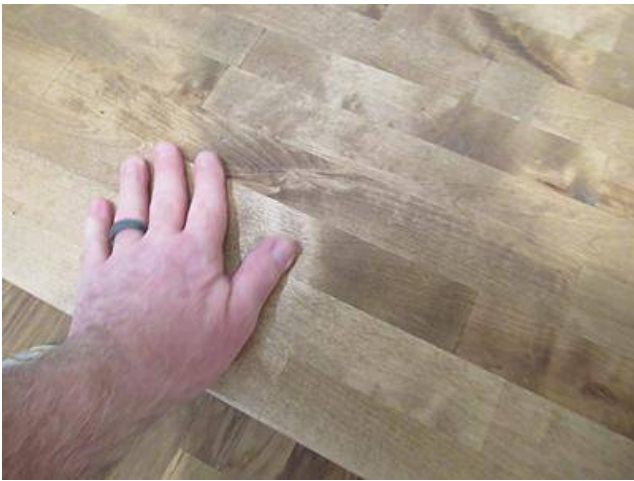
Photo 41-1

41) 🛠️ There is a rough finish on the bench in the basement hallway areas. Recommend having the builder evaluate and make any necessary repairs.

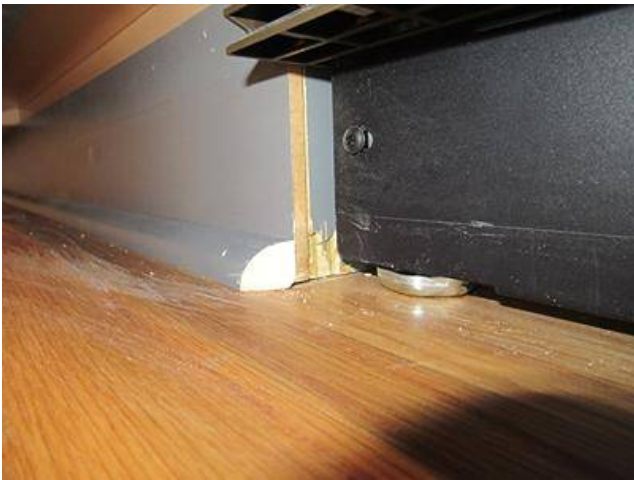
Photo 42-1

42) 🛠️ The ends of the shoe moulding in the basement bar area are not painted. Recommend having the builder evaluate and make any necessary repairs.

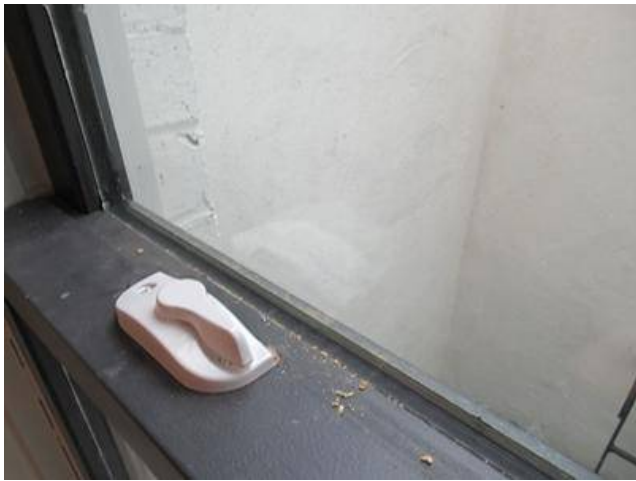
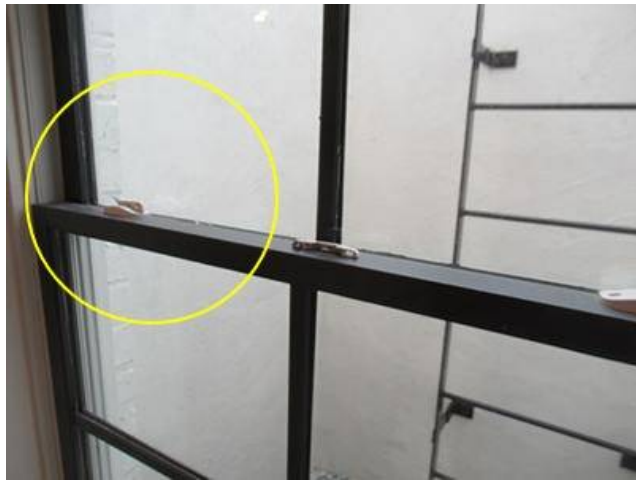
Photo 43-1

43) 🛠️ The lock receiver for the basement bedroom window needs repair. Recommend having the builder evaluate and make any necessary repairs.

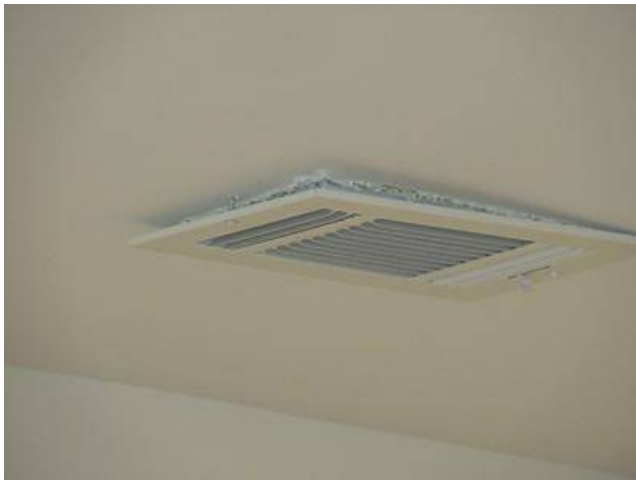
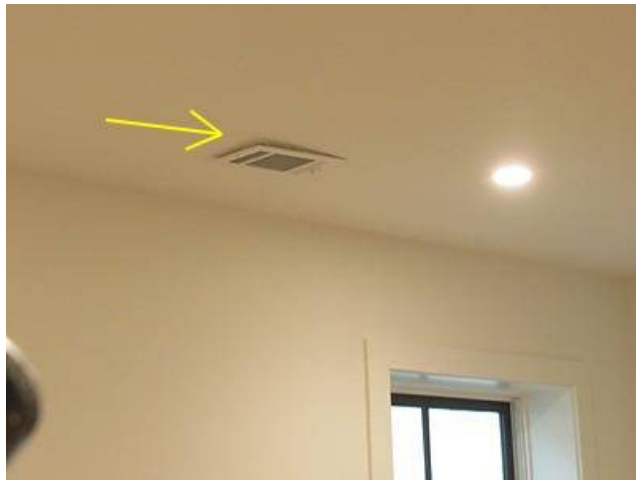
Photo 44-1

44) 🛠️ The air register in the basement bedroom is not flush with the ceiling. Recommend having the builder evaluate and make any necessary repairs.

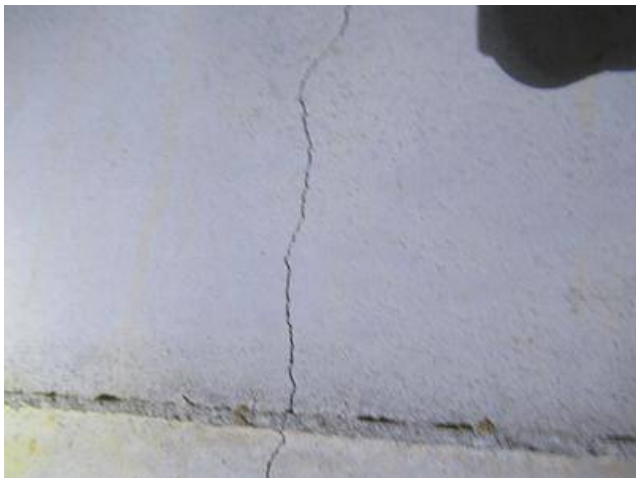
Photo 45-1

45) 🔍🏠📌 One or more minor cracks (1/8 inch or less) were found at the front wall of the foundation. These didn't appear to be a structural concern, but recommend sealing them to prevent water infiltration and monitor them in the future. Numerous products exist to seal such cracks including hydraulic cement, non-shrinking grout, resilient caulks and epoxy sealants.

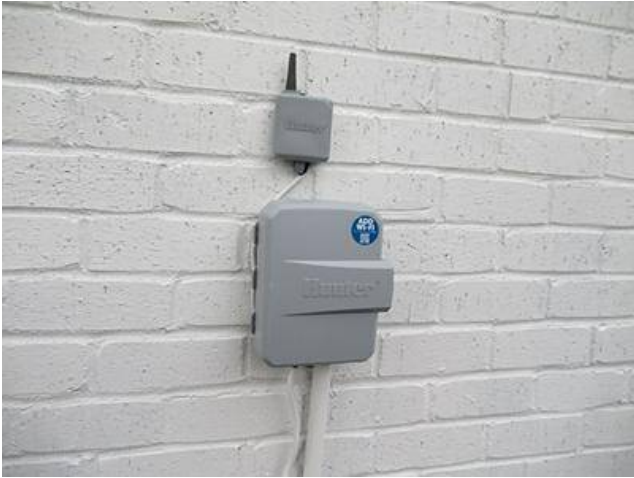
Photo 51-1

Based on visible equipment or information provided to the inspector, this property appeared to have a yard irrigation (sprinkler) system. These are specialty systems and are excluded from this inspection. Comments in this report related to this system are made as a courtesy only and are not meant to be a substitute for a full evaluation by a qualified specialist. When this system is operated, recommend verifying that water is not directed at building exteriors, or directed so water accumulates around building foundations. Sprinkler heads may need to be adjusted, replaced or disabled. Consider having a qualified plumber verify that a backflow prevention device is installed per standard building practices to prevent cross-contamination of potable water. Recommend that a qualified specialist evaluate the irrigation system for other defects (e.g. leaks, damaged or malfunctioning sprinkler heads) and repair if necessary.

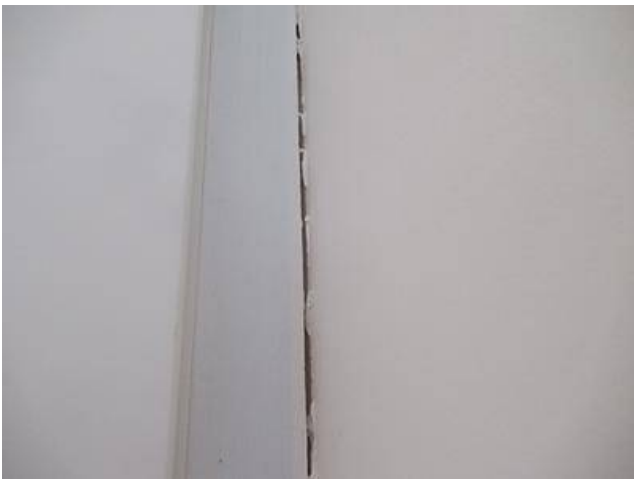
Photo 52-1

There is a gap at the wall by the cabinets in the laundry room. Recommend having the builder evaluate and make any necessary repairs.

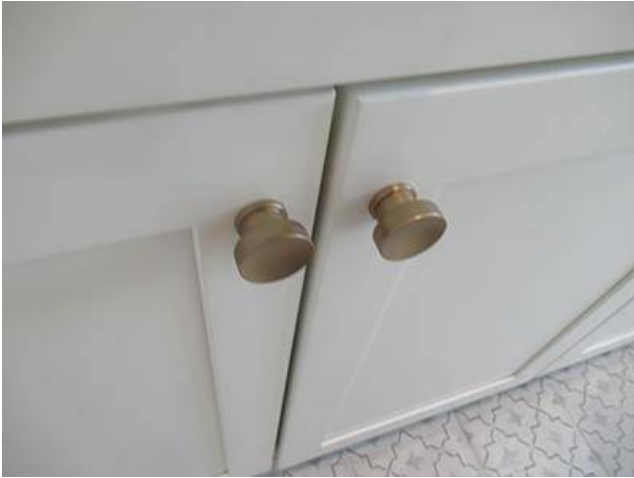
Photo 53-1

The cabinet doors in the laundry room need to be adjusted. Recommend having the builder evaluate and make any necessary repairs.

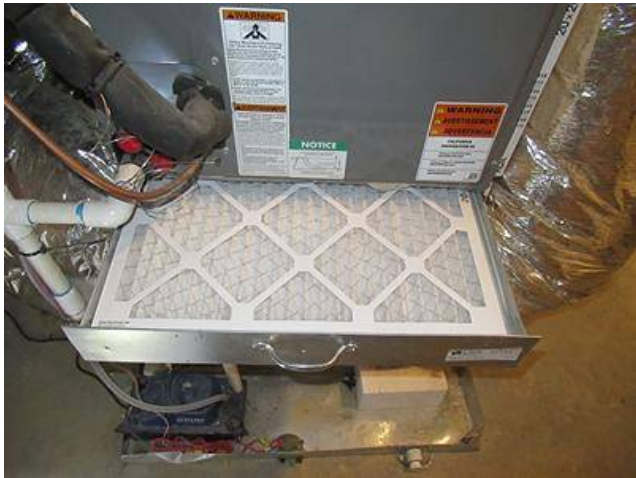
Photo 62-1

62) **i** Recommend that home buyers replace or clean HVAC filters upon taking occupancy depending on the type of filters installed. Regardless of the type, recommend checking filters monthly in the future and replacing or cleaning them as necessary. How frequently they

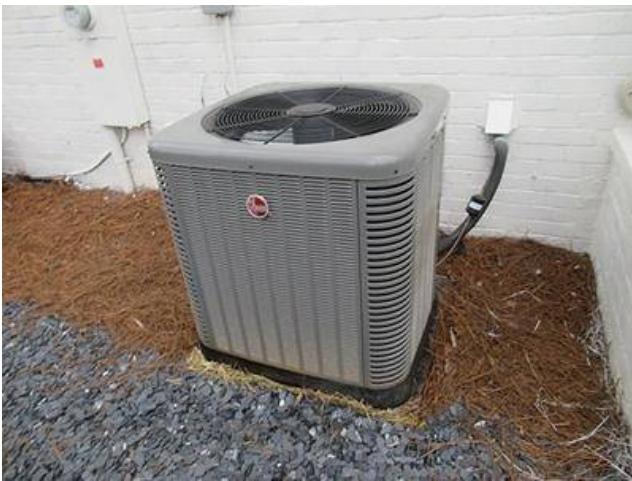
Photo 67-1

67) **i** The outdoor air temperature was below 65 degrees Fahrenheit during the inspection. Air conditioning systems can be damaged if operated during such low temperatures. Because of this, the inspector was unable to operate and fully evaluate the cooling system.

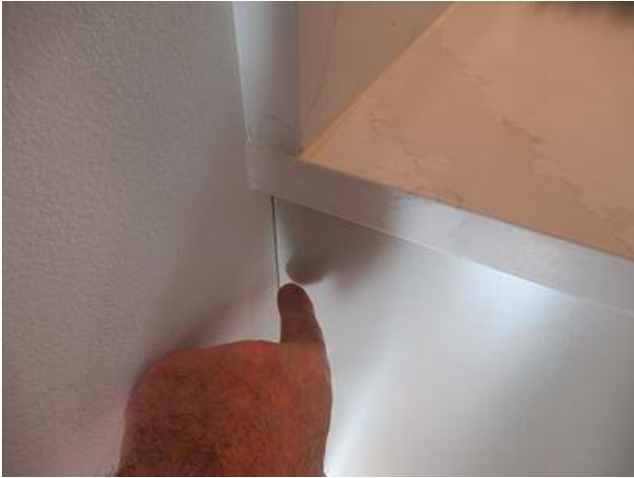
Photo 71-1

71) 🛠️ The cabinet scribes or trim pieces between the cabinets and the walls, are missing in one or more areas of the kitchen. Recommend having the builder evaluate and make any necessary repairs.

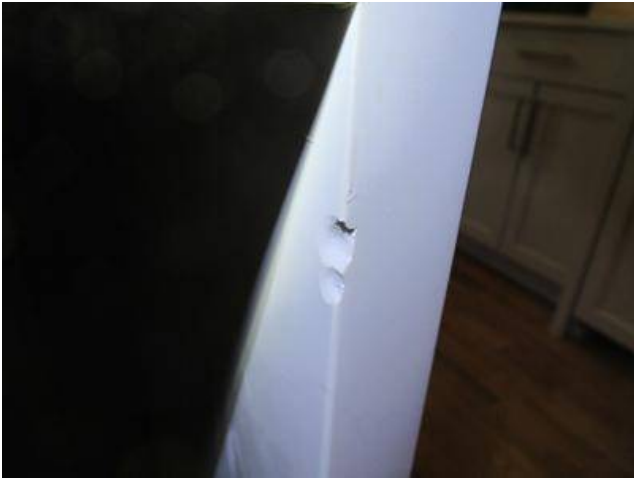
Photo 72-1

There is a chip in the side of the kitchen island. Recommend having the builder evaluate and make any necessary repairs or replacement.

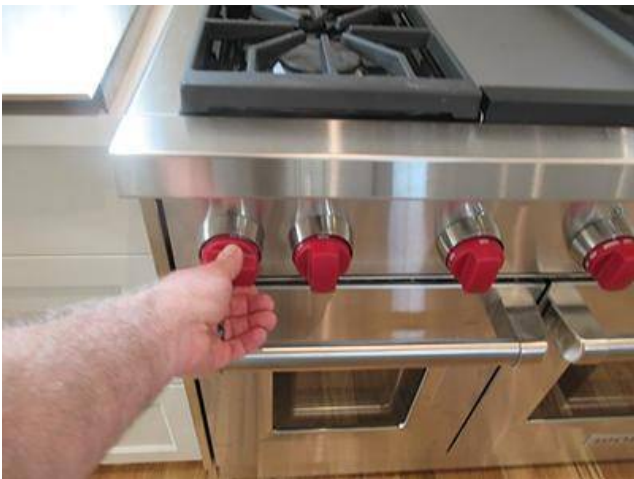
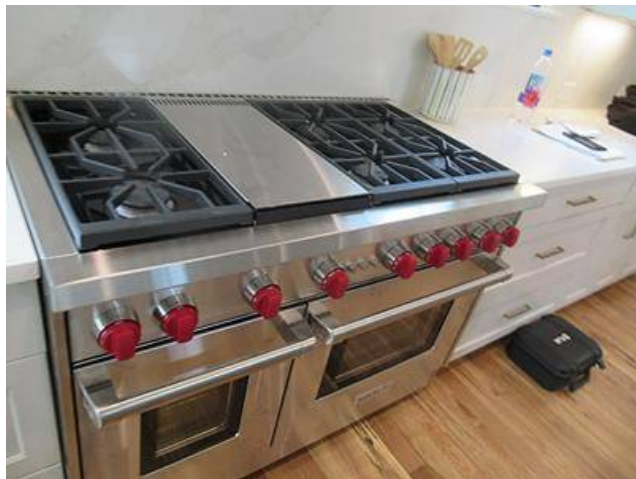
Photo 73-1

The gas stove and ovens were not functional at the time of the inspection. Recommend having the builder evaluate and make any necessary repairs.

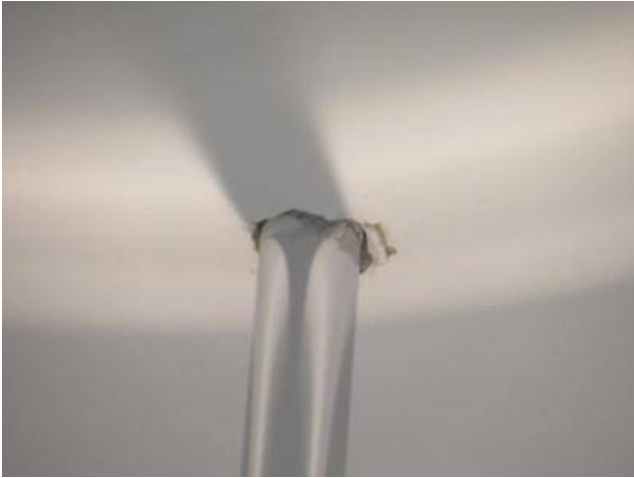
Photo 81-1

The upper showerheads in the master bathroom are missing the stem flanges at the ceiling. Recommend having the builder evaluate and make any necessary repairs.

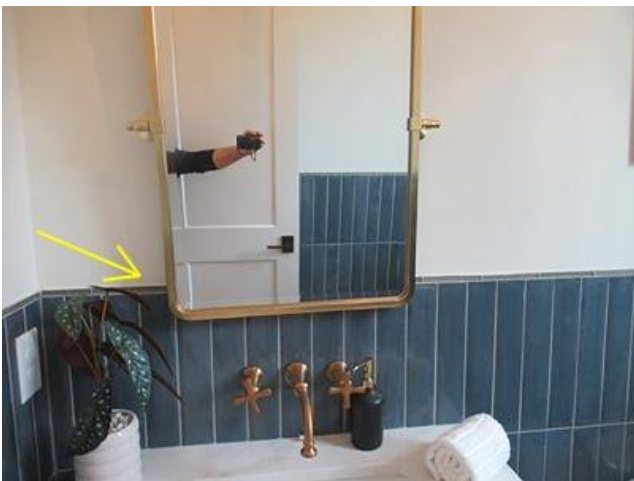
Photo 82-1

The mirror in the main floor half bathroom is installed crooked. Recommend having the builder evaluate and make any necessary repairs.

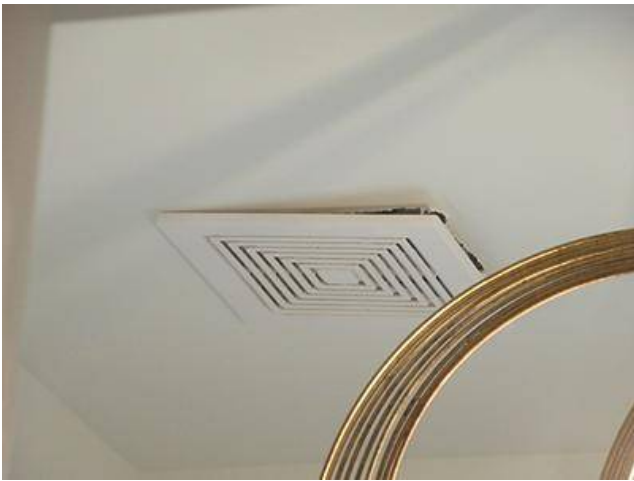
Photo 83-1

The fan grill for the main floor half bathroom is not flush with the ceiling. Recommend having the builder evaluate and make any necessary repairs.

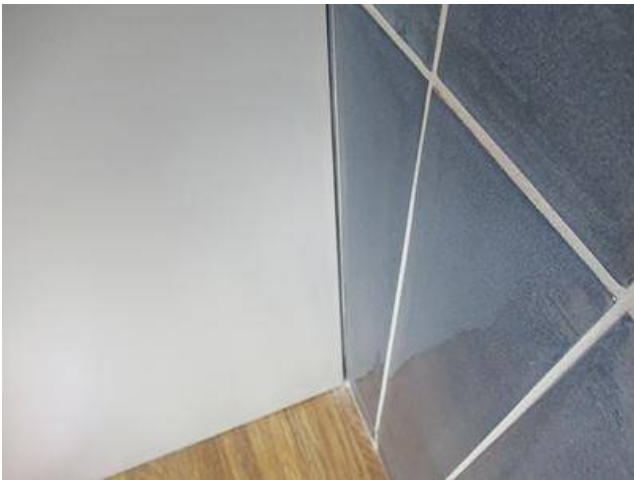
Photo 84-1

The main floor half bathroom cabinet is missing the scribe or trim piece between the cabinet and the wall. Recommend having the builder evaluate and make any necessary repairs.

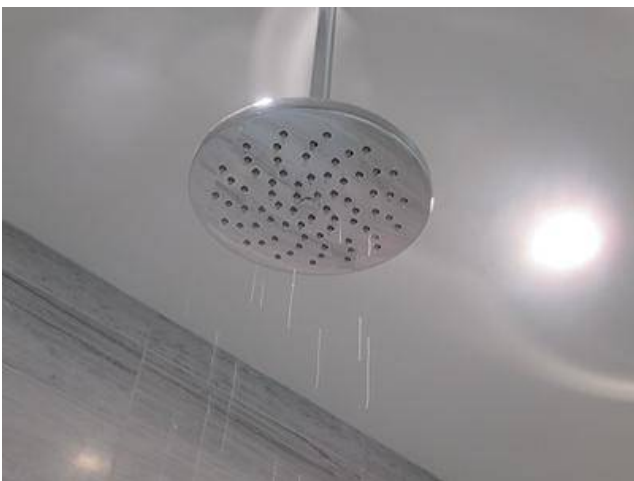
Photo 85-1

The left side upper showerhead in the master bathroom shower was not functional at the time of the inspection. Recommend having the builder evaluate and make any necessary repairs.

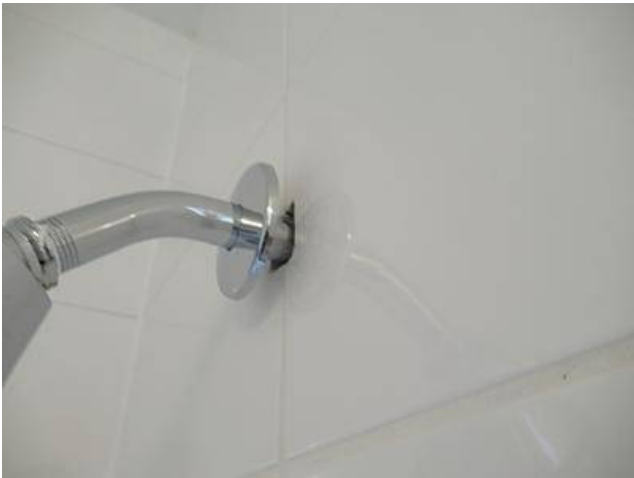
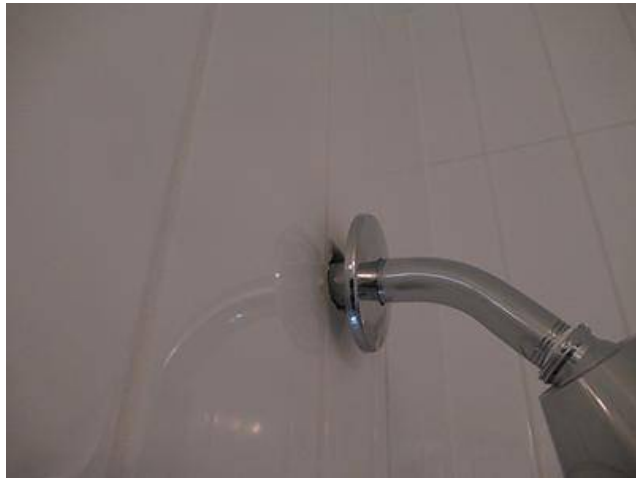
Photo 86-1

86) 🛠️ The bathroom shower stem flanges are not secured to the wall. Recommend having the builder evaluate and make any necessary repairs.

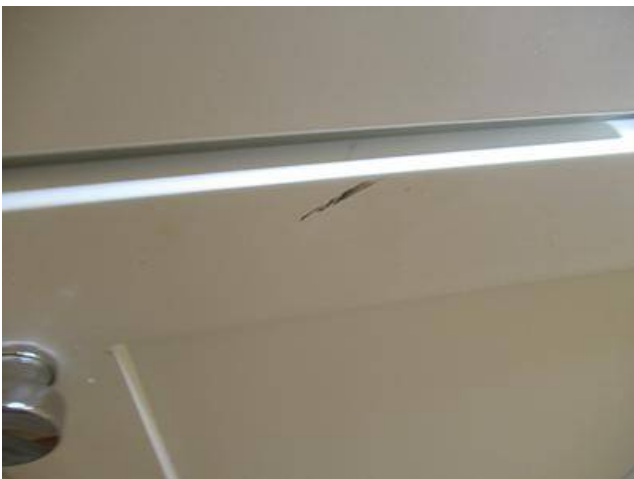
Photo 87-1

87) 🛠️ There is a mark on the cabinet door in the basement bathroom. Recommend having the builder evaluate and make any necessary repairs.

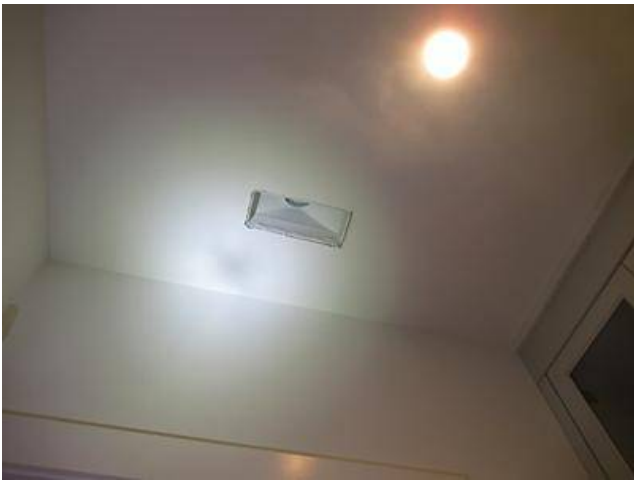
Photo 90-1

One air register vent in the bar area by the kitchen is missing. Recommend having the builder evaluate and make any necessary repairs.

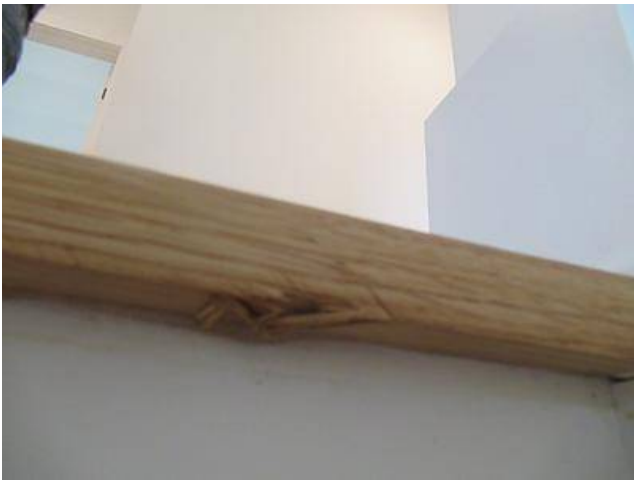
Photo 91-1

Damage was noticed at the stairs in one or more areas. Recommend having the builder evaluate and make any necessary repairs.

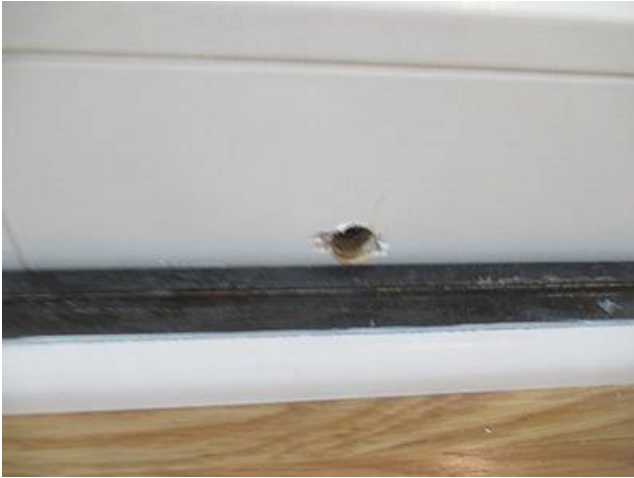
Photo 92-1

The sliding glass doors are missing the screw dowels that cover the holes at the bottom of the door. In addition, there is paint or sealant on the exterior side of the glass. Recommend having the builder evaluate and make any necessary repairs.

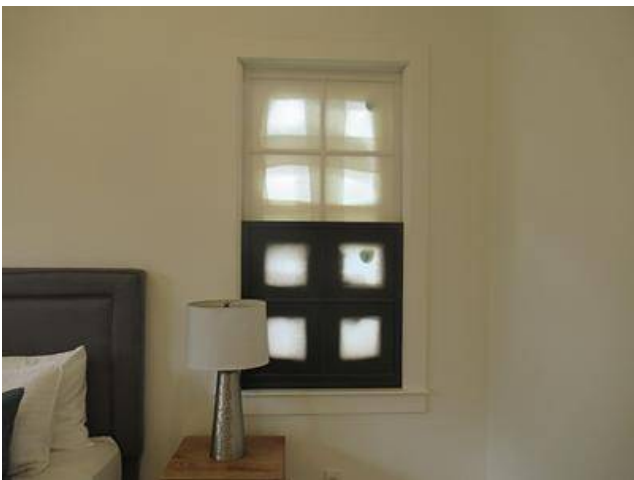
Photo 93-1

93) 🛠️ One master bedroom window is broken. The builder is aware of this replacement.

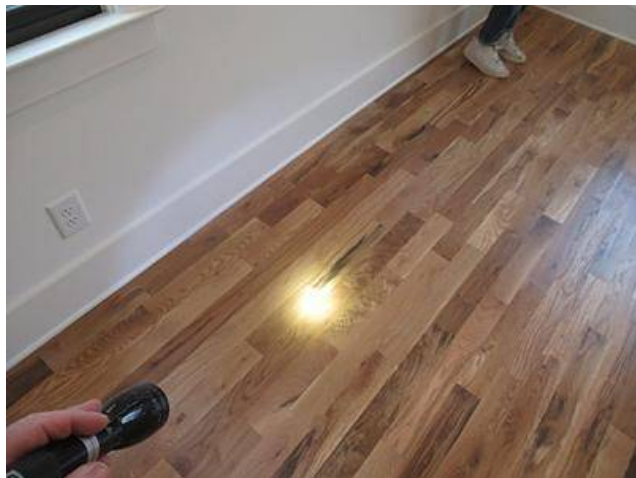
Photo 94-6

94) 🛠️ The flooring made popping noises in multiple areas throughout the house. Recommend having the builder evaluate and make any necessary repairs.
