## Open Eye Home Inspections LLC

### Property New Home Final Inspection Report

Client(s): **Sample Report 3**

Inspection date: **Thursday, January 26, 2023**

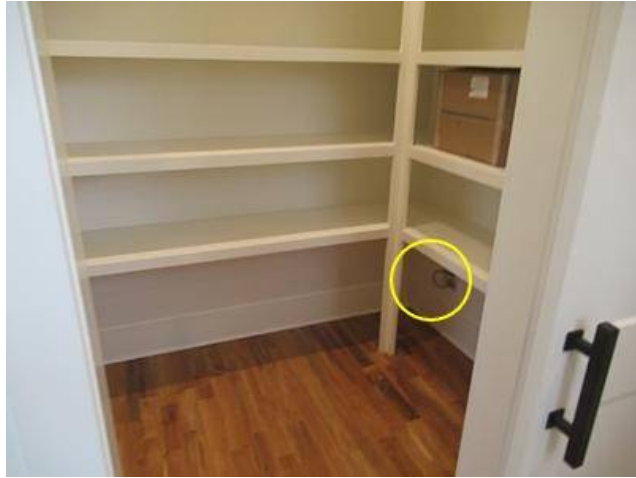
Photo 95-2

95) 🛠️ The water supply line in the pantry was protruding from the cut out area. Leaks may occur if stored items under the shelf come in contact with the water line. Recommend having the builder evaluate and make any necessary repairs.

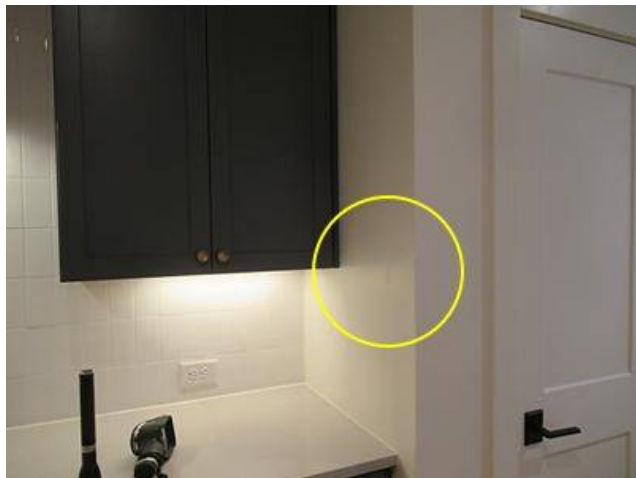
Photo 96-22

96) 🛠️ Multiple cosmetic concerns were noticed throughout the house. Recommend having the builder evaluate and make any necessary repairs.

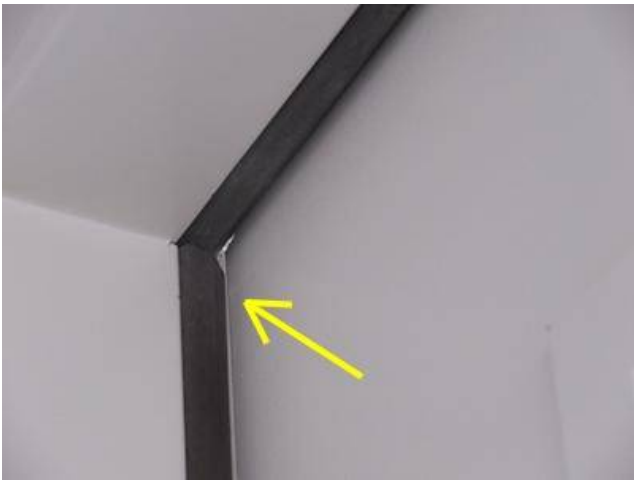
Photo 97-1

97) 🛠️ The door to the back deck does not make a good seal at the top when closed and latched. The infrared scan shows the energy loss in this area. Recommend having the builder evaluate and make any necessary repairs.

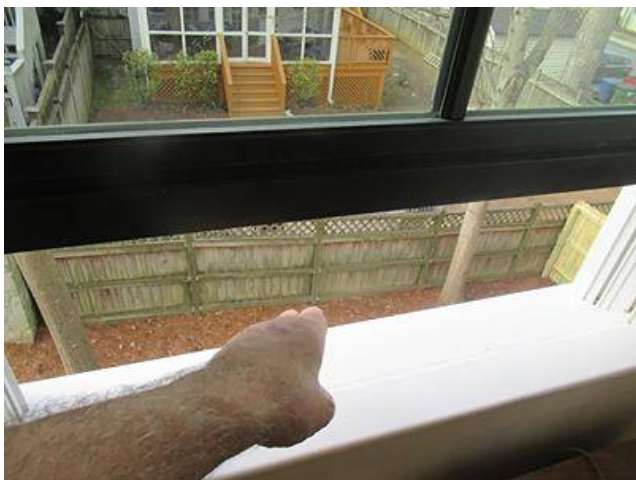
Photo 100-1

Screens were missing from all windows. These windows may not provide ventilation during months when insects are active.
