## Open Eye Home Inspections LLC

### Property Pre-Drywall Inspection Report

Inspection date: **Wednesday, August 2, 2023**

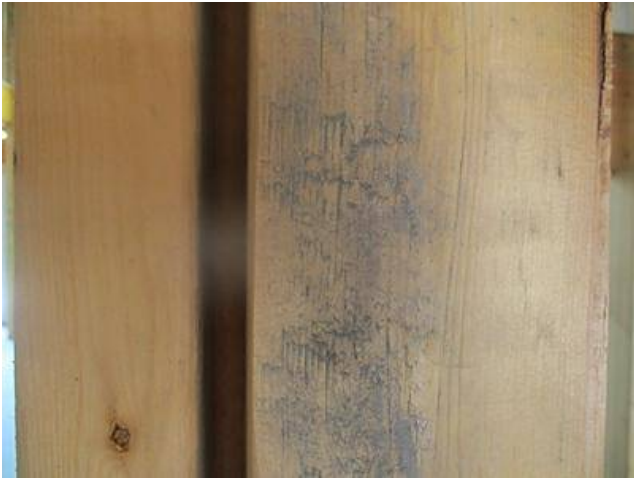
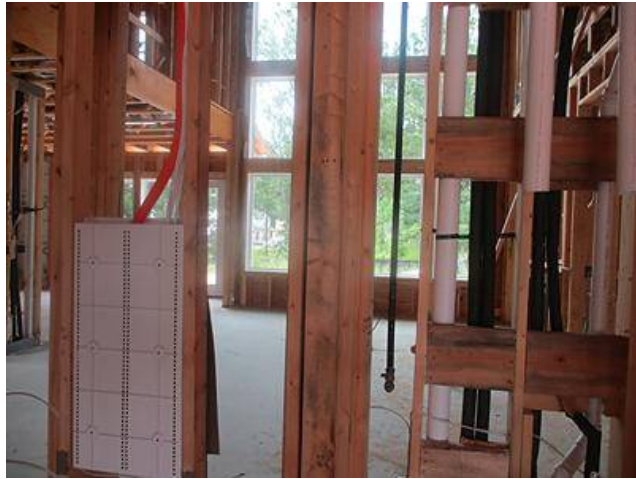
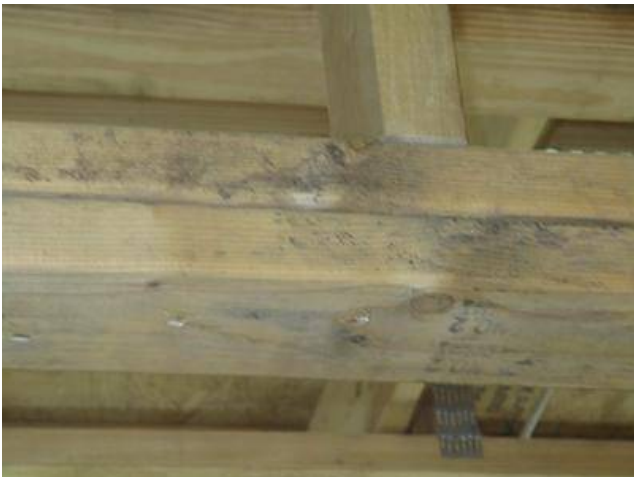
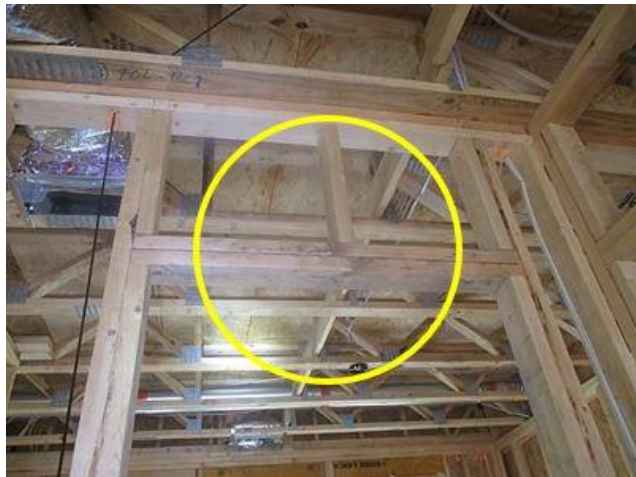
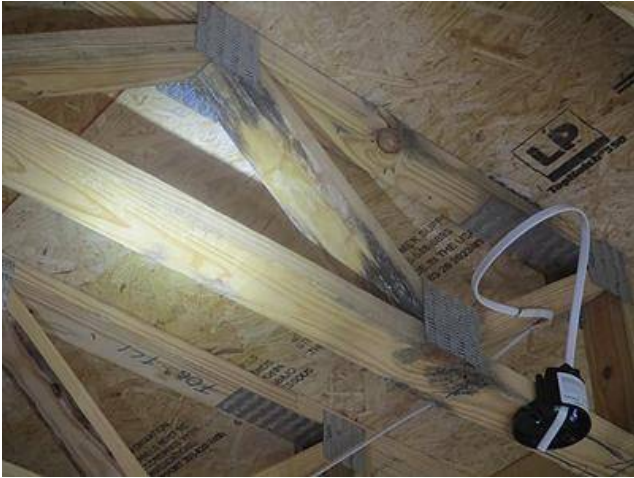
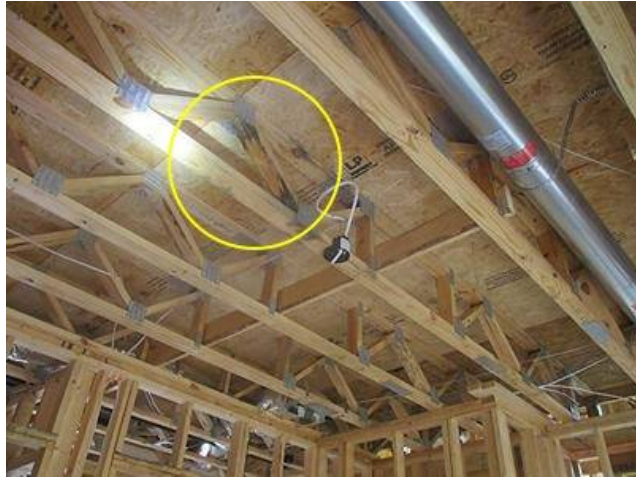
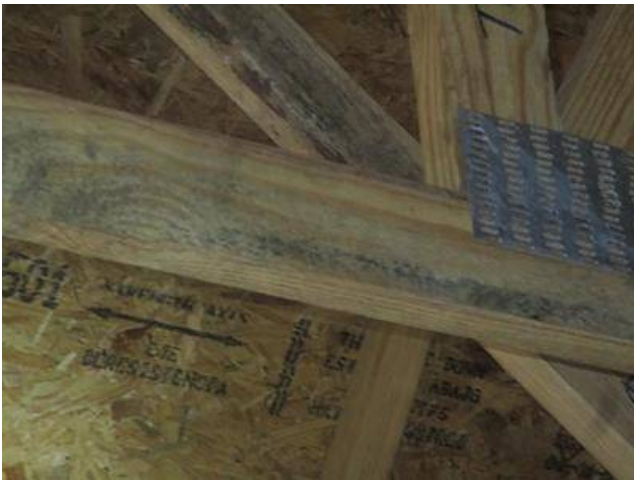
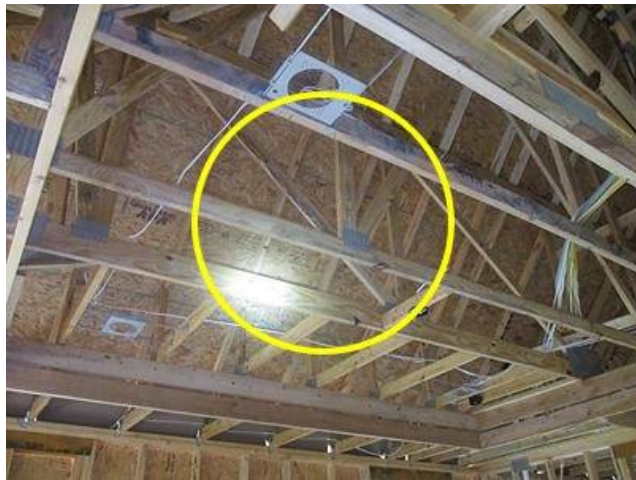
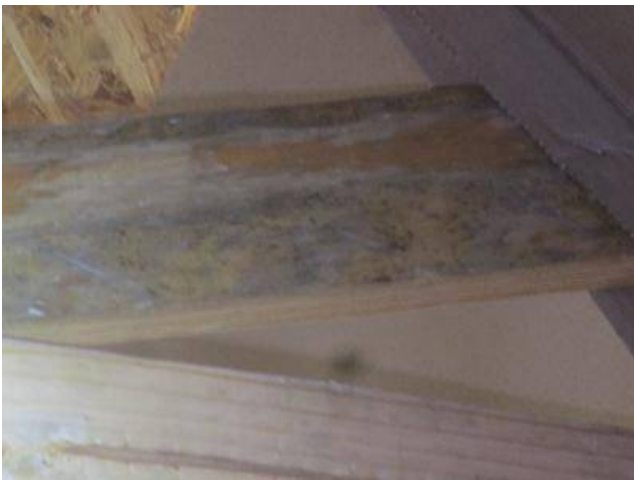
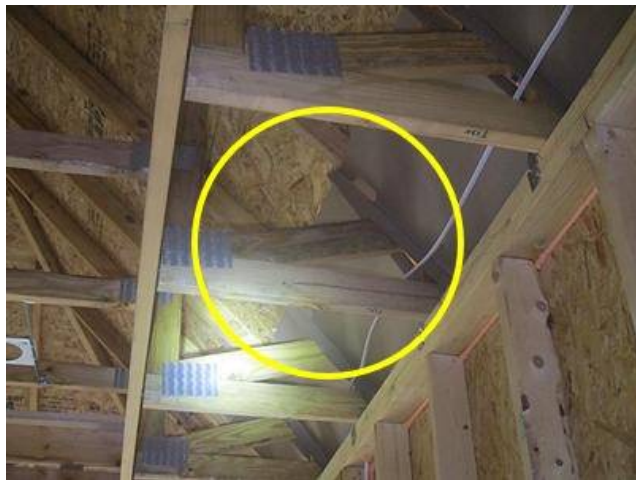
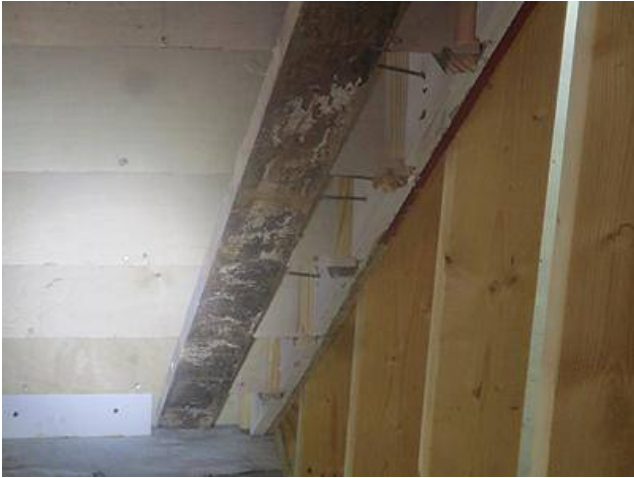
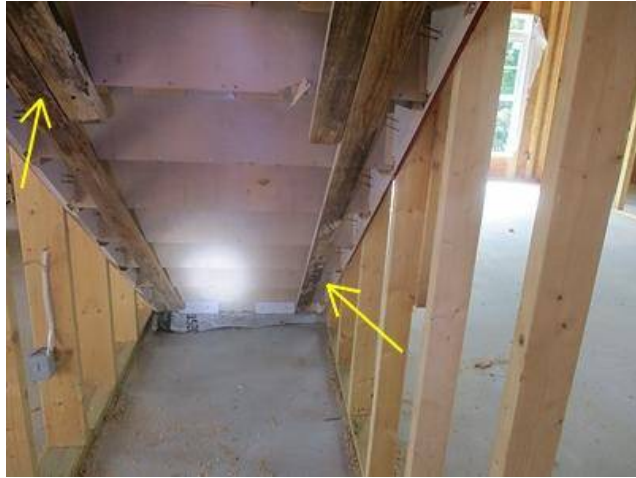
Microbial growths were found at one or more locations in interior rooms and/or wood framing. It is beyond the scope of this inspection to identify what substance or organism this staining is. However such staining is normally caused by excessively moist conditions in the wood before and during construction. These conducive conditions should be corrected before making any attempts to add drywall. Recommend having the builder evaluate and make any necessary repairs. For more information, visit:

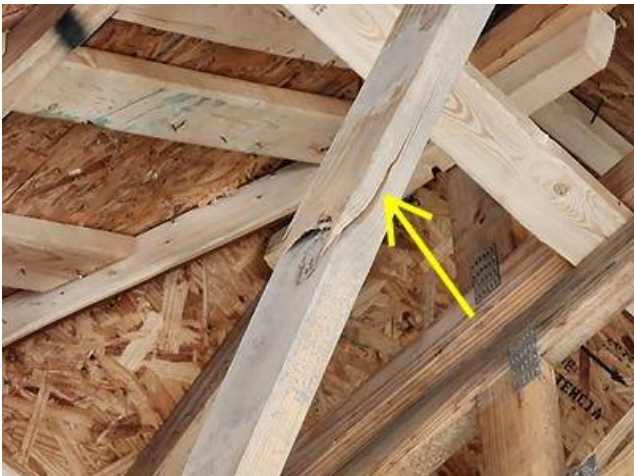
Photo 4-1

4) **i** One or more roof trusses were cut, damaged or modified. The roof structure has likely been weakened as a result. Trusses are engineered components and shouldn't be cut or modified by builders or homeowners. Repairs may involve restoring the trusses to their original condition or configuration. Recommend that a licensed structural engineer evaluate and prescribe repairs as necessary. A qualified contractor should perform repairs per the engineer's specifications.

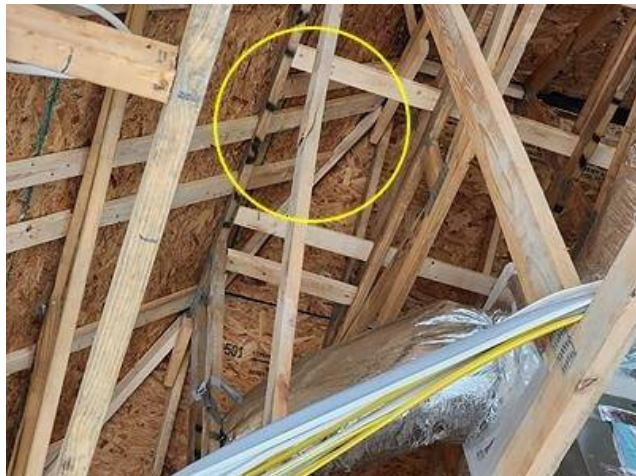
Photo 4-2 LOCATED ABOVE THE MASTER BEDROOM.

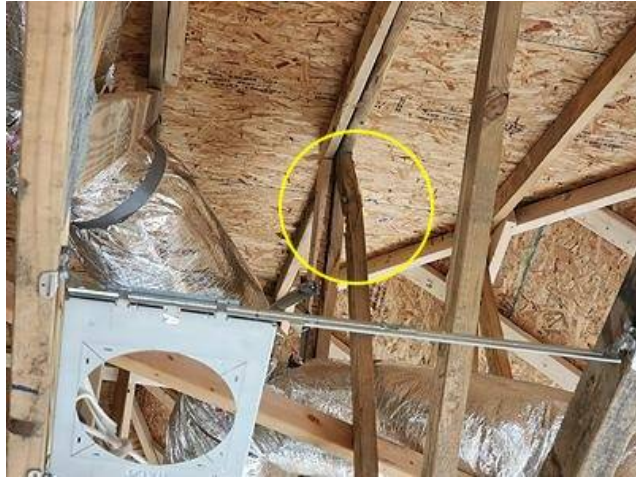
Photo 4-4 LOCATED ABOVE THE MASTER BATHROOM AND MASTER CLOSET AREA.

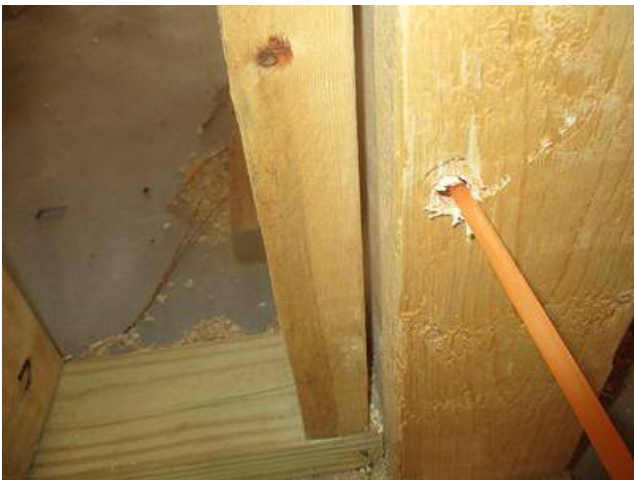
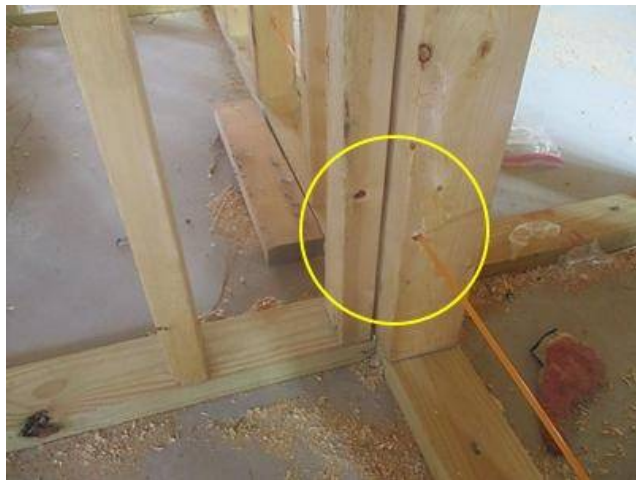
Nail plates or kick plates meant to protect wiring were missing at one or more locations. Wiring can be damaged when finished wall materials are installed. This can be a shock or fire hazard. Recommend having the builder evaluate and install nail plates where needed and missing.

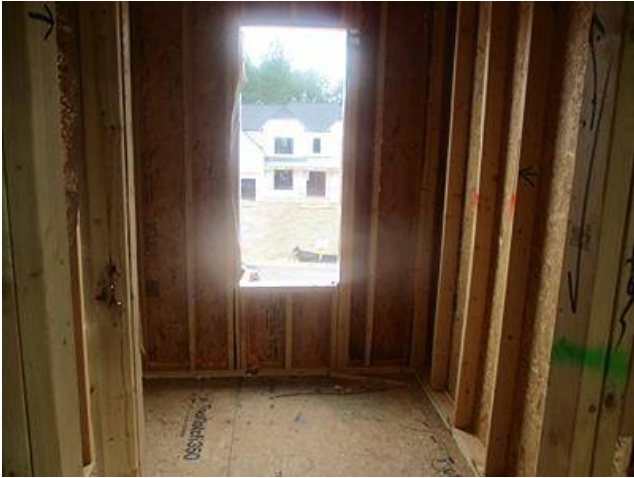
Photo 6-1

One window was missing at the front left side of the structure at the time of the inspection. Recommend having the builder evaluate and repair.

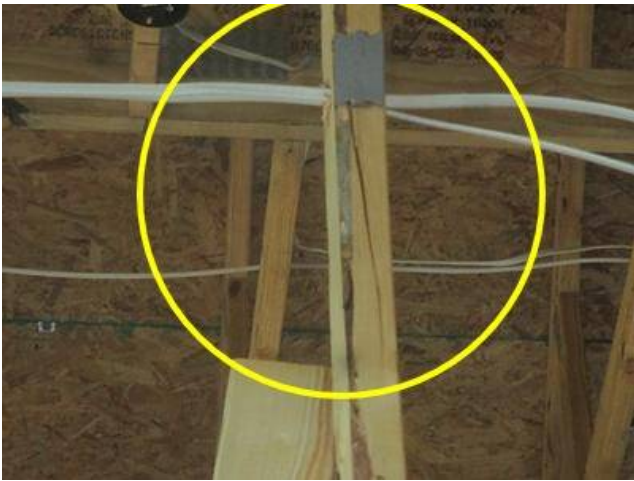
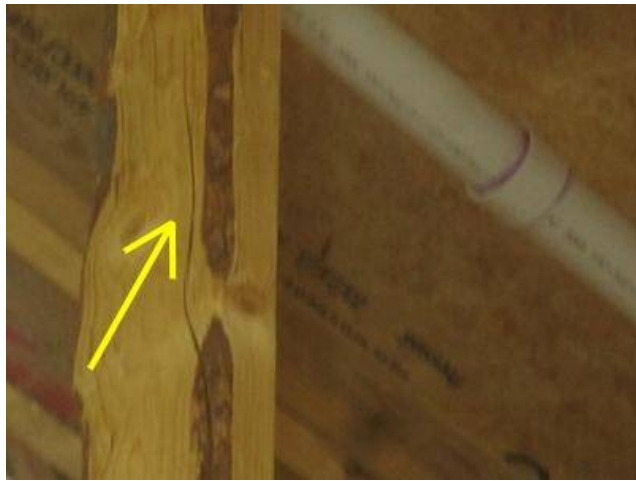
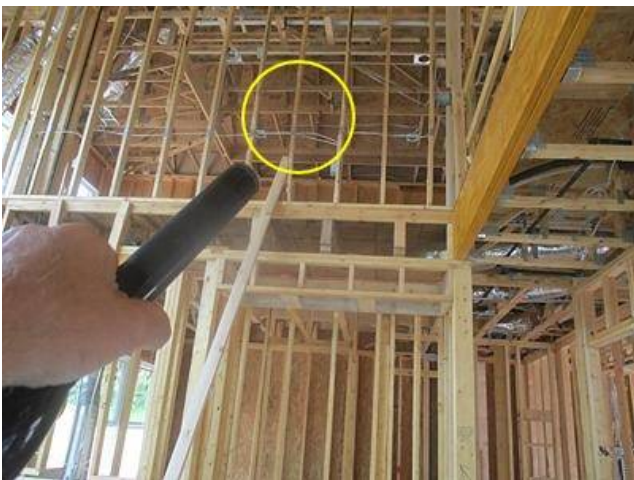
One wall stud on the upper level, is split. Recommend having the builder evaluate and repair.

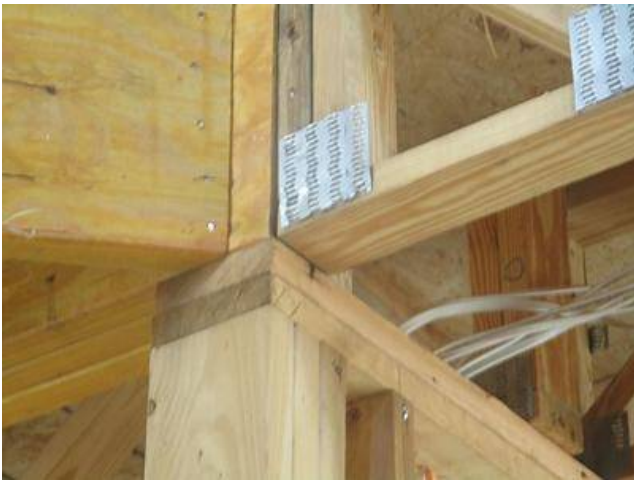
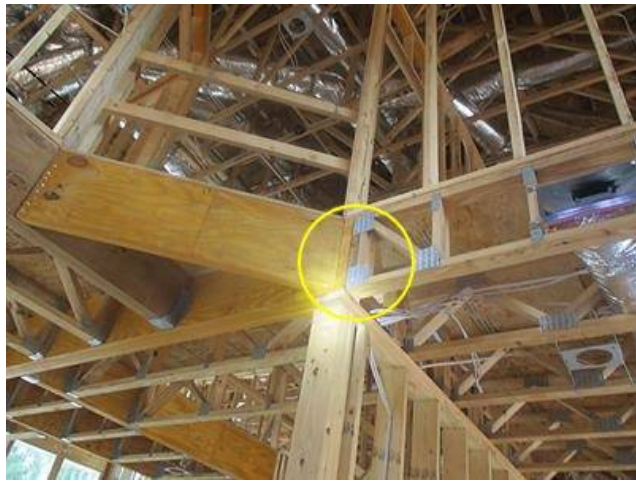
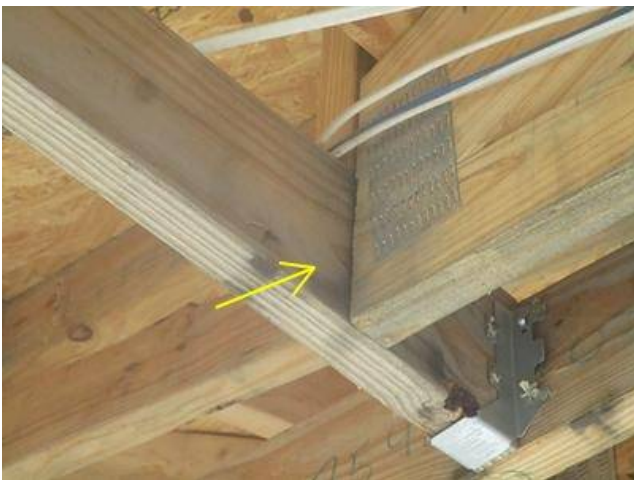
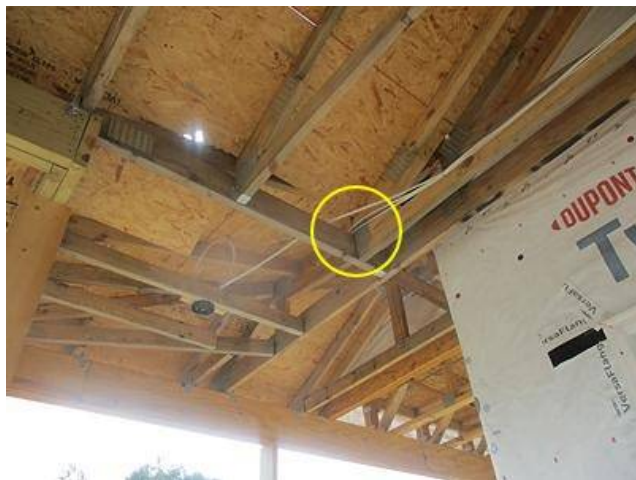
Joist hangers are missing at one truss in the foyer wall ceiling and one on the front porch area. Recommend having the builder evaluate and install joist hangers where they are missing.

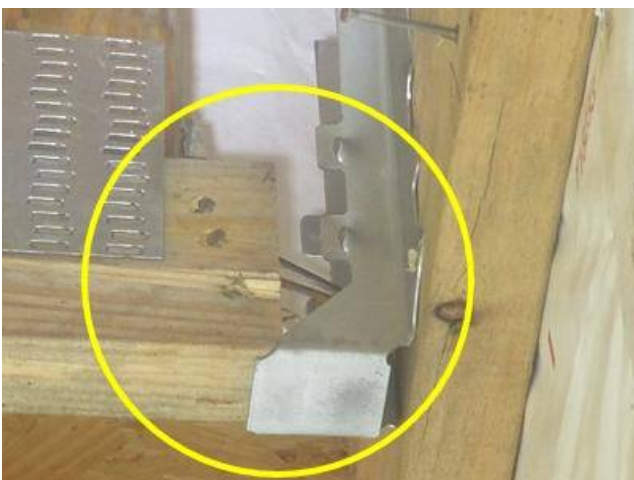
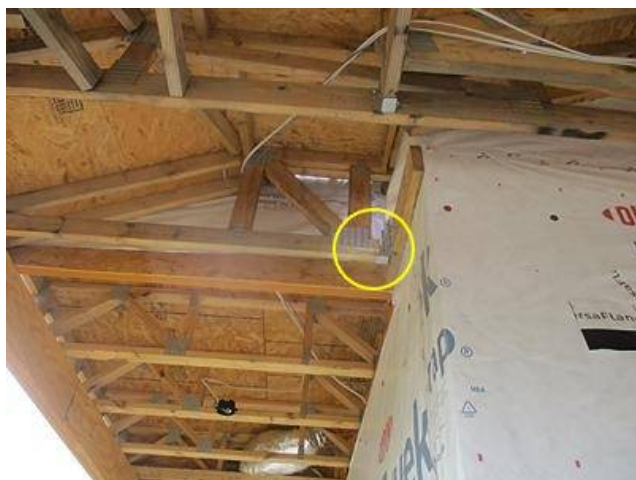
One rafter truss at the front porch area is barely touching the joist hanger. Recommend having the builder evaluate and repair.

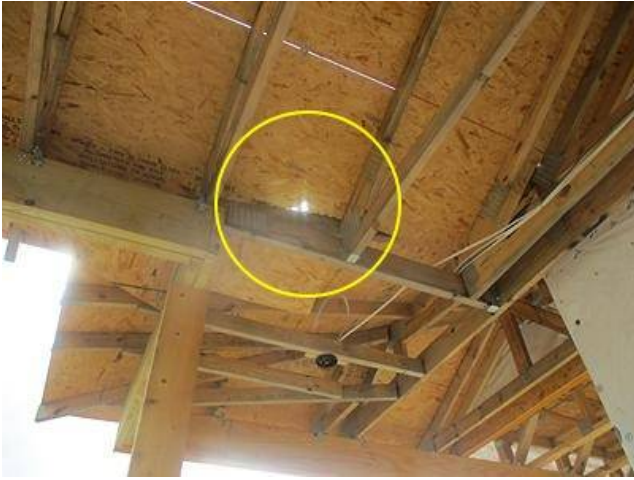
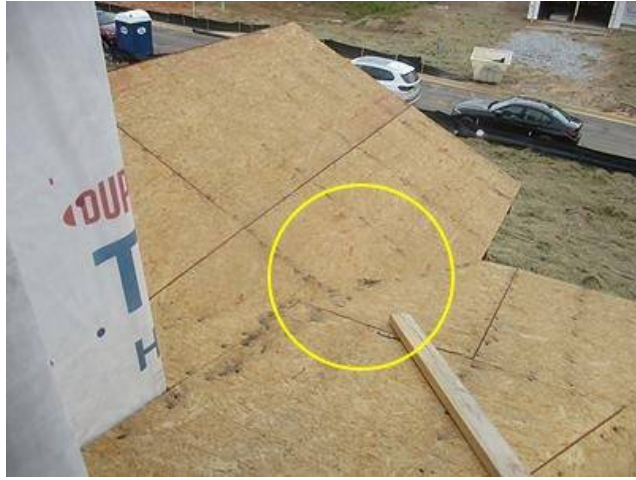
A hole was noticed in the roof decking in the valley at the front of the roof above the front porch. Recommend having the builder evaluate and repair.

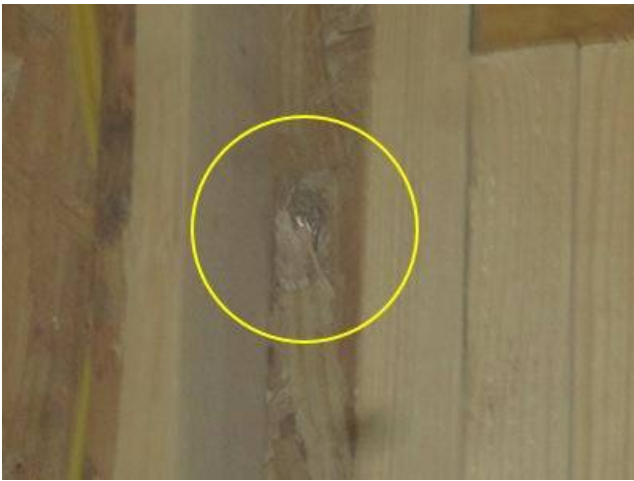
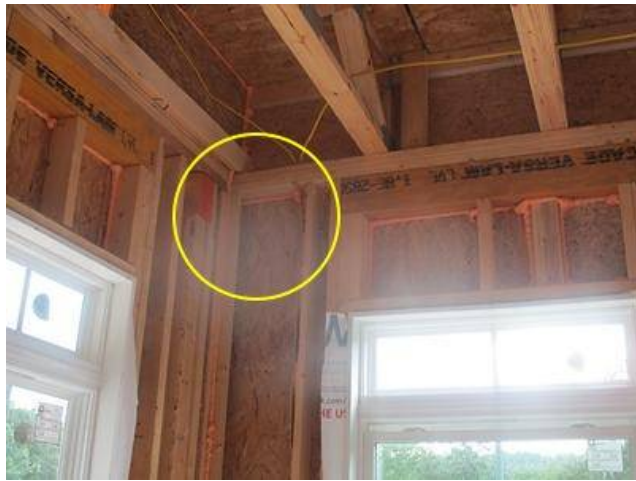
There is a hole in the wood sheathing at the front left side of the house. Recommend having the builder evaluate and repair.

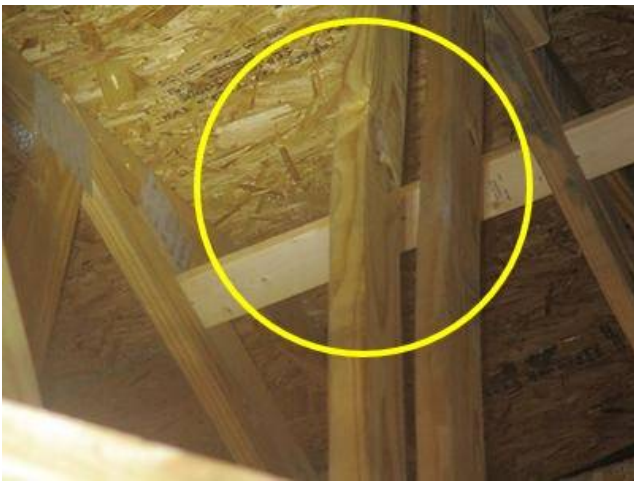
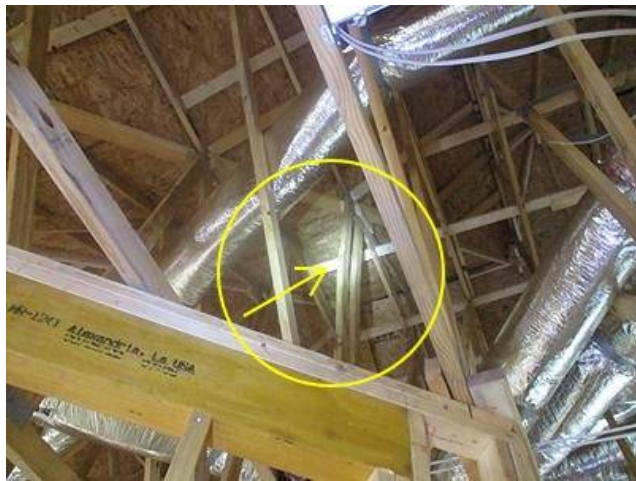
One truss board is bowed in the attic area above the left side of the house. Recommend having the builder evaluate and repair.

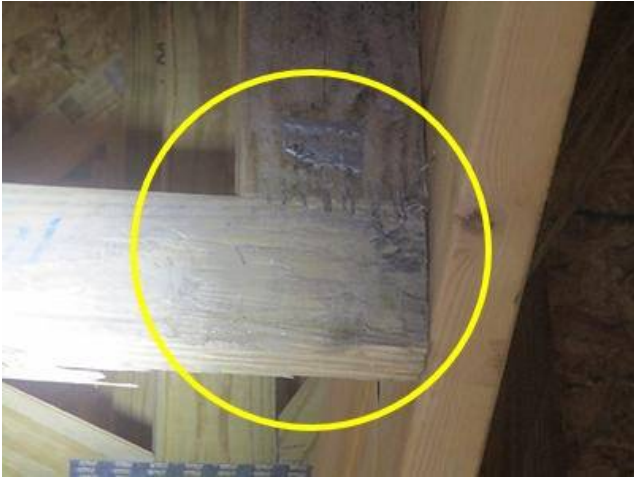
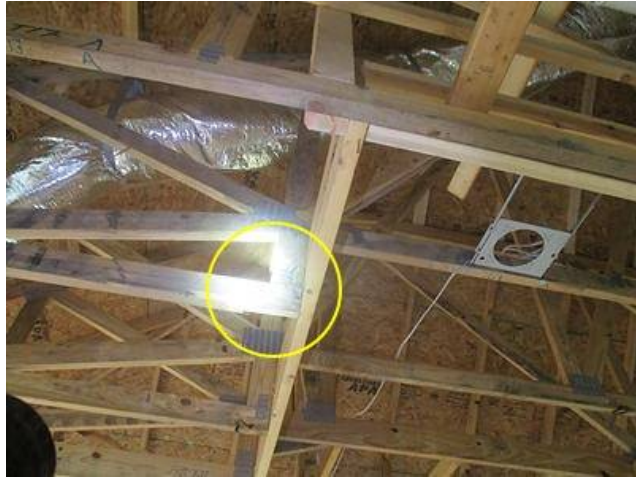
One gusset is missing at a truss above the master bedroom at the back of the room. Recommend having the builder evaluate and repair.

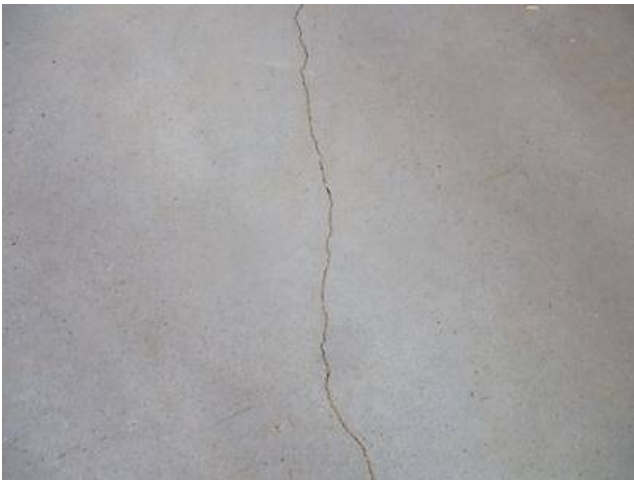
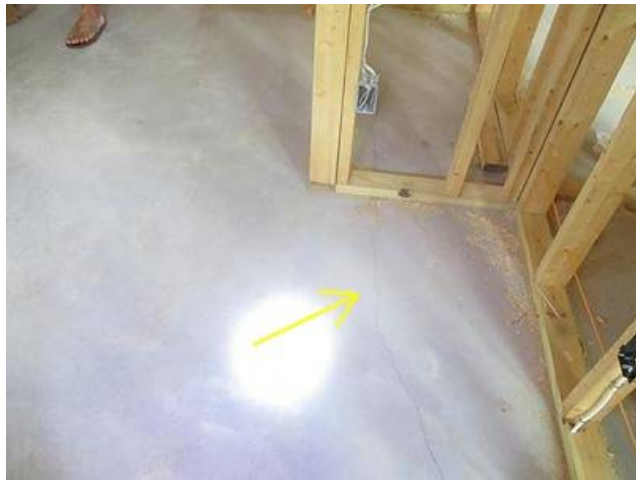
14) 🛠️ Minor cracks were noticed in the concrete slab. These are not a structural concern. However, recommend having the builder evaluate and fill the cracks as necessary before the flooring is installed.
