## Open Eye Home Inspections LLC

### Property Inspection Report

Inspection date: **Monday, July 1, 2024**

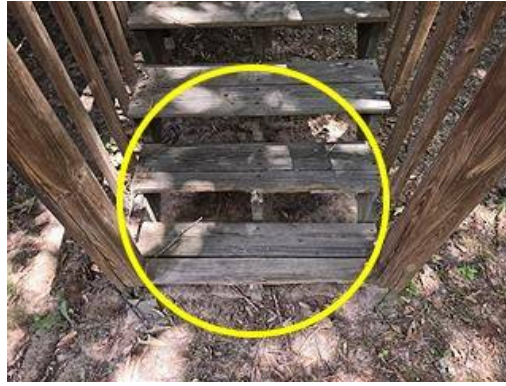
Photo 4-2

One or more treads at exterior stairs were deteriorated. This is a potential fall hazard. Recommend that a qualified person repair as necessary.

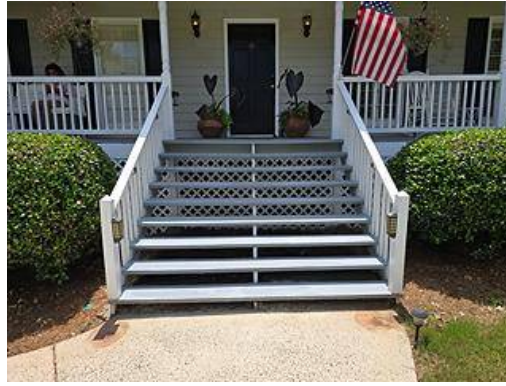
Photo 7-2

The front steps need more stringers to support the stair treads. Recommend having a qualified contractor evaluate and make any necessary repairs.

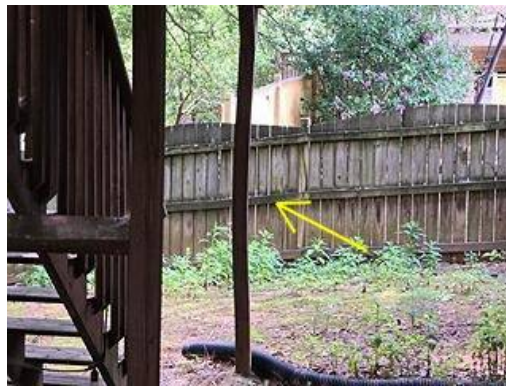
Photo 8-2

This deck is not considered safe by today's standards. The 4x4 posts are too small and in contact with the soil. The deck frame is single board band instead of double. One post is bowed. Recommend having a qualified contractor evaluate and make any necessary repairs.

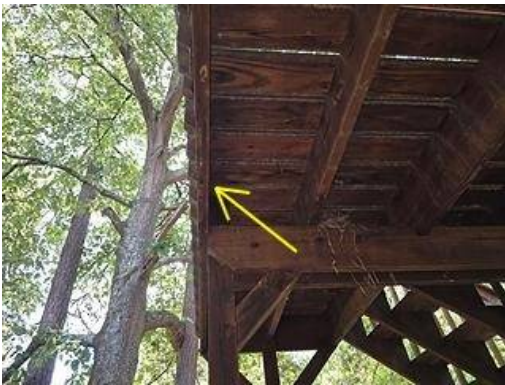
Photo 8-3 SINGLE BOARD FRAME.

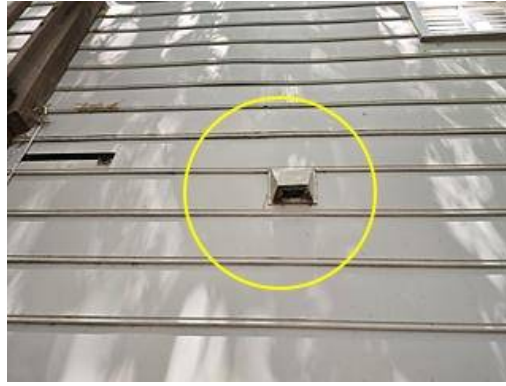
Photo 11-2

11) **+** **i** The clothes dryer exhaust duct appeared to need cleaning. Significant amounts of lint build-up were visible and may reduce air flow. This is a fire hazard. Recommend that a qualified person clean this duct now and as necessary in the future. Some chimney sweeps or heating/cooling duct cleaners perform this service. For more information, visit:

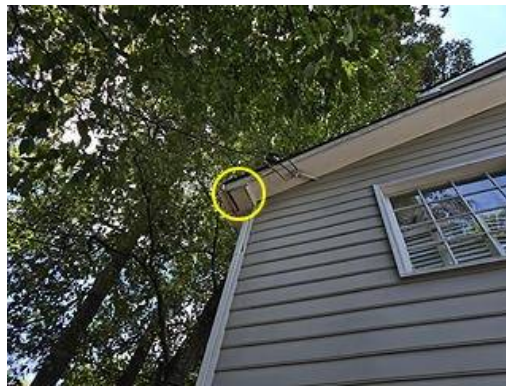
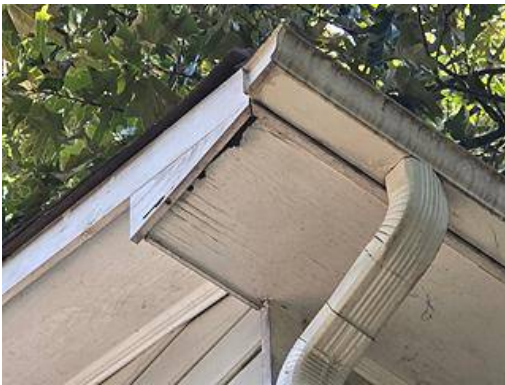
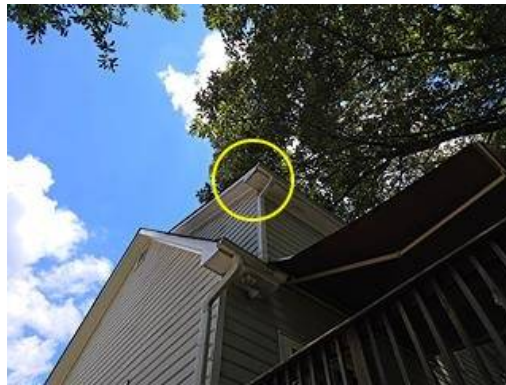
Soffit boards are sagging or damaged in one or more areas. Recommend having a qualified contractor evaluate and make any necessary repairs.

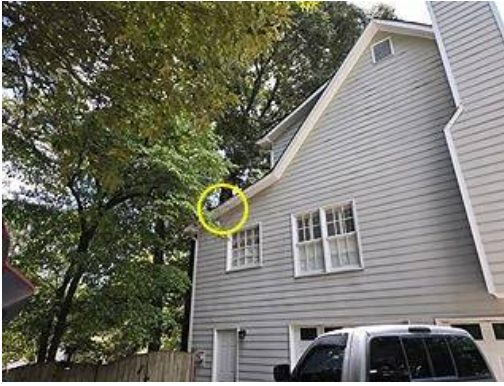
Photo 13-2

Fascia boards are damaged in one or more areas. Recommend having a qualified contractor evaluate and make any necessary repairs.

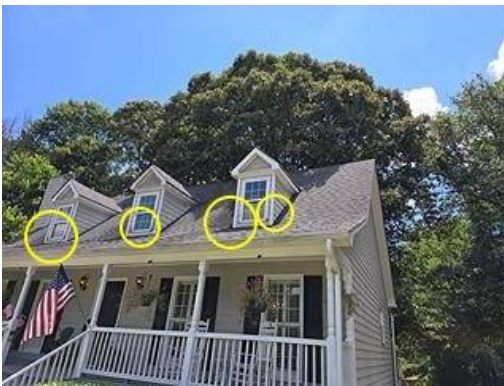
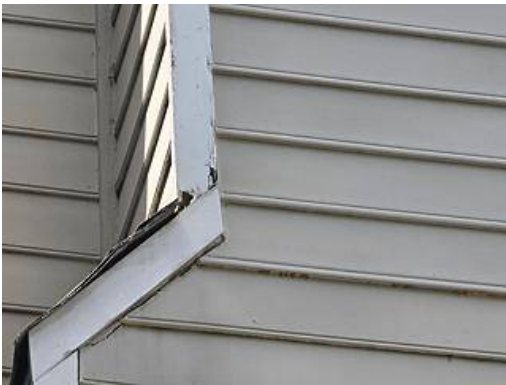
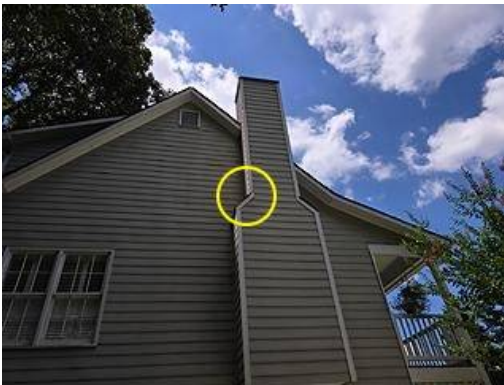
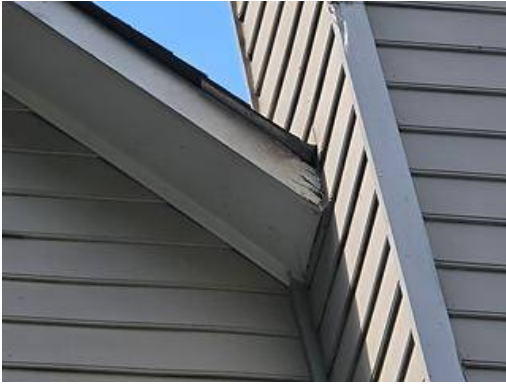
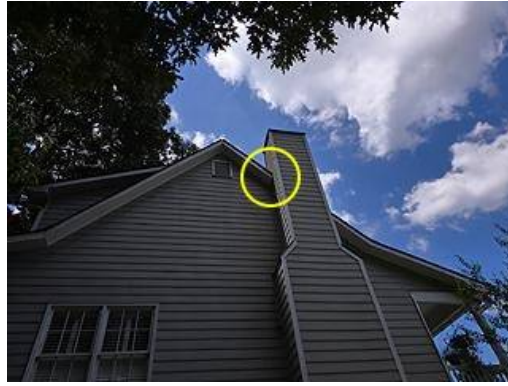
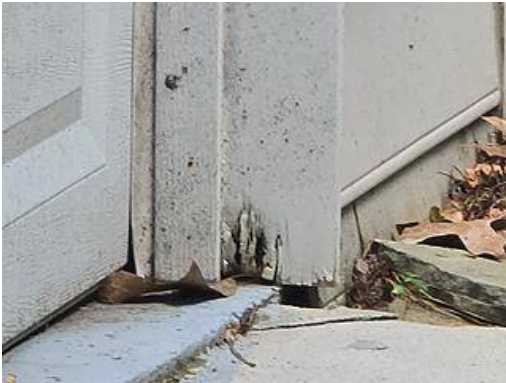
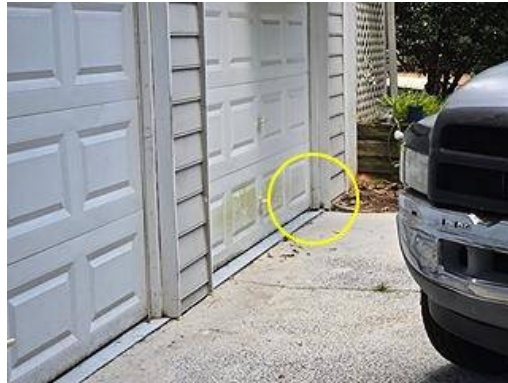
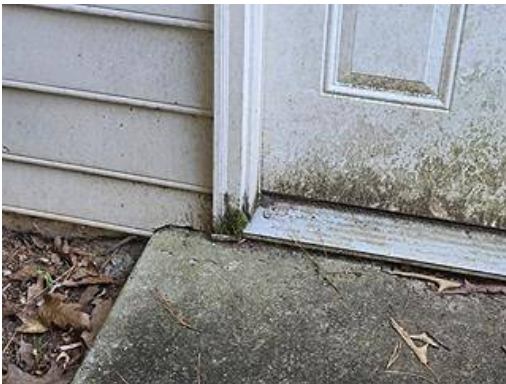
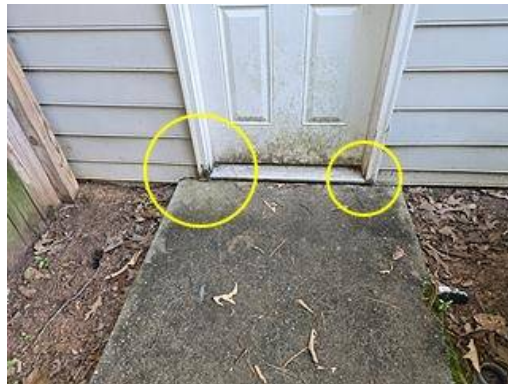
Some sections of siding and/or trim were deteriorated. Recommend that a qualified person repair, replace or install siding or trim as necessary.

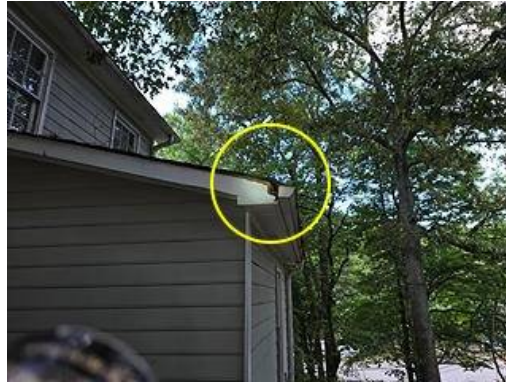
Photo 15-2

Potential rodent entry points were noticed at one or more areas of the exterior. Rodents can enter gaps of 1/2 inch or more. Recommend having a qualified contractor evaluate and make all necessary repairs.

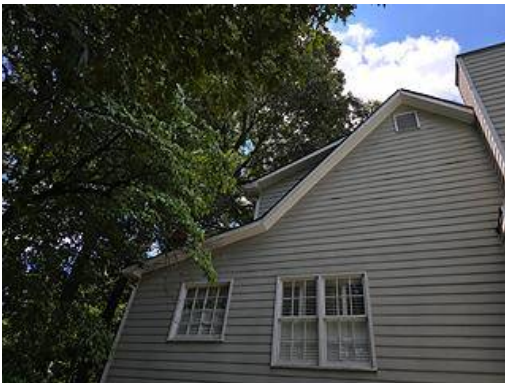
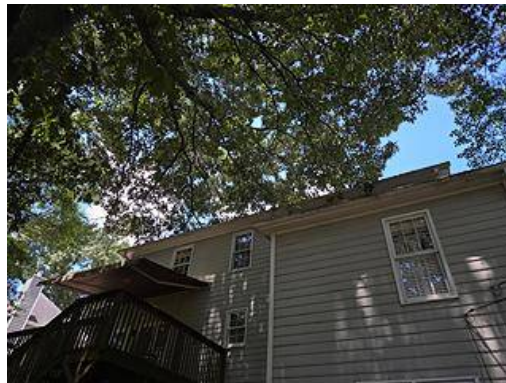
Vegetation such as trees, shrubs, and/or vines overhung the roof surface or were in contact with the roof edge. Organic debris such as leaves or needles are likely to accumulate in gutters and on the roof surface. Gutters can overflow and cause water to come in contact with the building exterior or water can accumulate around the foundation. This is a conducive condition for wood-destroying organisms. Vegetation in contact with the roof can damage the roof surface and/or the roof drainage system. Recommend pruning vegetation so as to not be in contact with the roof and to not overhang the roof surface. If vegetation is too tall then it should be pruned at least 10 feet above the roof surface.

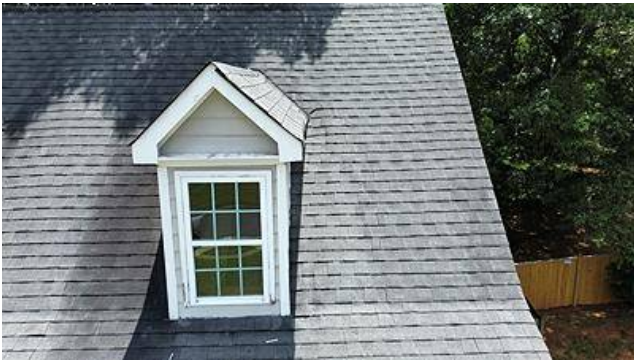
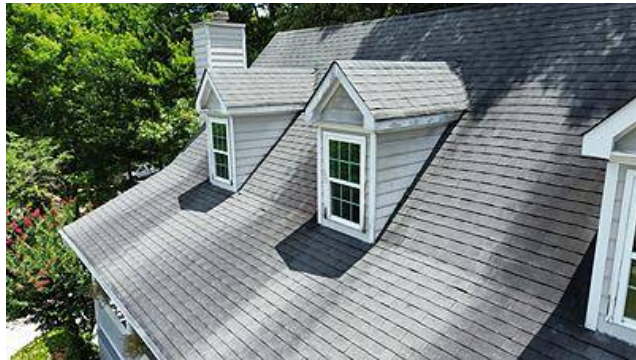
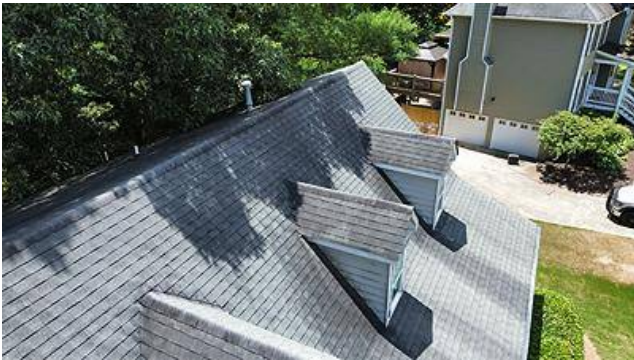
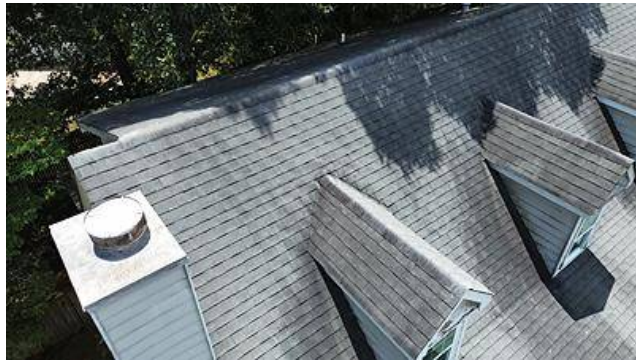
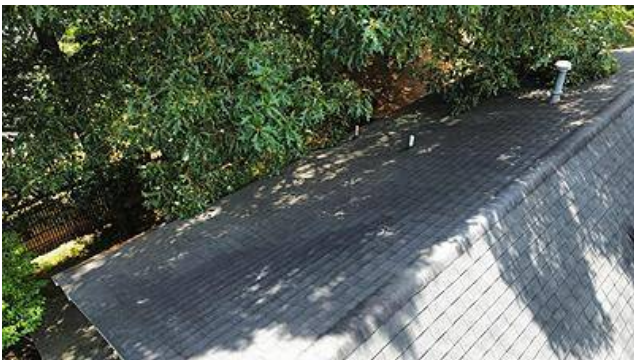
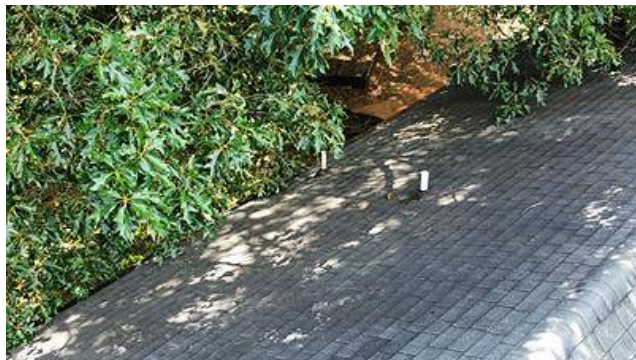
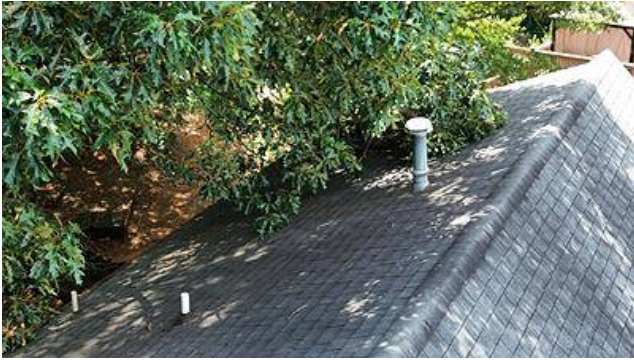
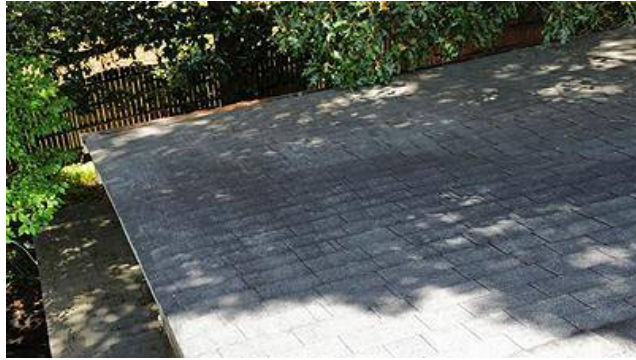
General pictures of the roof.

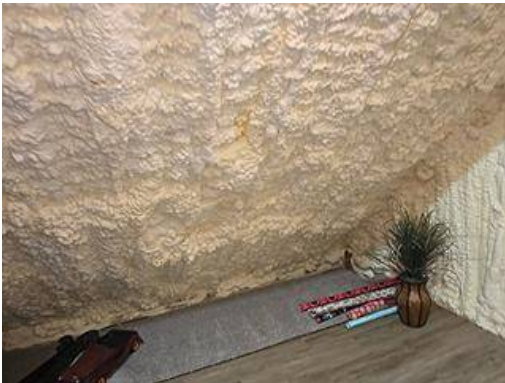
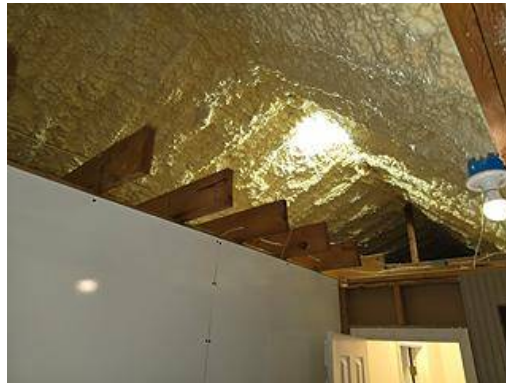
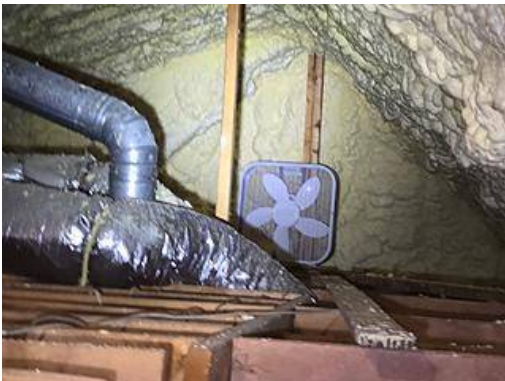
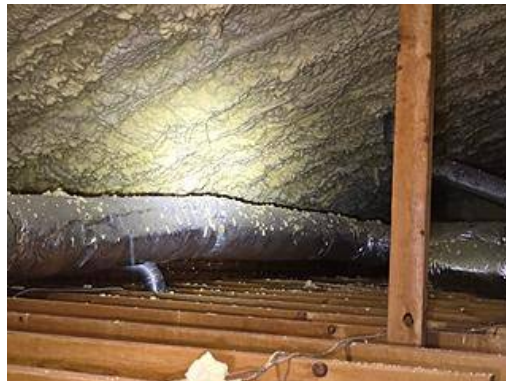
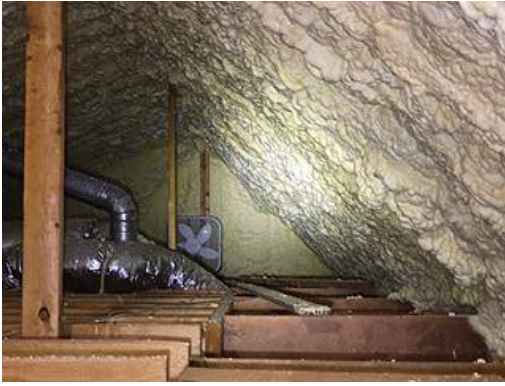
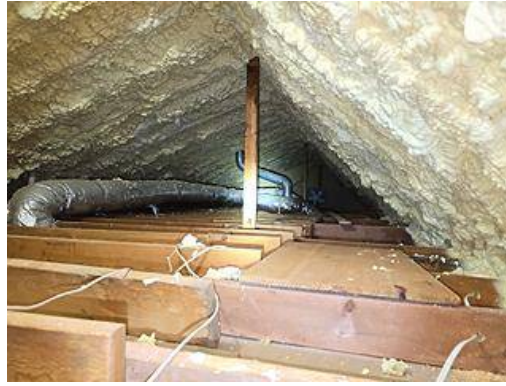
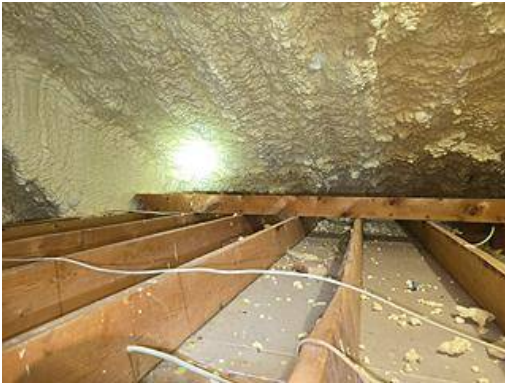
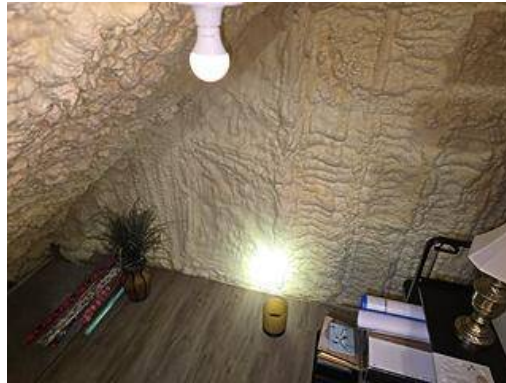
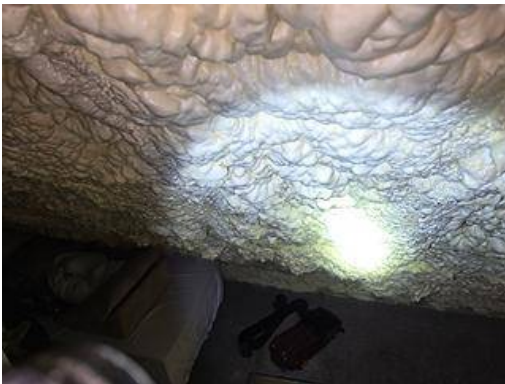
The inside of the roof decking could not be viewed due to the spray foam insulation. General pictures of the main attic area.

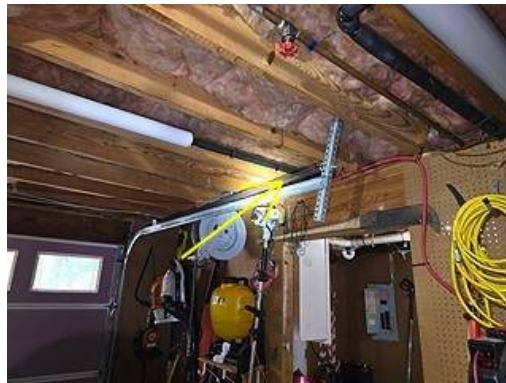
Photo 30-2

30) 🛠️ One or more extension springs supporting garage vehicle doors had no safety containment cables installed. These cables prevent injury to people located nearby when springs eventually break. This is a potential safety hazard. Recommend that a qualified contractor install cables where missing per standard building practices. For more information, visit:

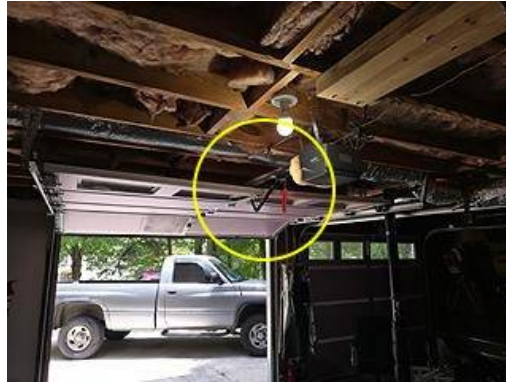
Photo 31-2

31) 🛠️ The right side garage vehicle door is damaged at the top. Recommend having a qualified contractor evaluate and make any necessary repairs.

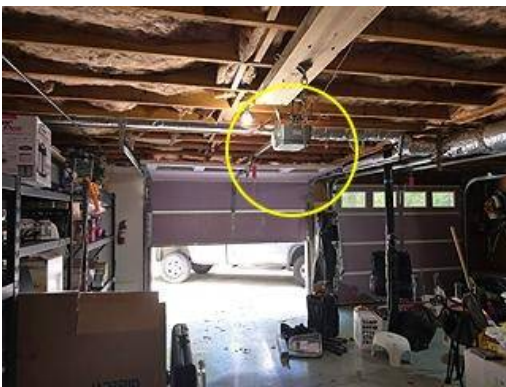
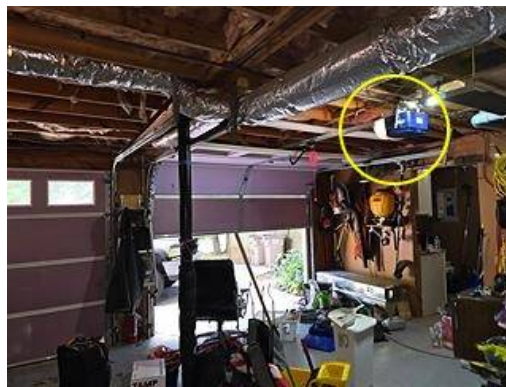
32) ✓ ⓘ The garage door opener[s] were evaluated and appeared functional at the time of the inspection.

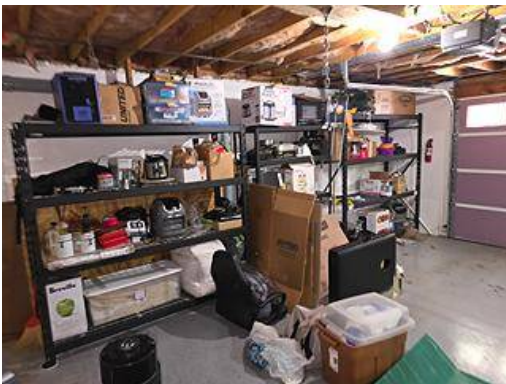
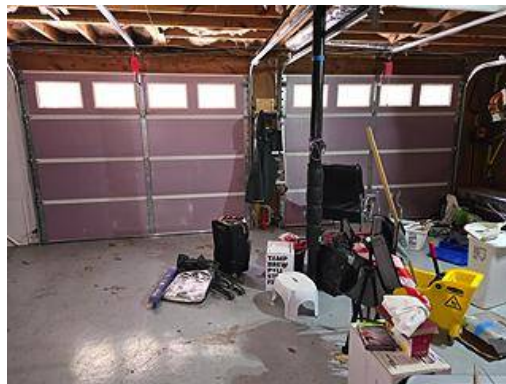
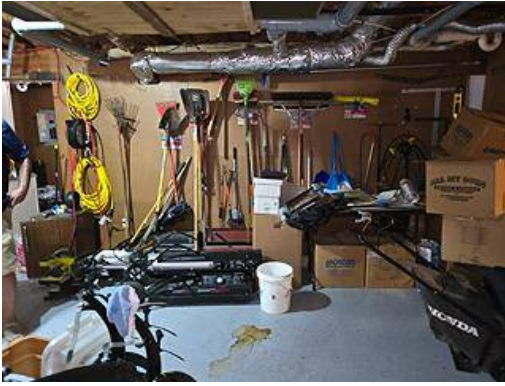
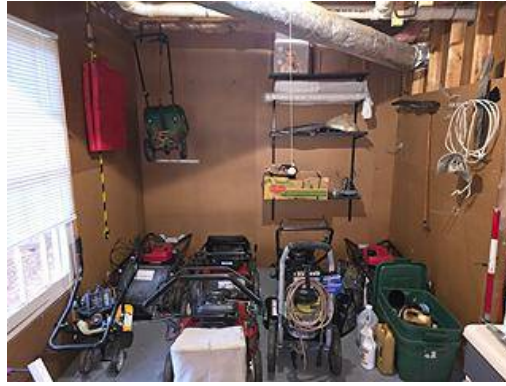
33) ⓘ General pictures of the garage.

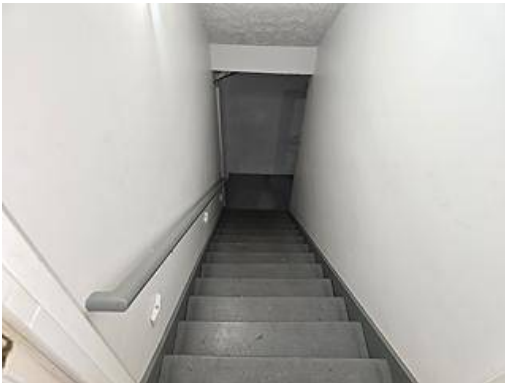
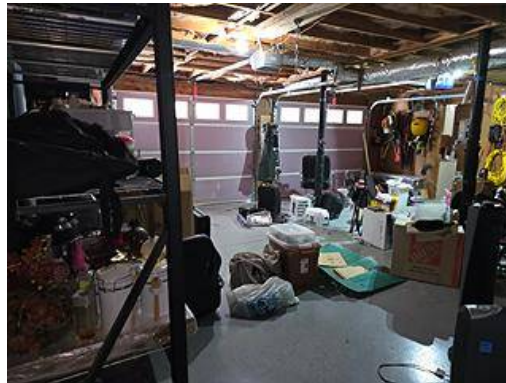
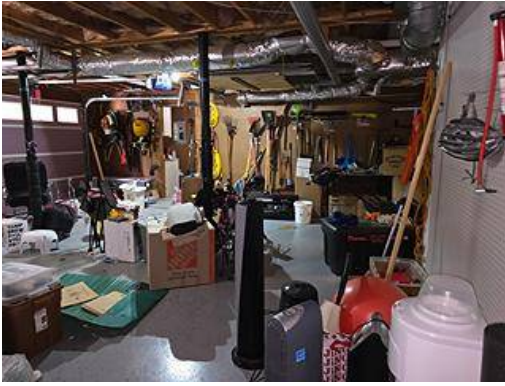
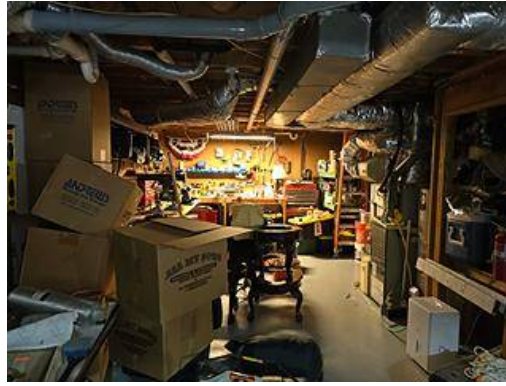
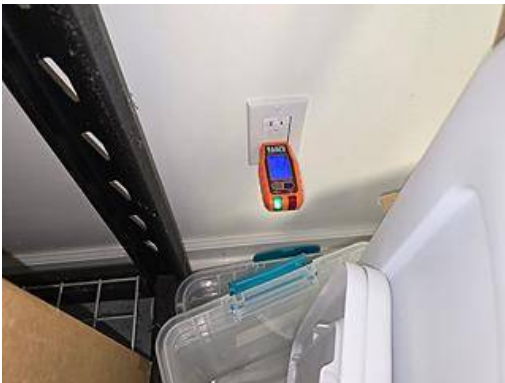
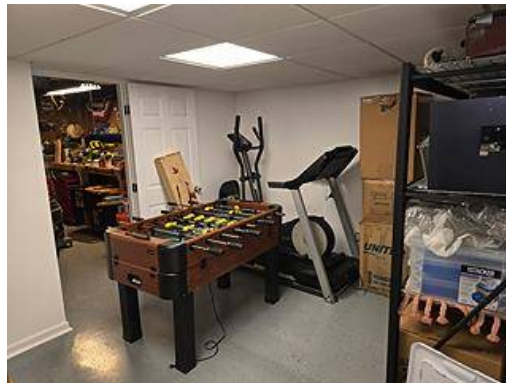
35) **i** General pictures of the basement.

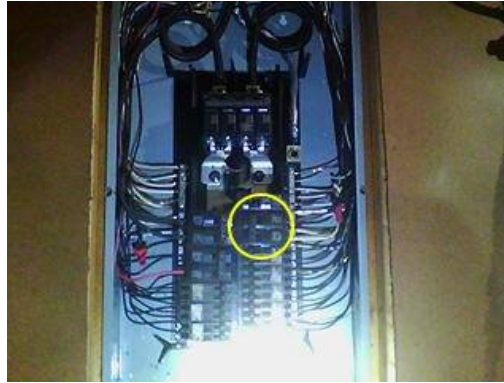
Photo 37-2

The infrared scan of the electrical panel showed an elevated temperature on the A/C breaker. Recommend having a

qualified electrician evaluate and make any necessary repairs.

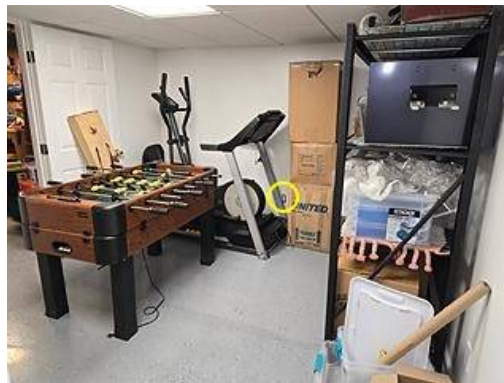
Photo 40-2

One or more cover plates for switches, receptacles or junction boxes were missing or broken. These plates are intended to contain fire and prevent electric shock from occurring due to exposed wires. Recommend that a qualified person install cover plates where necessary.

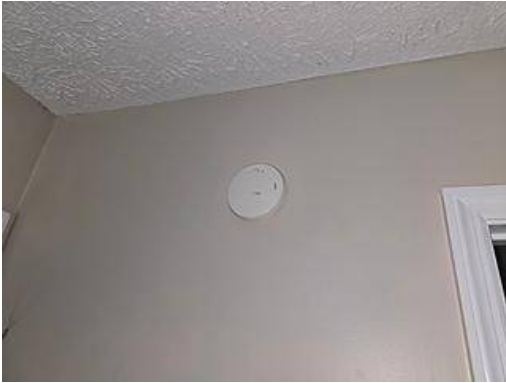
Photo 41-1

The functionality of, power source for and placement of smoke alarms is not determined as part of this inspection. Smoke alarms should be installed in each bedroom, in hallways leading to bedrooms, on each level and in attached garages. They have a limited lifespan and should be replaced every 10 years. For home buyers, batteries in smoke alarms should be changed when taking occupancy. Batteries should be replaced annually in the future. Carbon monoxide alarms should be installed in the vicinity of sleeping areas and on each level. For more information, visit:

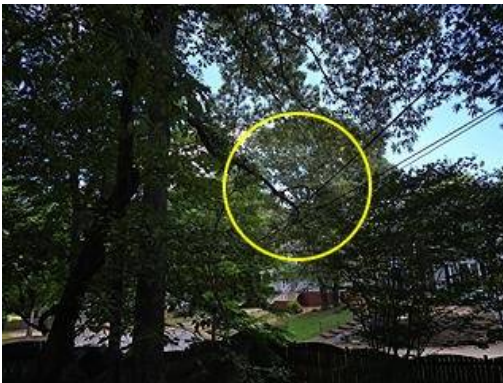
Photo 42-2

The service drop wires were in contact with trees or vegetation. This can result in damage to wiring insulation or broken wires during high winds. Recommend pruning trees or vegetation as necessary. The utility company may prune trees at no charge.

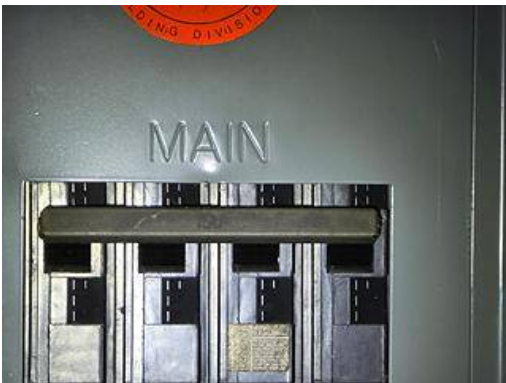
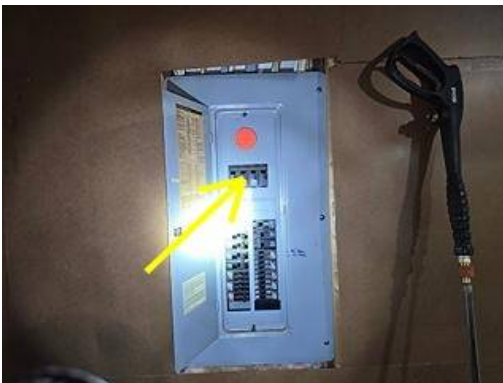
Location of the main service disconnect.

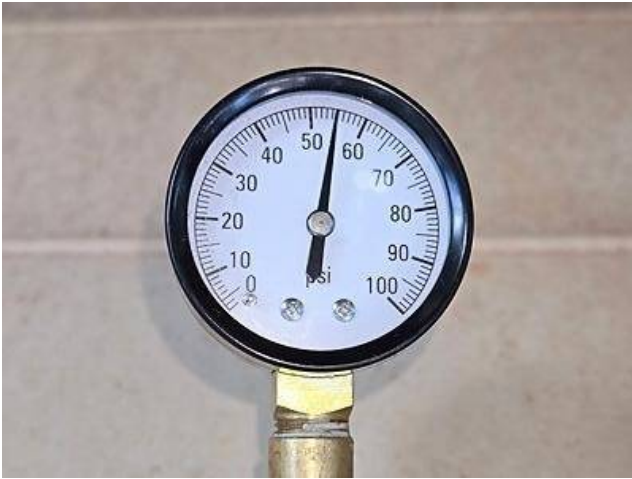
Photo 48-1

48) ✓ **i** Water pressure.

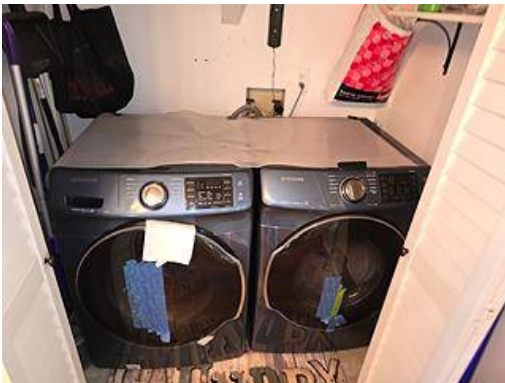
Photo 49-1

49) **i** The washer, dryer and connections were not evaluated and are excluded from the inspection.

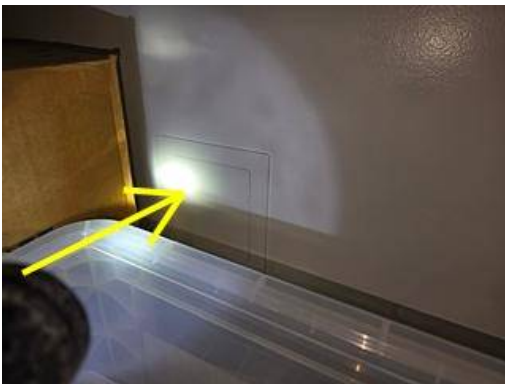
Photo 50-1

50) **i** Location of the main water shut off valve. In the basement against the front wall of the finished room.

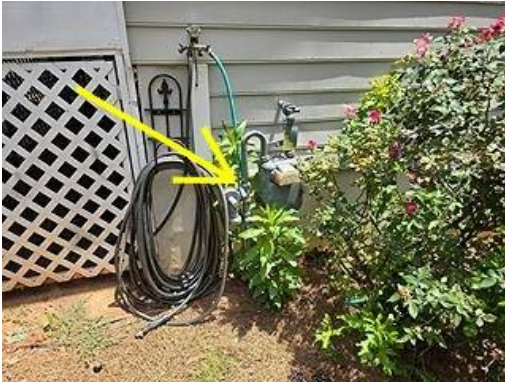
Photo 51-1

51) **i** Location of the gas shut off valve.

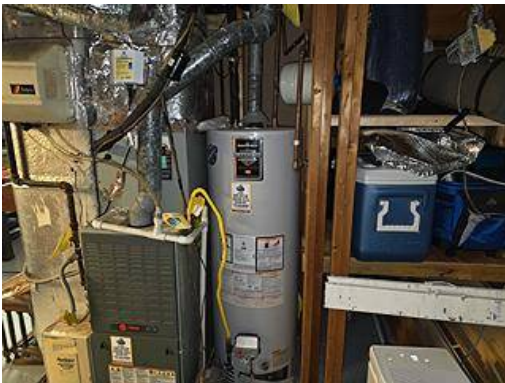
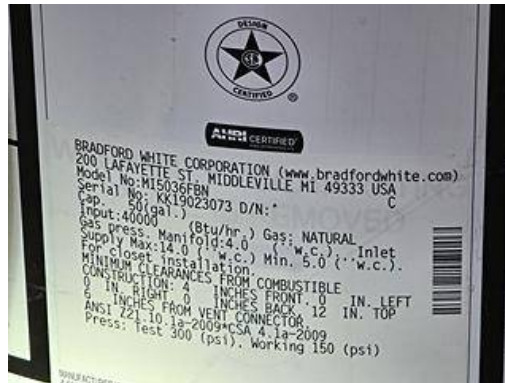
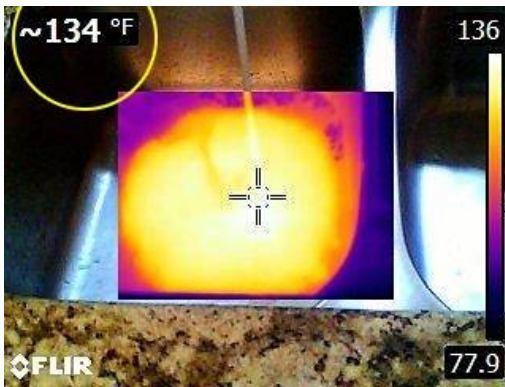
52) The water heater appeared functional at the time of the inspection.

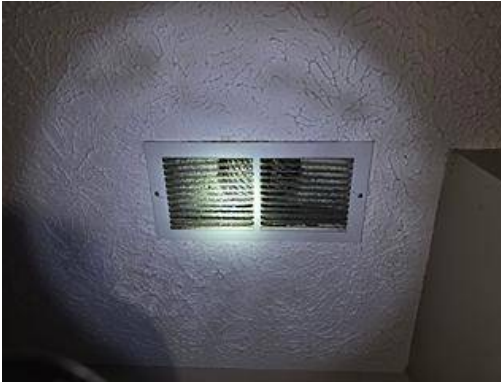
Photo 54-2

54) **+🔧** Significant amounts of debris, dirt and/or dust were visible in one or more sections of supply and/or return air ducts for the heating or cooling system. This can be a health hazard, especially for those with allergies or respiratory problems. The Environmental Protection Agency (EPA) recommends considering having ducts professionally cleaned when "ducts are clogged with excessive amounts of dust and debris and/or particles are actually released into the home from your supply registers." At a minimum, the visible debris should be thoroughly cleaned. Recommend that a qualified contractor clean the ducts. For more information on duct cleaning in relation to indoor air quality, visit:

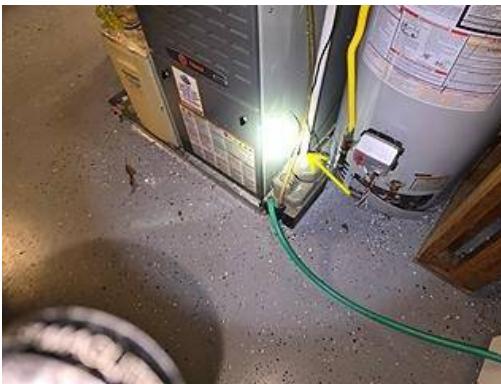
Photo 55-2

The air handler's primary condensate drain line was routed into a plumbing drain pipe. Such drain lines should terminate in surface waterways (e.g. a floor drain or outside). Recommend that a qualified HVAC contractor repair per standard building practices.

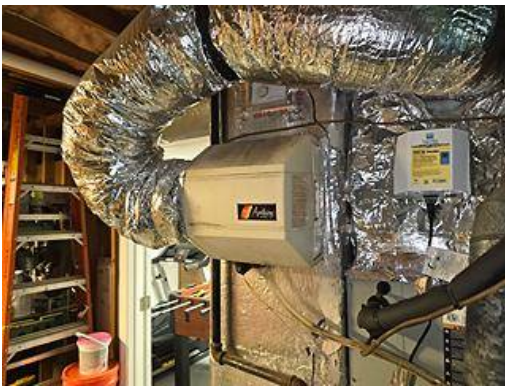
Photo 58-1

58) There is a humidifier installed on the main floor HVAC system. These are not excluded from the inspection. Recommend asking the seller for any information regarding this system.

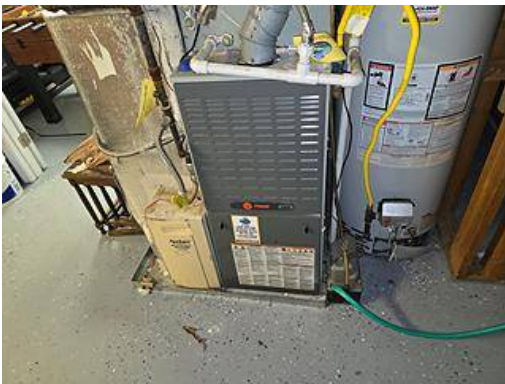
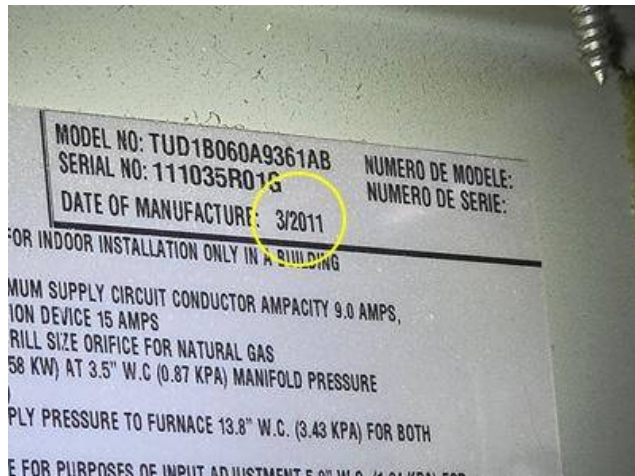
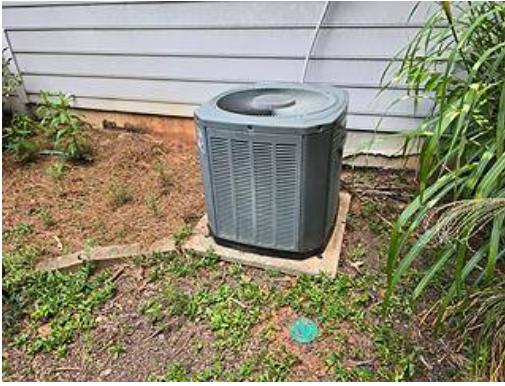
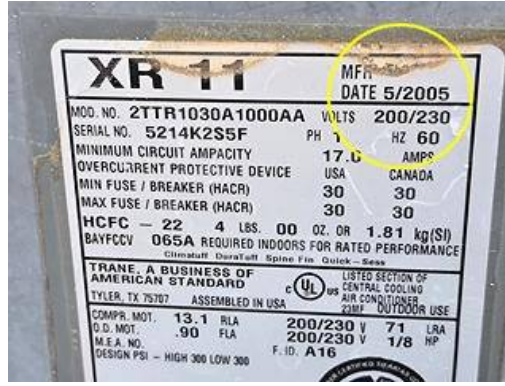
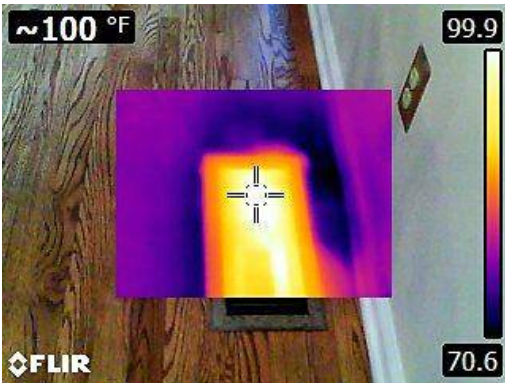
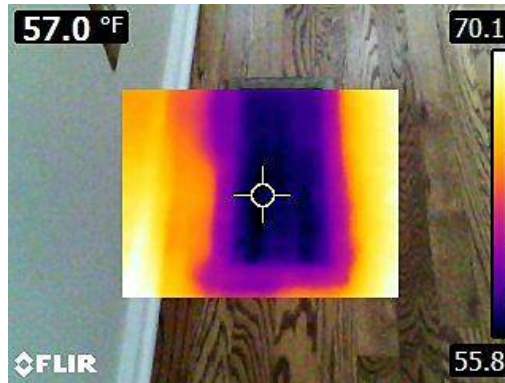
60) The main floor heating and air conditioning systems were evaluated and appeared functional at the time of the inspection.

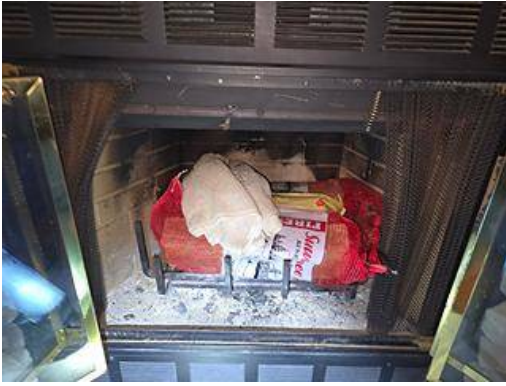
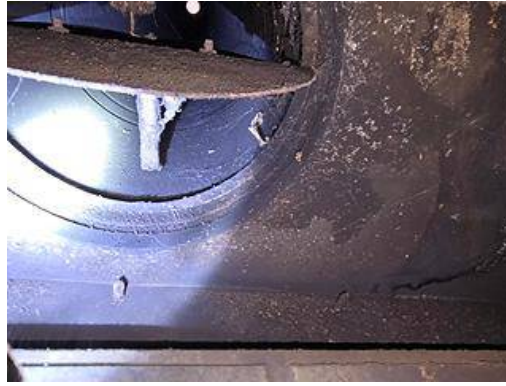
- 63) One or more solid fuel-burning fireplaces or stoves were found at the property. When such devices are used, they should be professionally inspected and cleaned annually to prevent creosote build-up and to determine if repairs are needed.

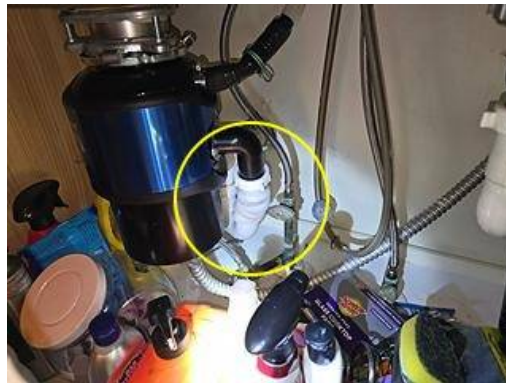
Photo 64-2

Ribbed, flexible drain pipe was used at the sink. This type of drain pipe accumulates debris more easily than smooth wall pipe and is more likely to clog. Recommend that a qualified plumber replace flexible piping with standard plumbing components (smooth wall pipe) to prevent clogged drains.

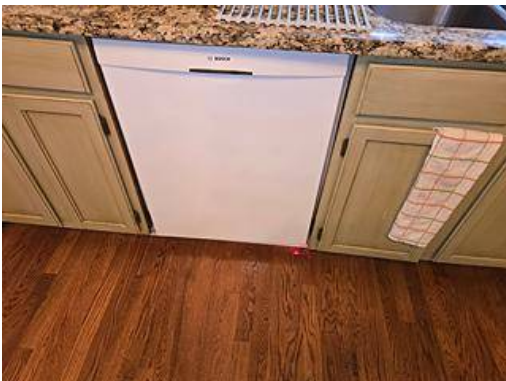
Photo 65-1

The dishwasher appeared functional at the time of the inspection.

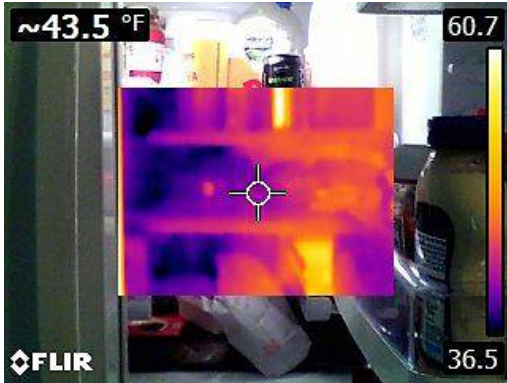
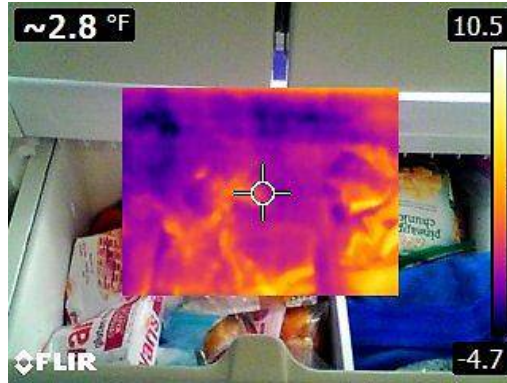
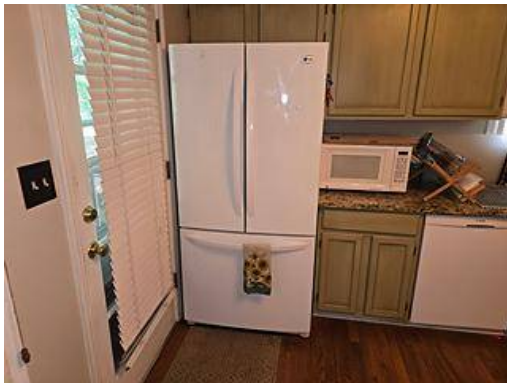
66) ✓ **i** The refrigerator appeared functional at the time of the inspection.

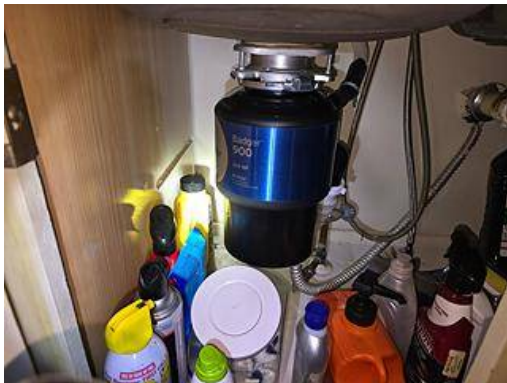
Photo 67-1

67) ✓ **i** The under sink food disposal appeared functional at the time of the inspection.

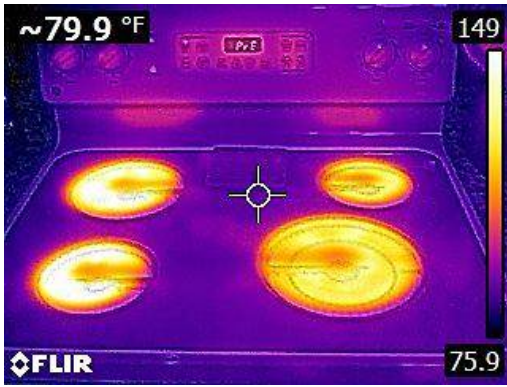
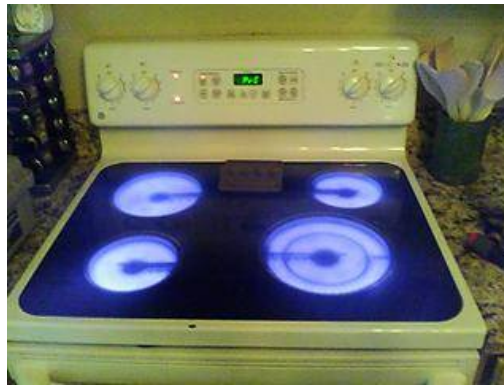
68) ✓ **i** The range was functional at the time of the inspection.

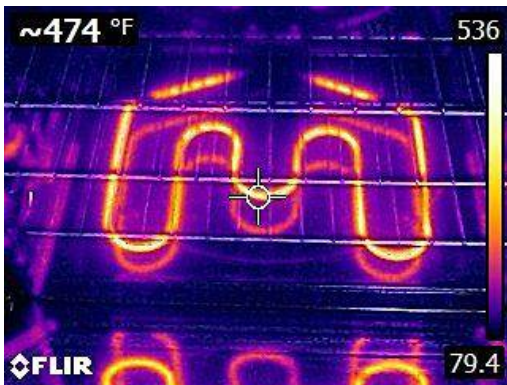
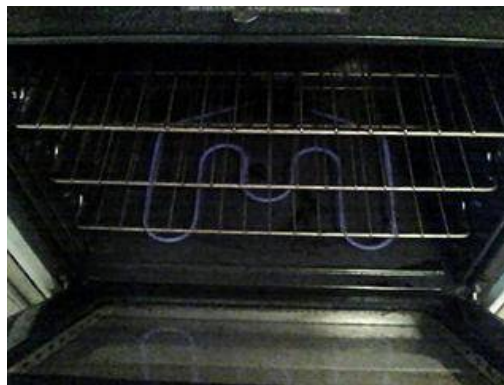
69) ✓ **i** The oven appeared functional at the time of the inspection.

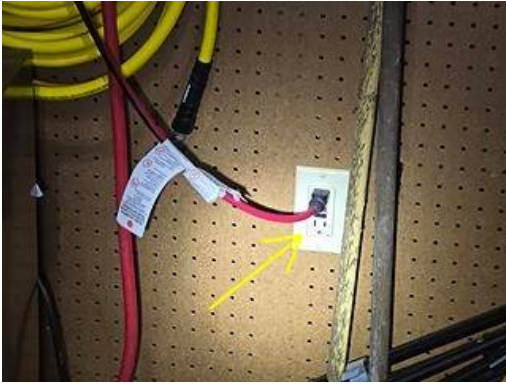
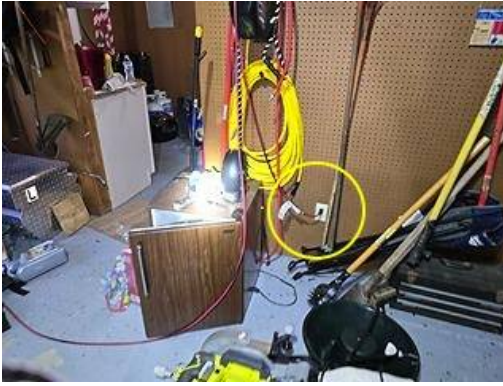
All bathrooms and exterior outlets are GFCI protected. The reset is located at the receptacle in the garage by the closet area.

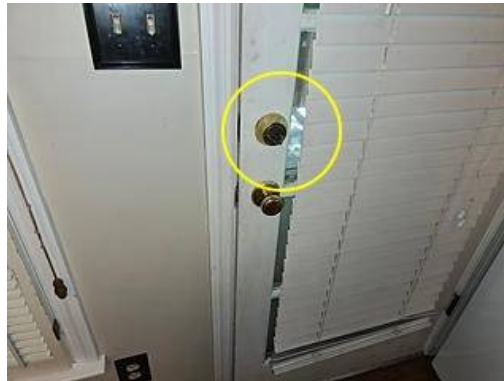
Photo 76-1

One or more interior doors had a keyed lockset or deadbolt installed. This is a safety hazard for small children in the event that they lock themselves in the room, do not know how to unlock the door, and the key is not available. Recommend that a qualified person replace keyed locksets and/or deadbolts with "privacy" locksets (no key required) as necessary.

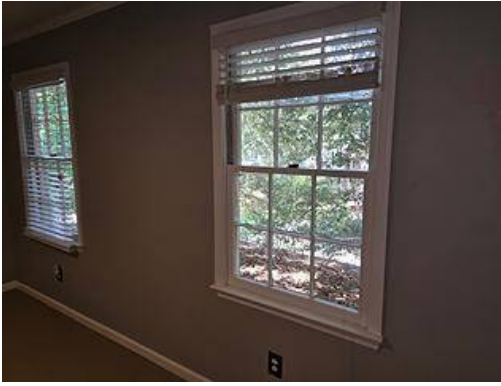
Photo 77-1

One or more windows that were designed to open and close were stuck shut. Recommend that a qualified person repair windows as necessary so they open and close easily.

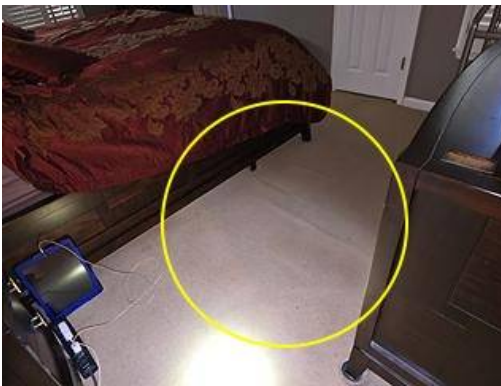
Photo 78-1

78) 🧰 Carpeting in one or more areas was loose. Recommend that a qualified contractor repair as necessary. For example, by stretching or replacing carpeting.

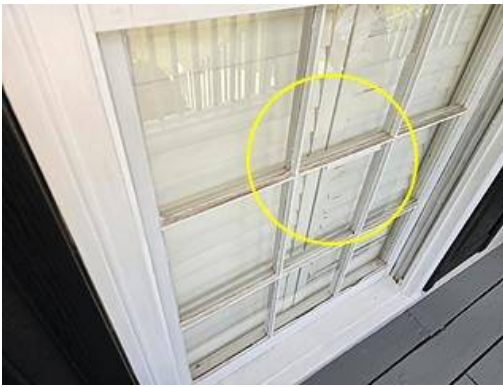
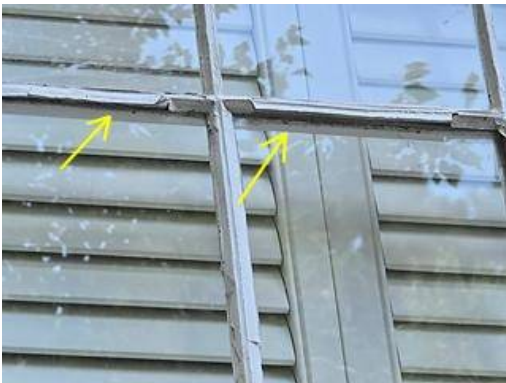
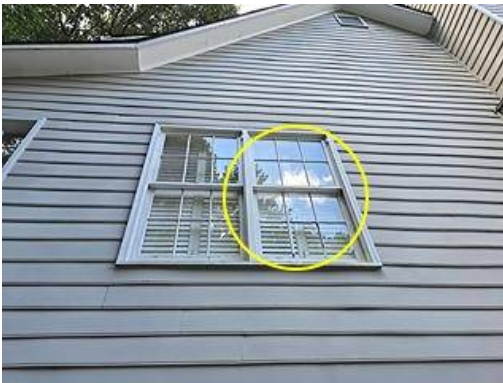
80) 🧰 The glazing compound or caulk that holds glass panes in one or more windows was deteriorated and/or substandard. Air and/or water can leak through windows, and wood window frames are prone to rot. This is a conducive condition for wood-destroying organisms. Recommend that a qualified person replace glazing compound as necessary. For more information, visit: <https://www.reporhost.com/?PUTTY>
