## Open Eye Home Inspections LLC

### Property Inspection Report

Inspection date: **Monday, July 1, 2024**

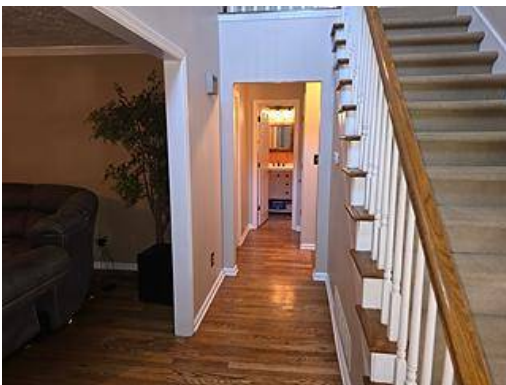
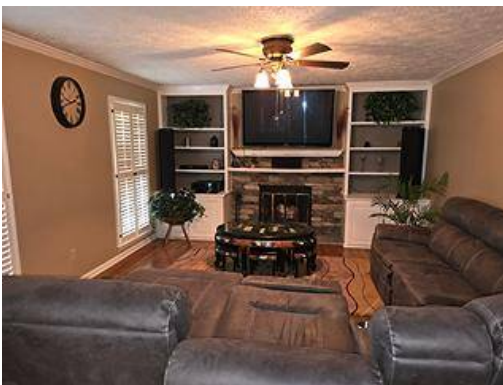
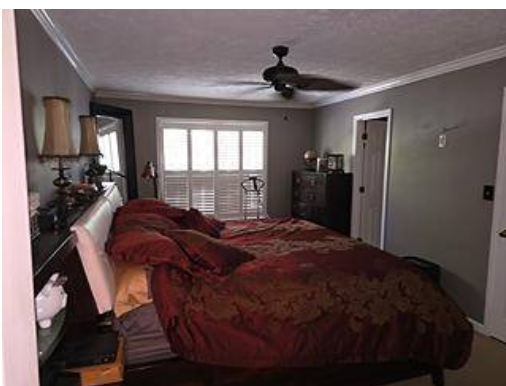
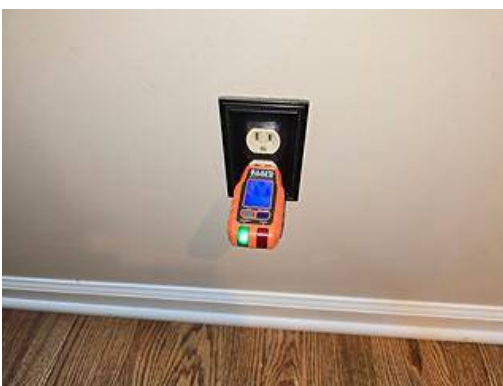
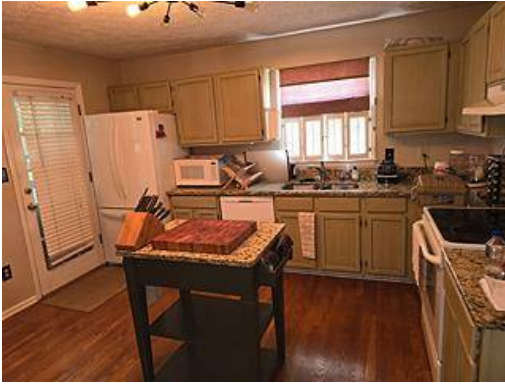
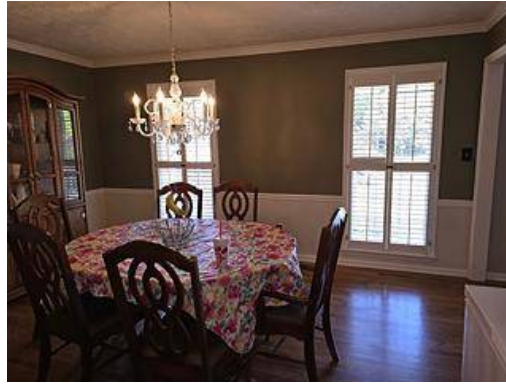
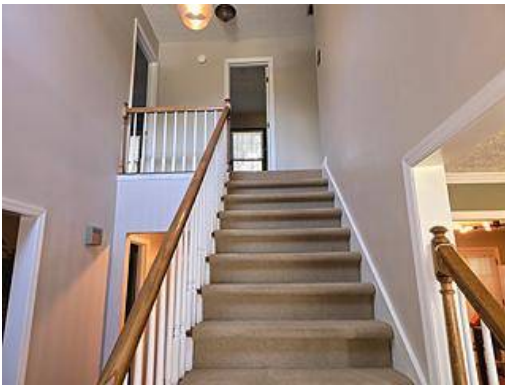
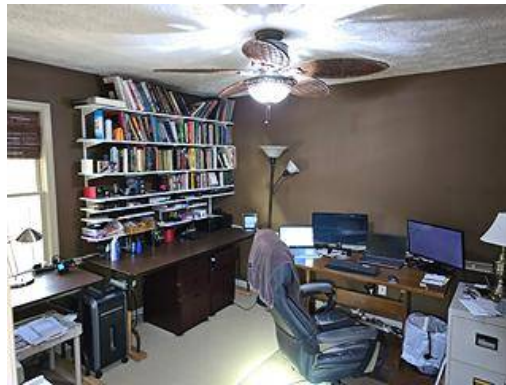
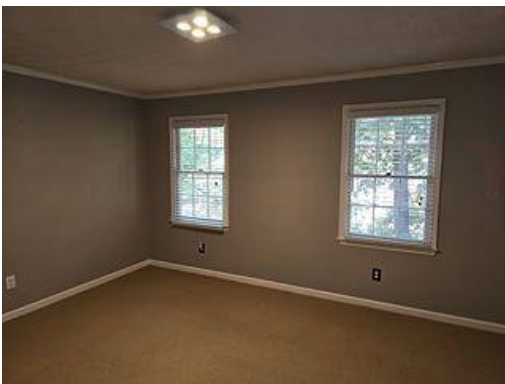
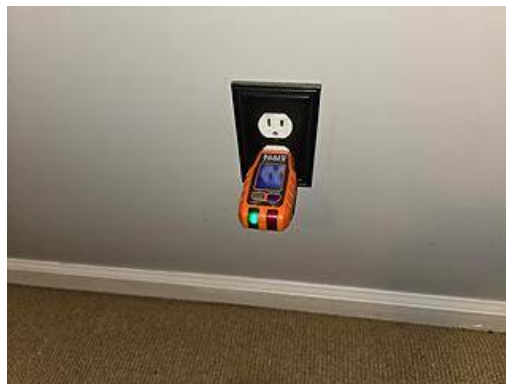
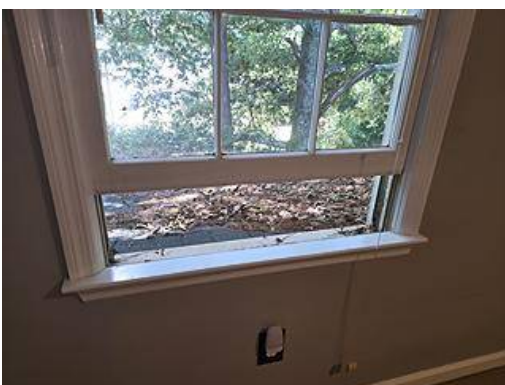
Windows, doors, and receptacles were evaluated at the time of the inspection. General pictures of the interior rooms.

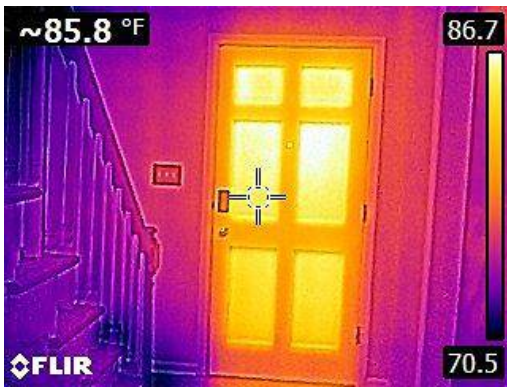
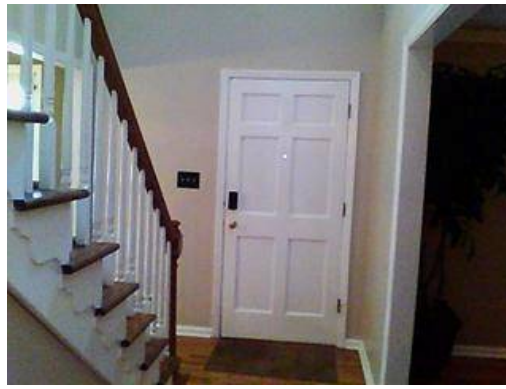
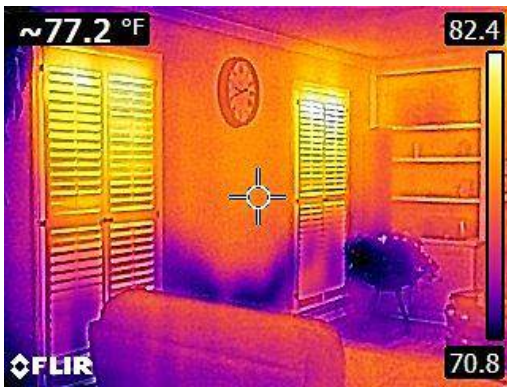
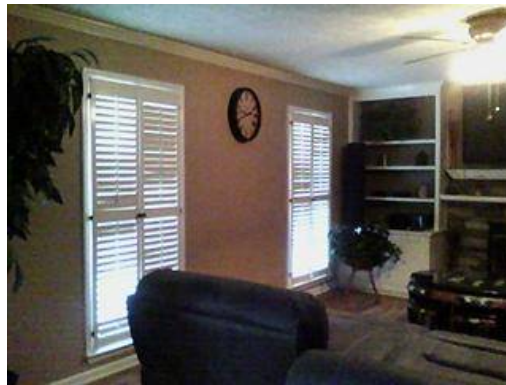
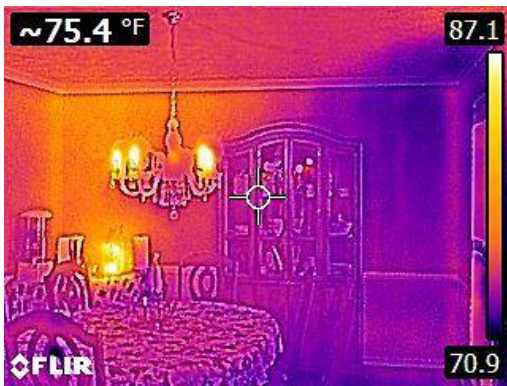
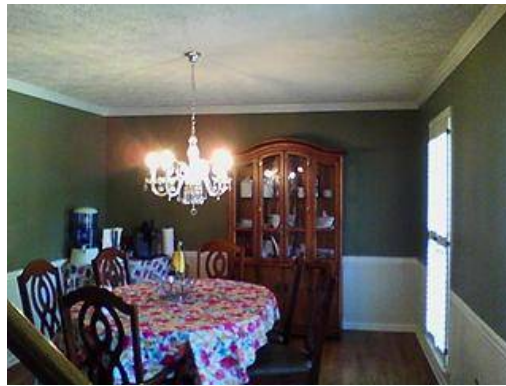
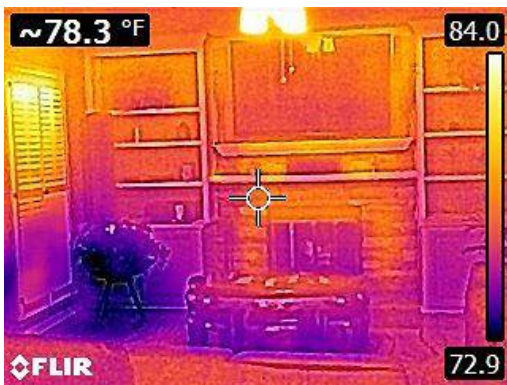
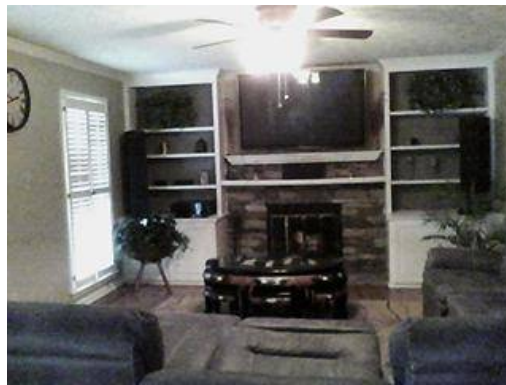
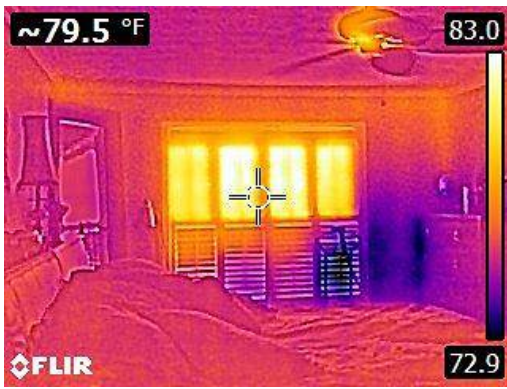
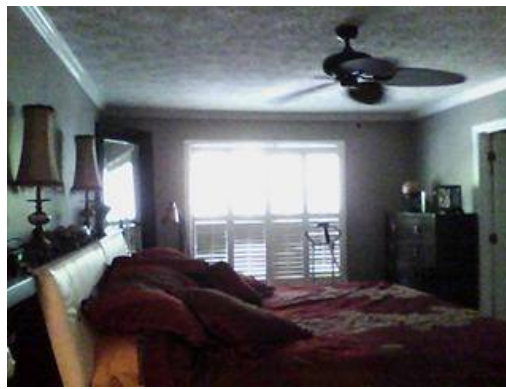
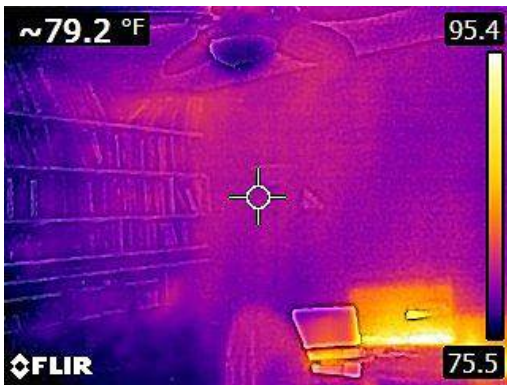
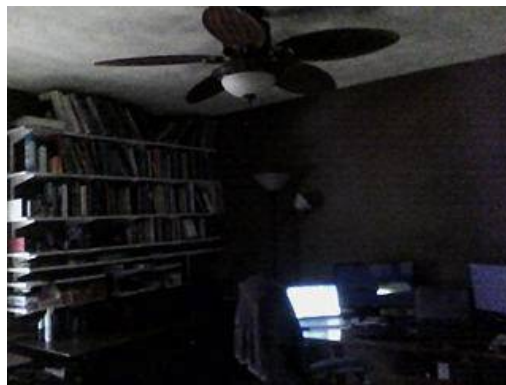
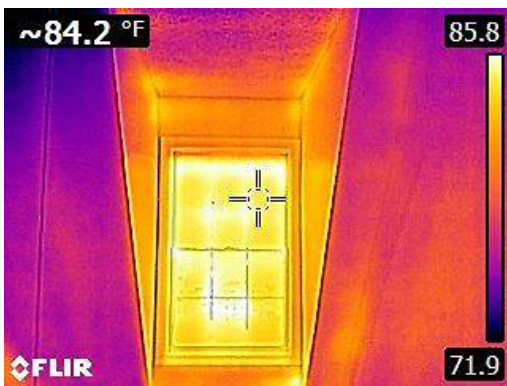
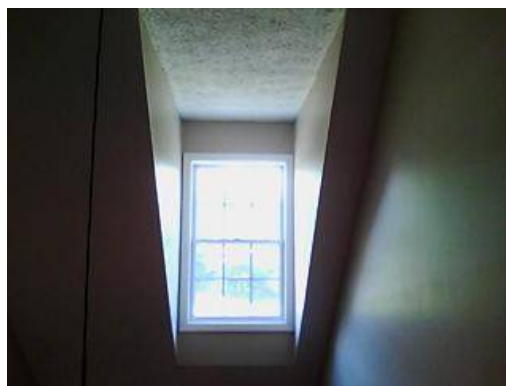
The basic infrared scans showed no abnormal anomalies at the time of the inspection.
