## Open Eye Home Inspections LLC

### Property New Home Final Inspection Report

Client(s): **Sample Report 3**

Inspection date: **Thursday, January 26, 2023**

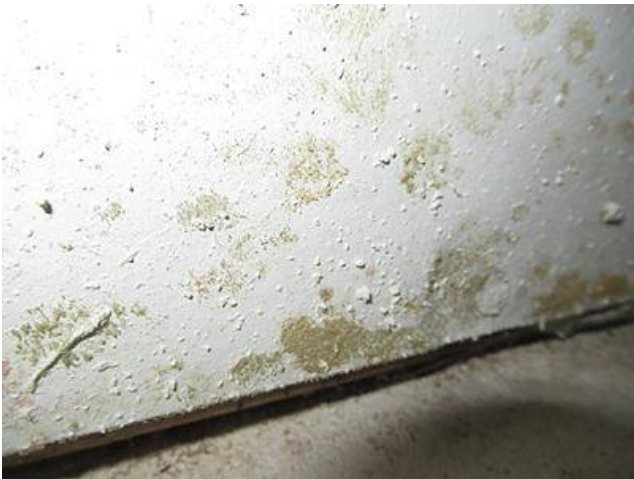
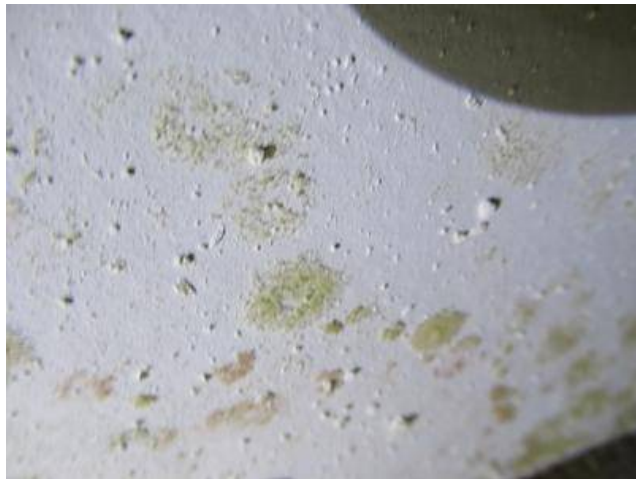
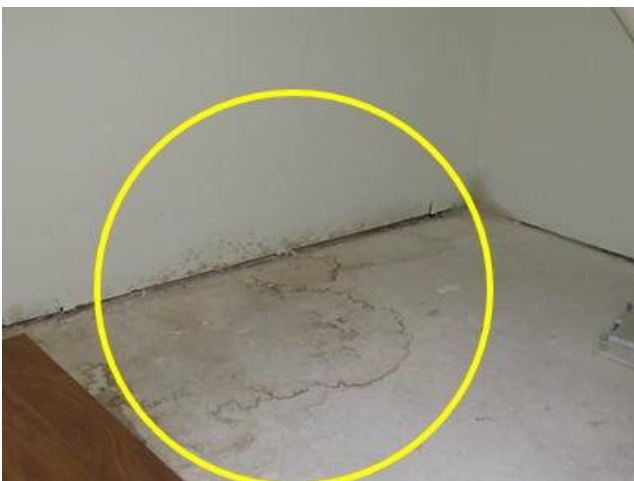
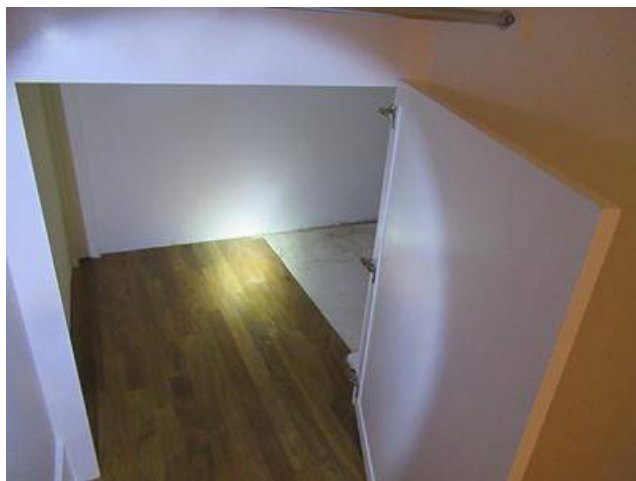
Microbial growths were found at one or more locations in the basement cubby area under the stairs. It is beyond the scope of this inspection to identify what substance or organism this staining is. However such staining is normally caused by excessively moist conditions, which in turn can be caused by plumbing or building envelope leaks and/or substandard ventilation. These conducive conditions should be corrected before making any attempts to remove or correct the staining. Normally affected materials such as drywall are removed, enclosed affected spaces are allowed to dry thoroughly, a mildewcide may be applied, and only then is drywall reinstalled. For evaluation and possible mitigation, consult with a qualified industrial hygienist or mold/moisture mitigation specialist. For more information, visit:

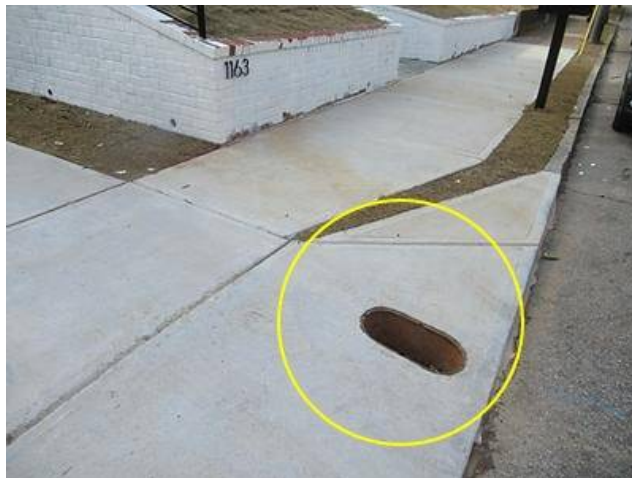
Photo 5-2

The metal sewer cleanout or meter cover in the driveway, was missing at the time of the inspection. Recommend having the builder evaluate and make any necessary repairs or replacement.

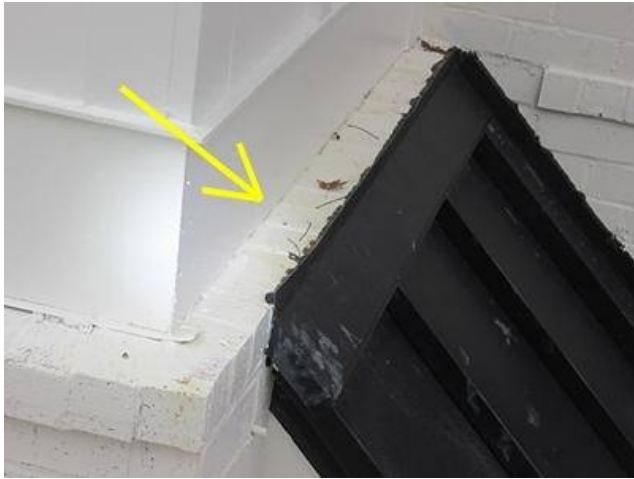
The brick ledge flashing is missing one or more areas around the structure. SEE CAPTIONS BELOW PHOTOS FOR LOCATIONS. Recommend having the builder evaluate and install flashing where missing.

Photo 9-2 LEDGE ABOVE THE BASEMENT ENTRY DOOR.

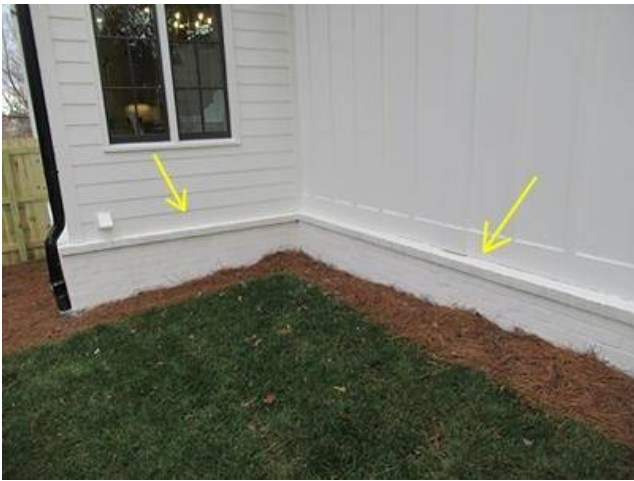
**Photo 9-5** BACK RIGHT SIDE OF THE STRUCTURE.

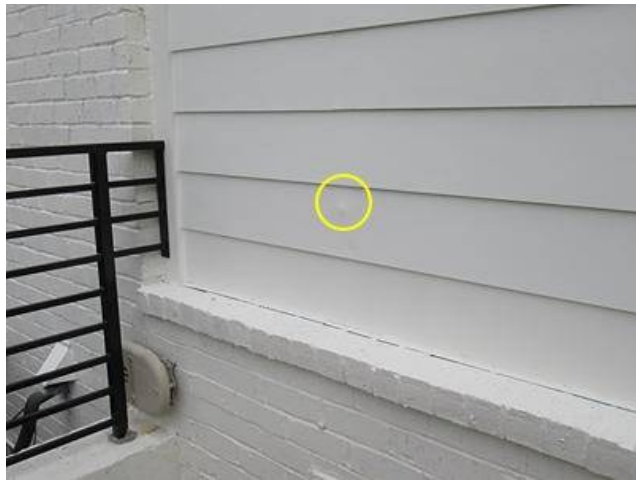
**Photo 10-2**

One piece of siding on the right side of the structure, has a noticeable protrusion in the siding board. Recommend having the builder evaluate and make any necessary repairs or replacement.

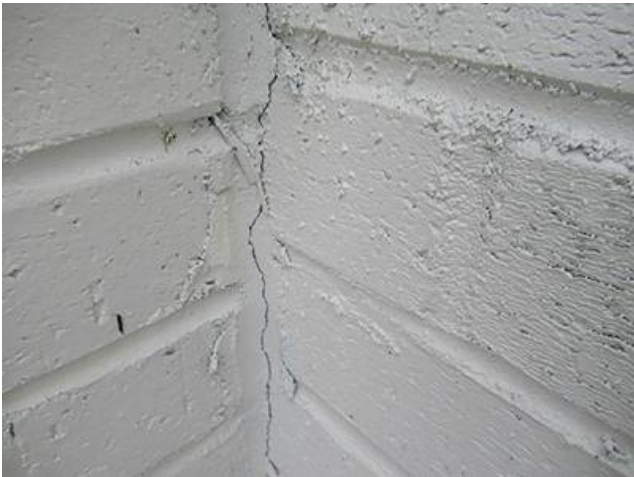
Photo 13-1

- 13) 🔍📍 One or more minor cracks were noticed in the brick veneer. These do not appear to be a structural concern. However, it is recommended to have a qualified contractor evaluate and repoint the mortar as necessary.

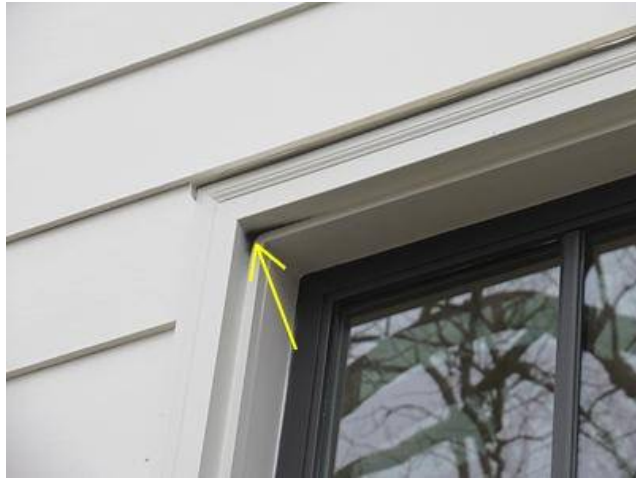
Photo 15-2

15) 🪛 Paint is missing at one or more pieces of window trim on the right side of the structure. Recommend having the builder evaluate and make any necessary repairs.

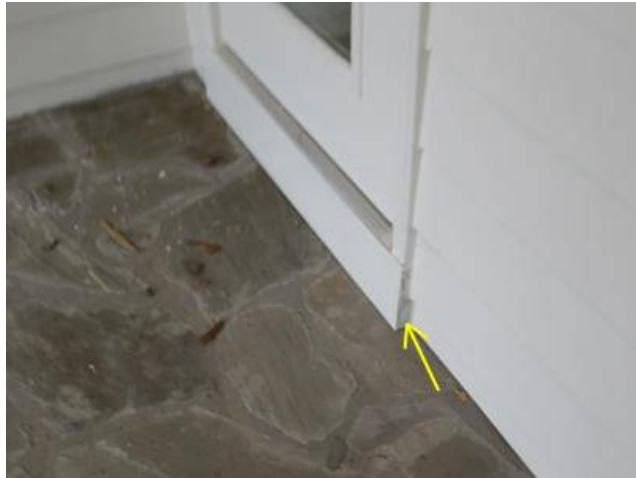
Photo 17-2

17) 🛠️ The ends of the threshold boards under the exterior doors were not painted on the ends. Recommend having the builder evaluate and make any necessary repairs.

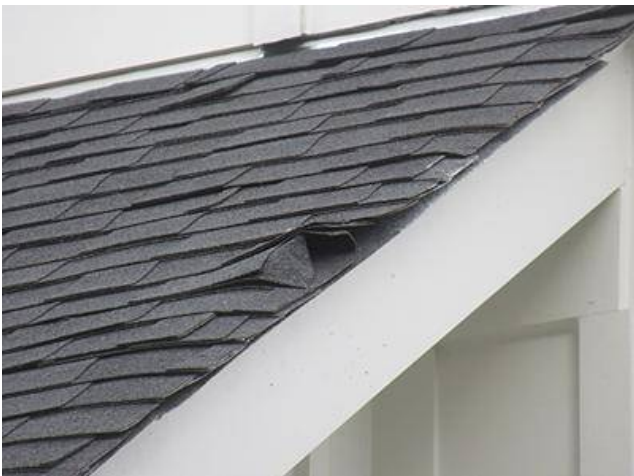
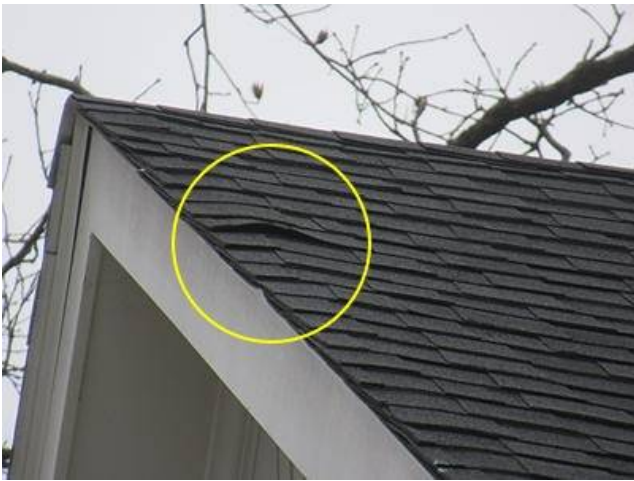
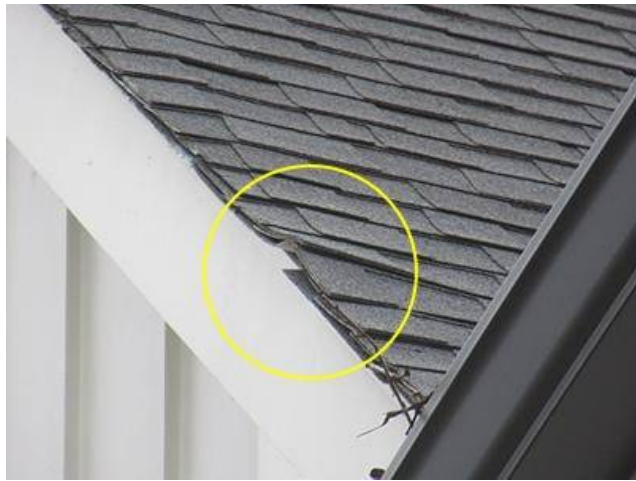
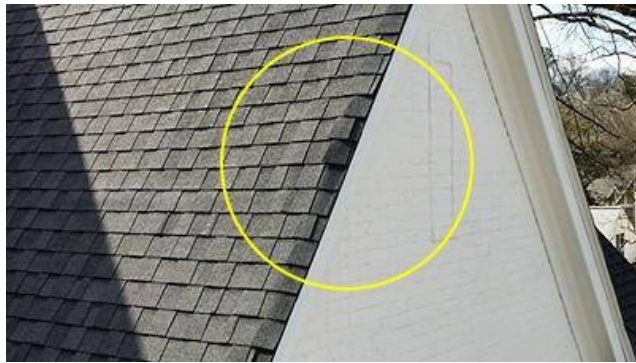
One or more shingles are damaged or lifted at the edges of the roof. Recommend having the builder evaluate and make any necessary repairs.

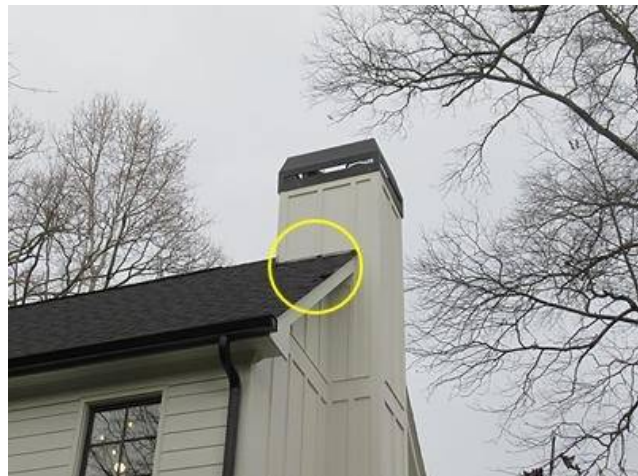
Photo 24-2 BACK LEFT SIDE OF THE ROOF.

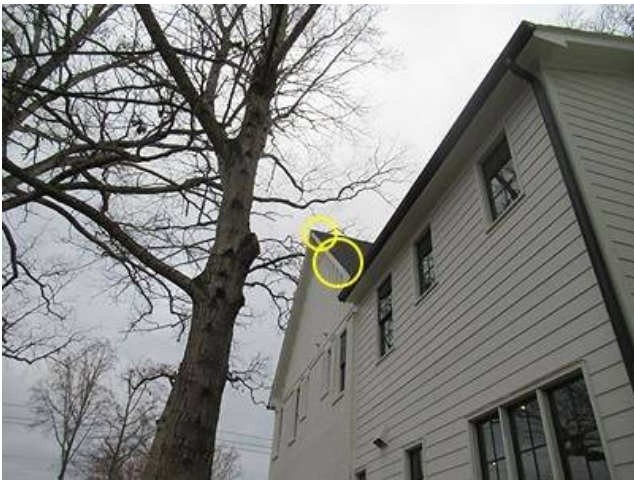
Photo 24-5 RIGHT SIDE OF THE ROOF.

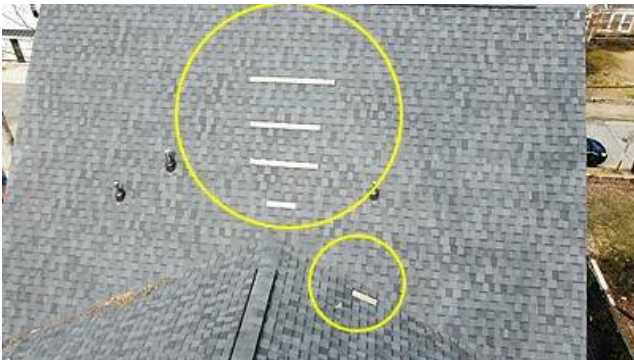
Photo 26-1

26) 🛠️ Toe boards were left on the roof. Recommend having the builder remove the toe boards and seal the holes.

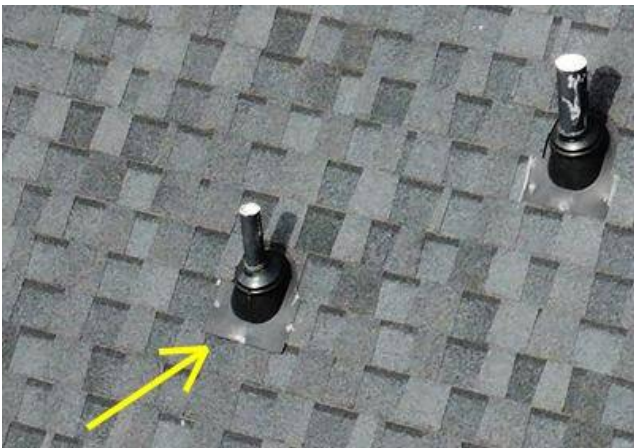
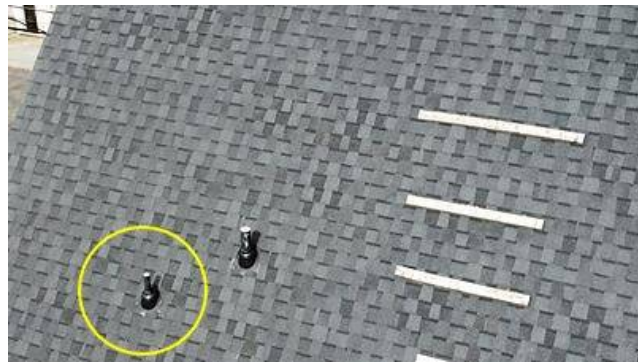
27) 🛠️ One plumbing vent pipe boot does not appear to be sealed to the roof at the bottom of the boot. Recommend having the builder evaluate and make any necessary repairs.

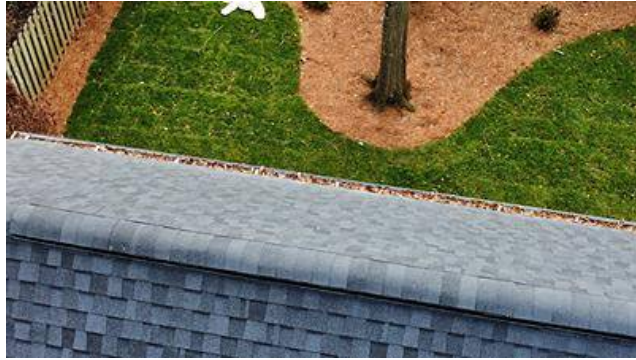
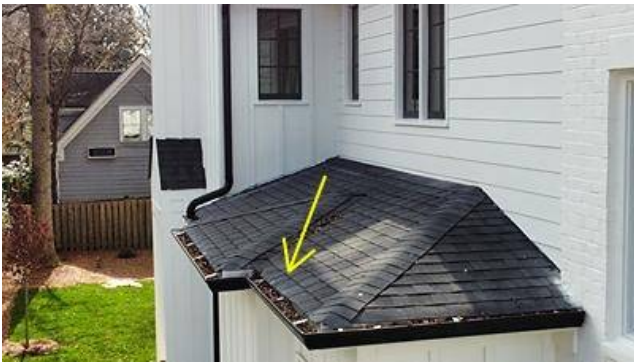
28) 🧹 Significant amounts of debris such as leaves, needles, seeds, etc. have accumulated on the roof surface. Water may not flow easily off the roof, and can enter gaps in the roof surface. Leaks can occur as a result. This is a conducive condition for wood-destroying organisms. Recommend cleaning debris from the roof surface now and as necessary in the future.

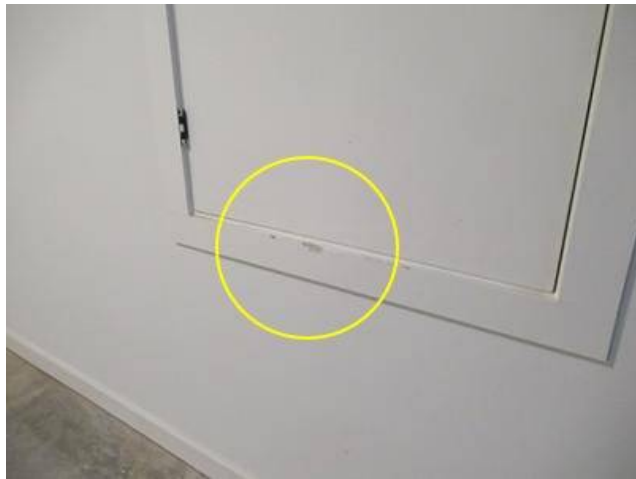
Photo 32-2

The trim at the front cubby hatch in the garage is damaged. Recommend having the builder evaluate and make any necessary repairs or replacement.

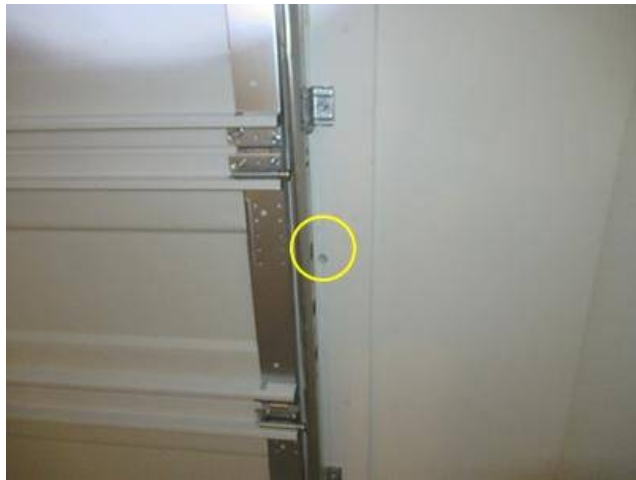
Photo 34-2

There is a hole in the garage door frame board on the right side if facing from inside the garage. Recommend having the builder evaluate and make any necessary repairs.

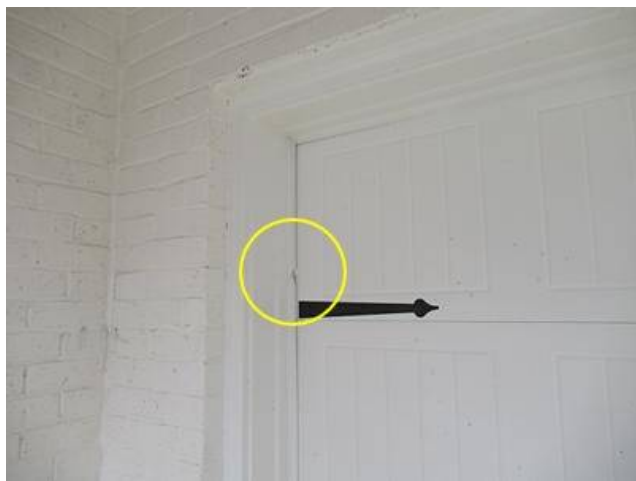
Photo 35-2

The weatherstripping at the left side of the garage door is damaged in one area. Recommend having the builder evaluate and make any necessary repairs.

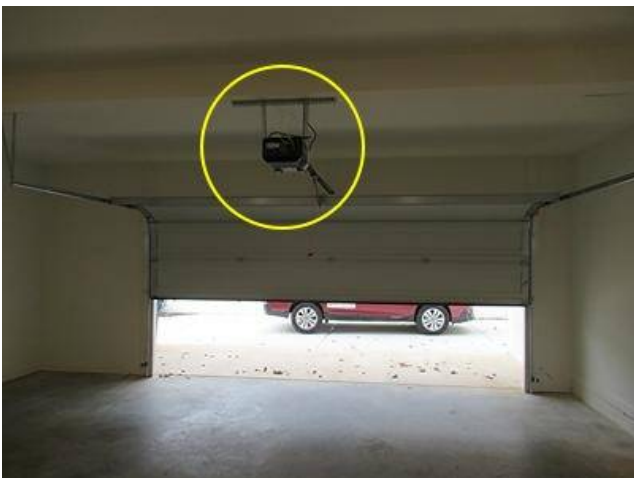
Photo 37-1

The garage door opener[s] were evaluated and appeared functional at the time of the inspection.

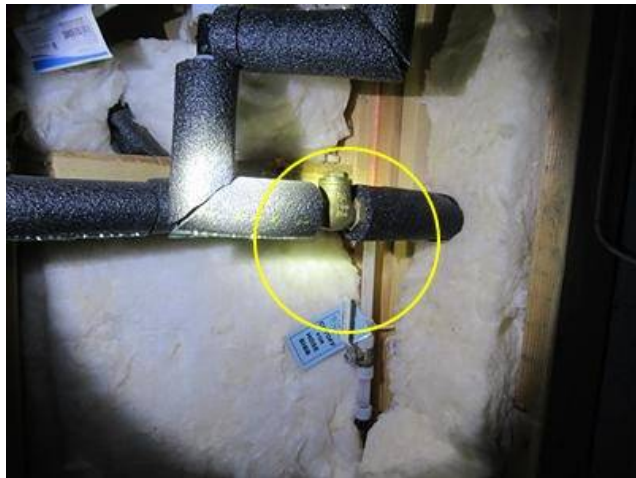
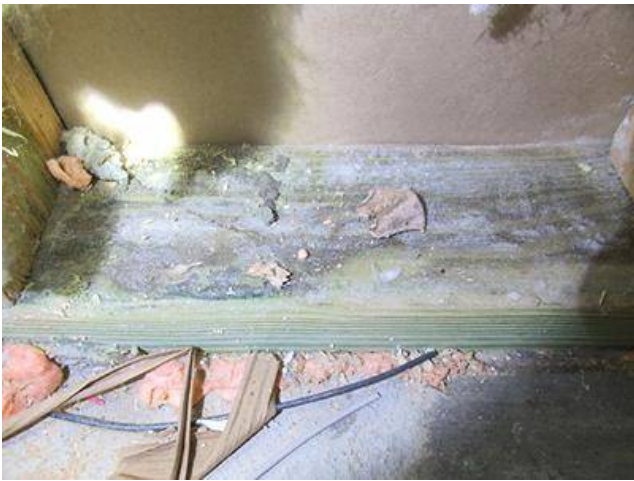
There appears to be a leak at one pipe connection for the tankless water heater. Recommend having the builder evaluate and make any necessary repairs.

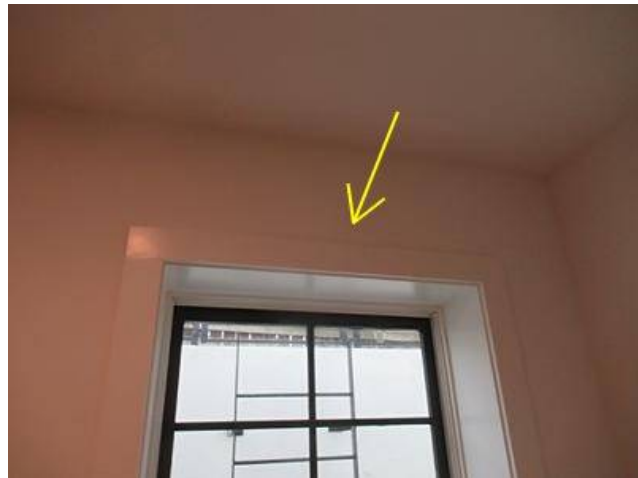
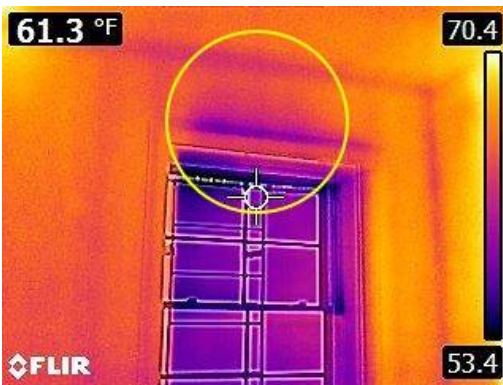
40) 🛠️ There is a gap, missing caulk, at the trim above the window in the basement bedroom. The infrared scan showed a temperature anomaly indicating cool air in this area. Recommend having the builder evaluate and make any necessary repairs.

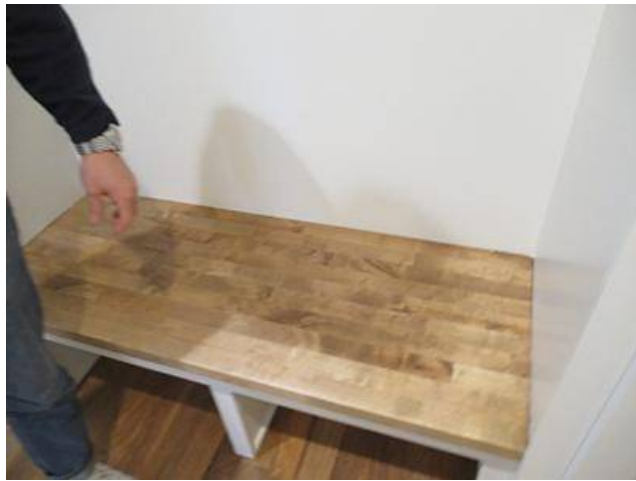
Photo 41-2

41) 🛠️ There is a rough finish on the bench in the basement hallway areas. Recommend having the builder evaluate and make any necessary repairs.

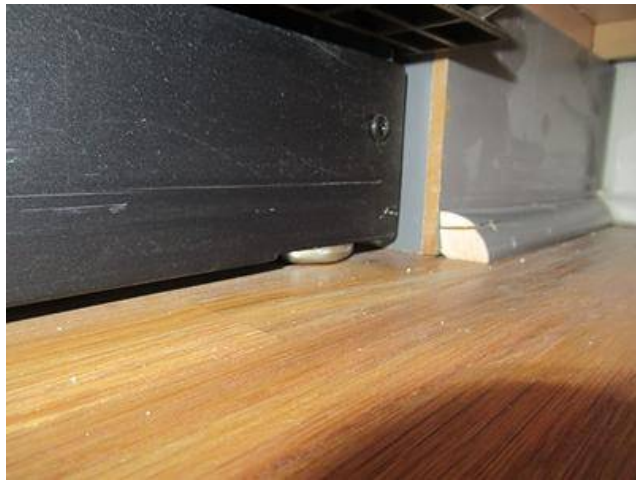
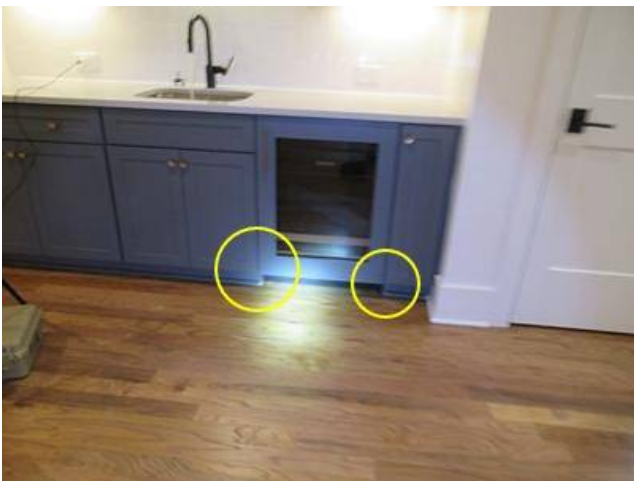
42) 🛠️ The ends of the shoe moulding in the basement bar area are not painted. Recommend having the builder evaluate and make any necessary repairs.

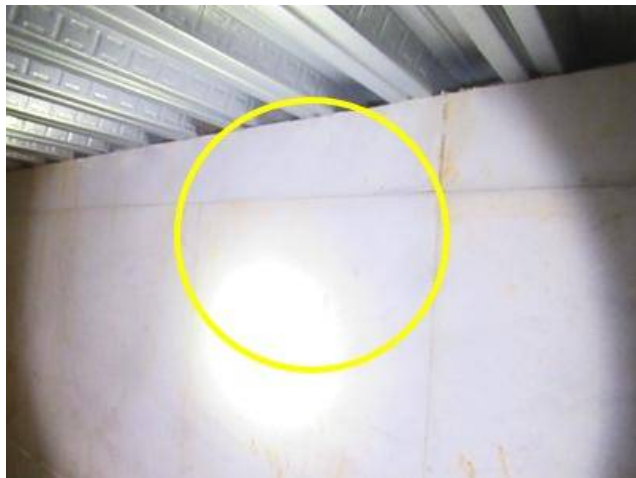
Photo 45-2

45) 🔍🏠📌 One or more minor cracks (1/8 inch or less) were found at the front wall of the foundation. These didn't appear to be a structural concern, but recommend sealing them to prevent water infiltration and monitor them in the future. Numerous products exist to seal such cracks including hydraulic cement, non-shrinking grout, resilient caulks and epoxy sealants.

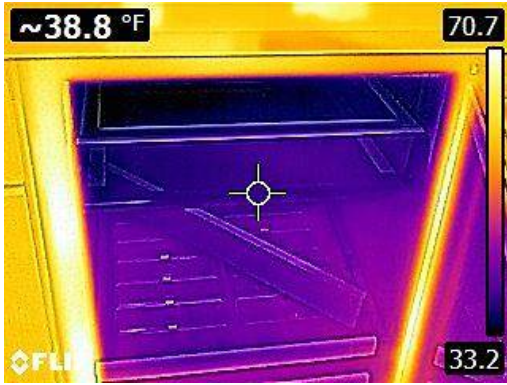
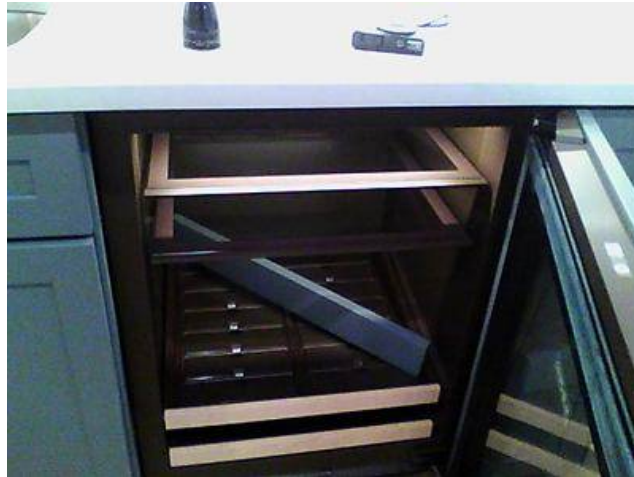
46) ✓ **i** The small refrigerator in the basement bar area was functional at the time of the inspection.

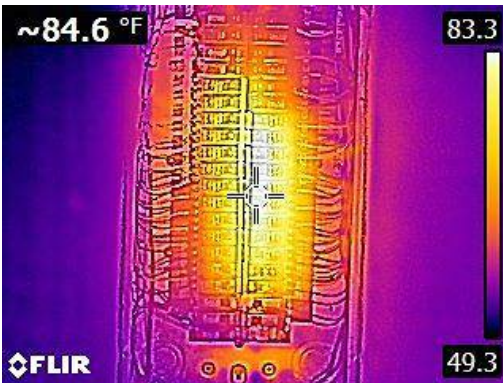
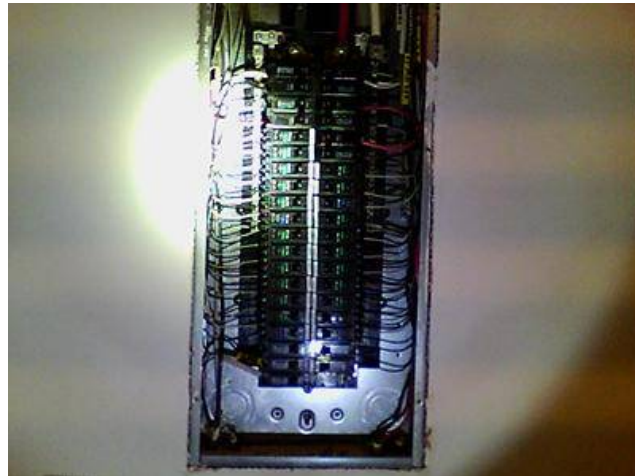
The basic infrared scan showed no abnormal anomalies at the time of the inspection. General pictures of the electrical panel.

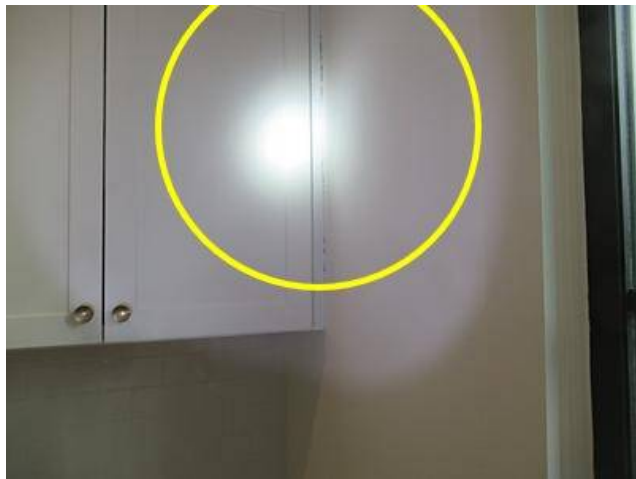
Photo 52-2

There is a gap at the wall by the cabinets in the laundry room. Recommend having the builder evaluate and make any necessary repairs.

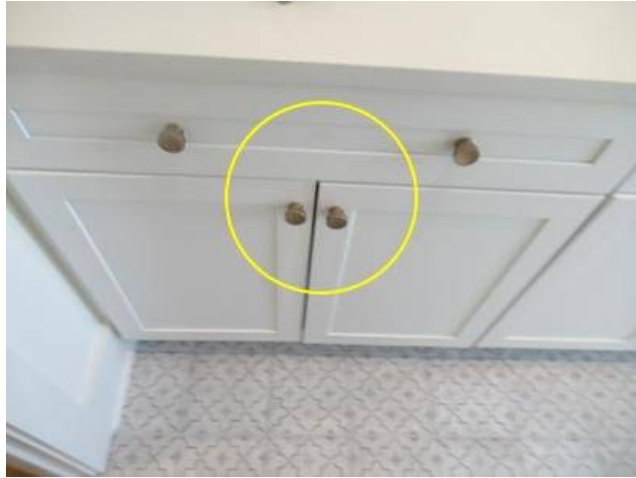
Photo 53-2

The cabinet doors in the laundry room need to be adjusted. Recommend having the builder evaluate and make any necessary repairs.

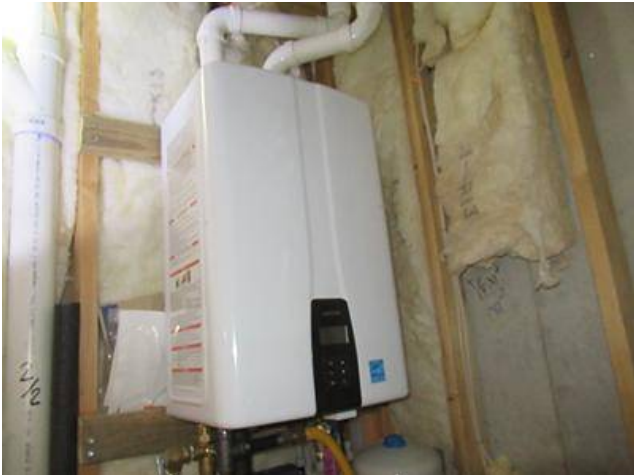
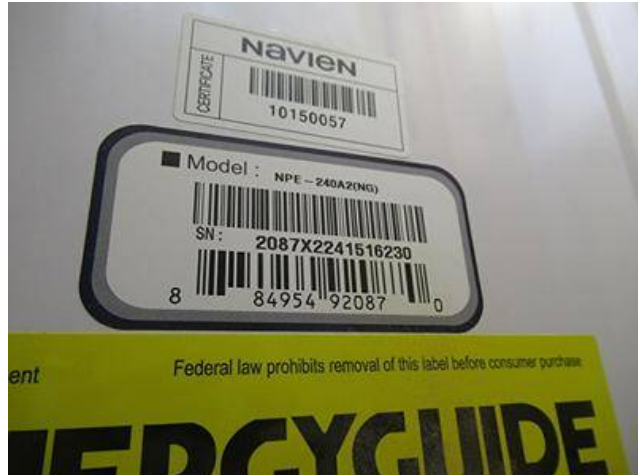
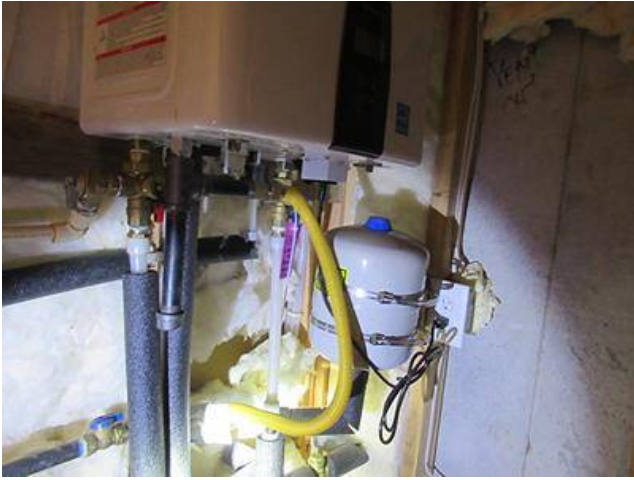
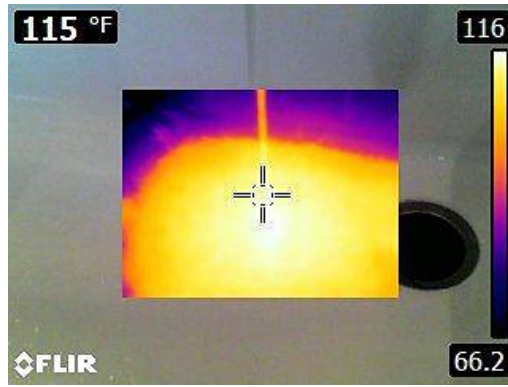
The water heater appeared functional at the time of the inspection.

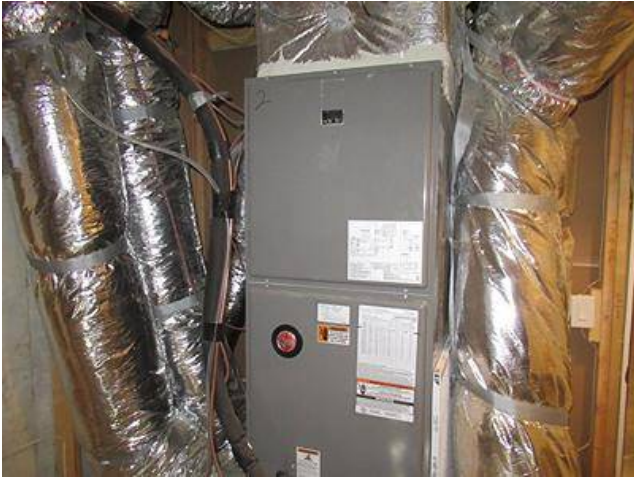
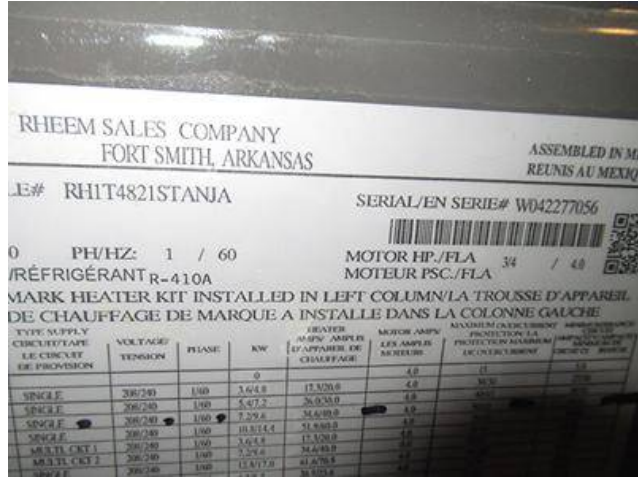
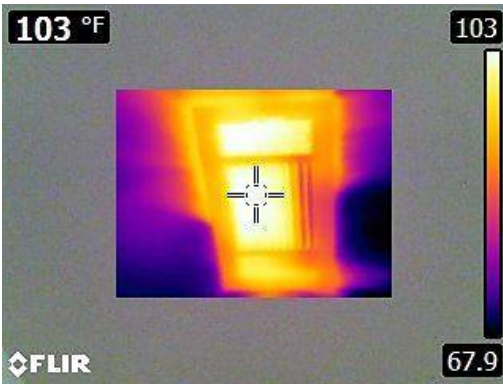
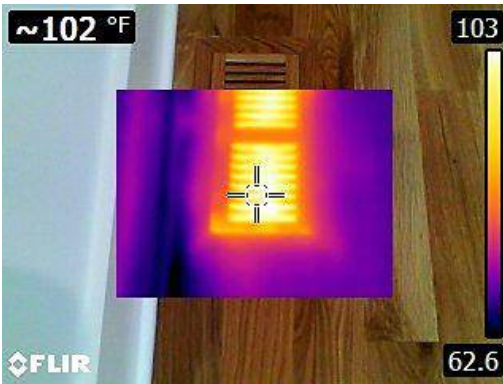
The main floor/basement zone controlled heating system was evaluated and appeared functional at the time of the inspection.

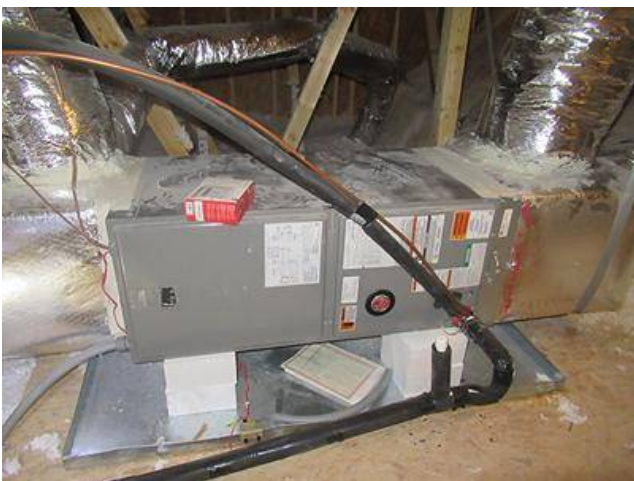
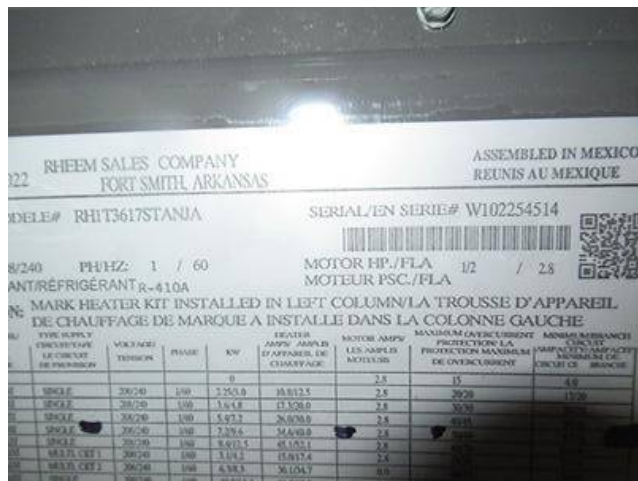
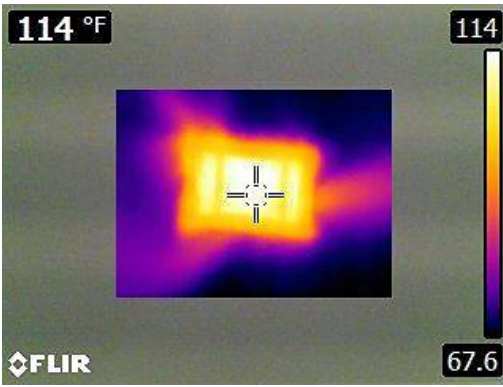
66) The upstairs heating system was evaluated and appeared functional at the time of the inspection.

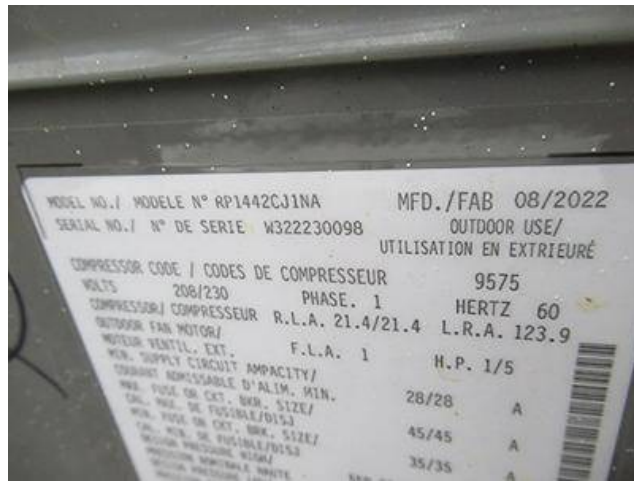
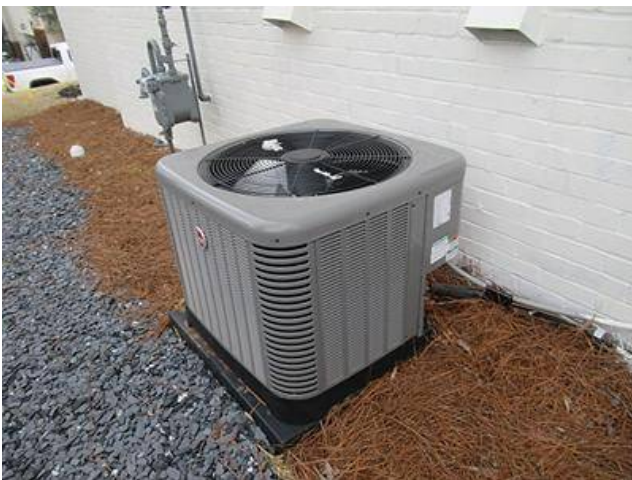
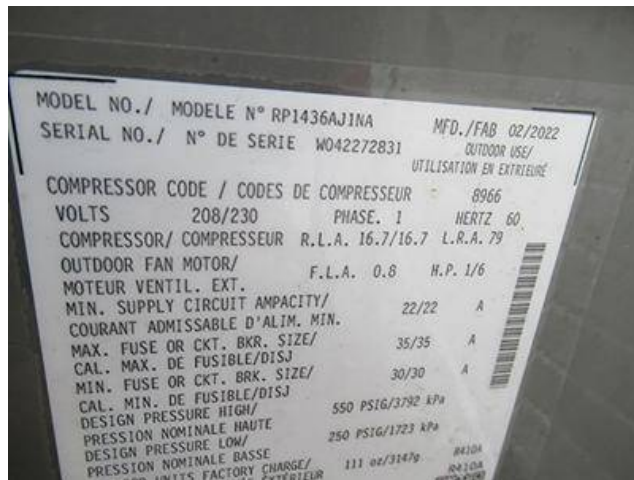
67) **i** The outdoor air temperature was below 65 degrees Fahrenheit during the inspection. Air conditioning systems can be damaged if operated during such low temperatures. Because of this, the inspector was unable to operate and fully evaluate the cooling system.

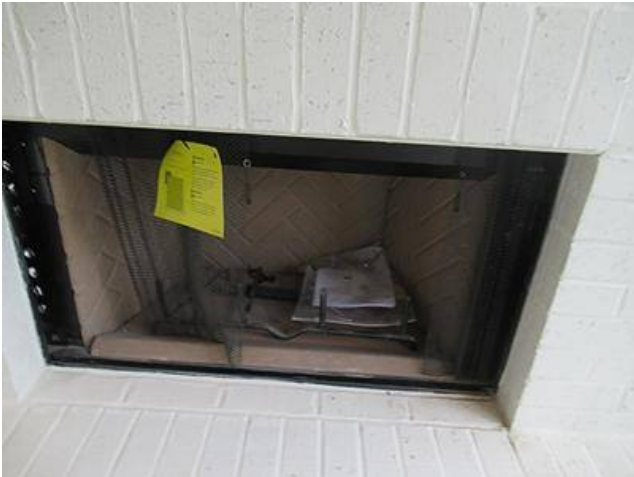
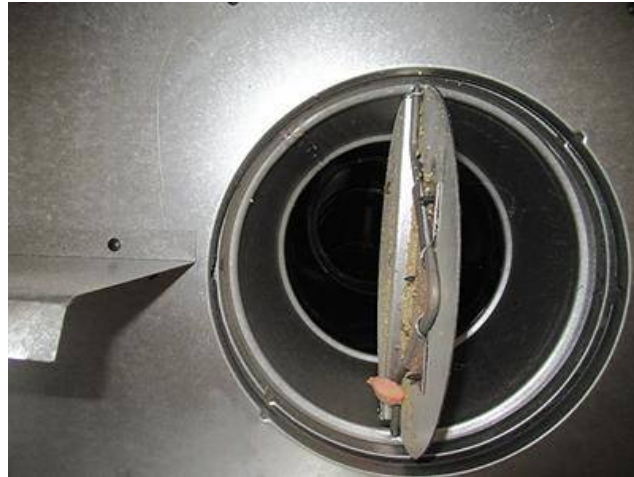
One or more solid fuel-burning fireplaces or stoves were found at the property. When such devices are used, they should be professionally inspected and cleaned annually to prevent creosote build-up and to determine if repairs are needed.

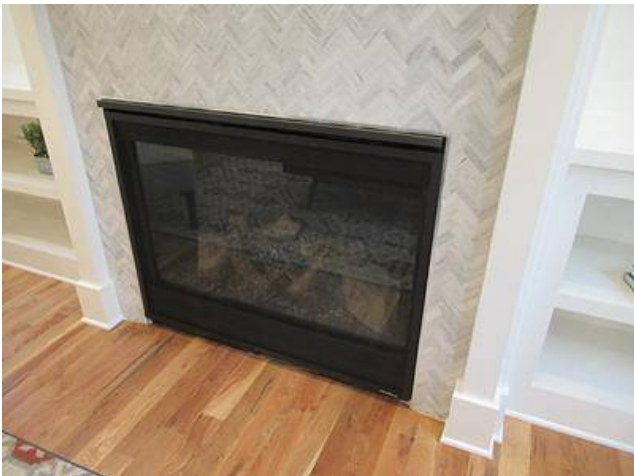
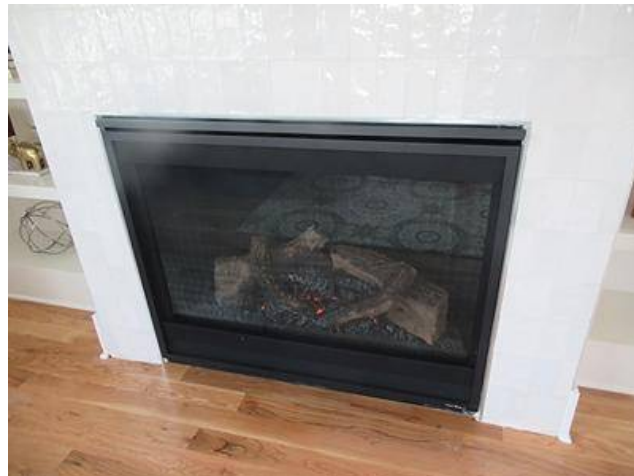
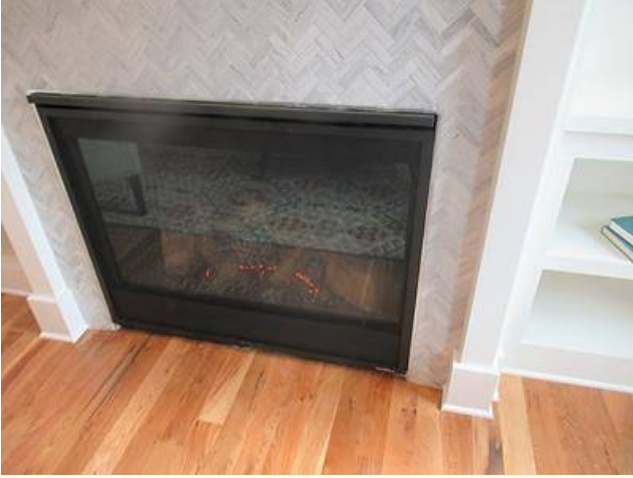
The gas fireplaces were functional at the time of the inspection.

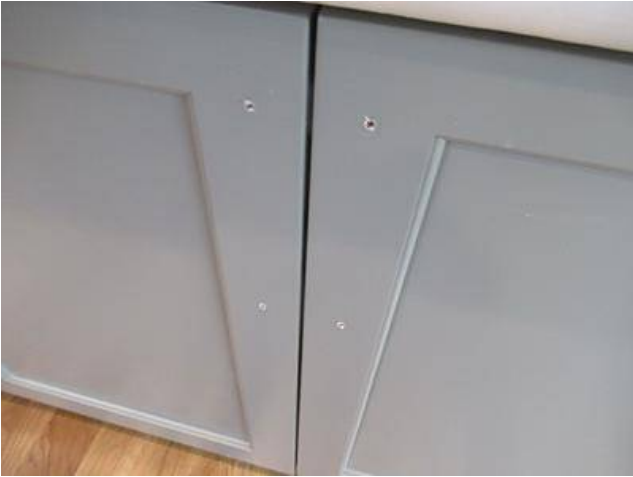
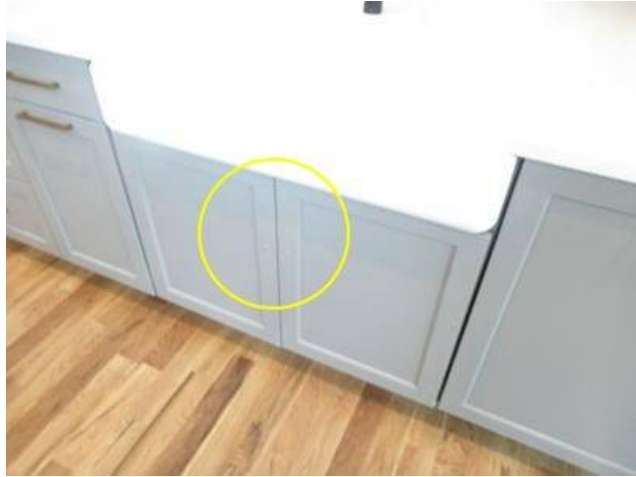
70) 🛠️ Handles were missing at the cabinet doors below the sink. Recommend having the builder evaluate and make any necessary repairs.

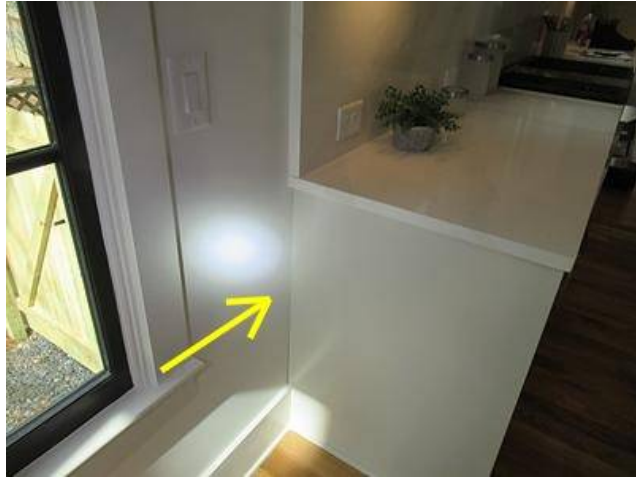
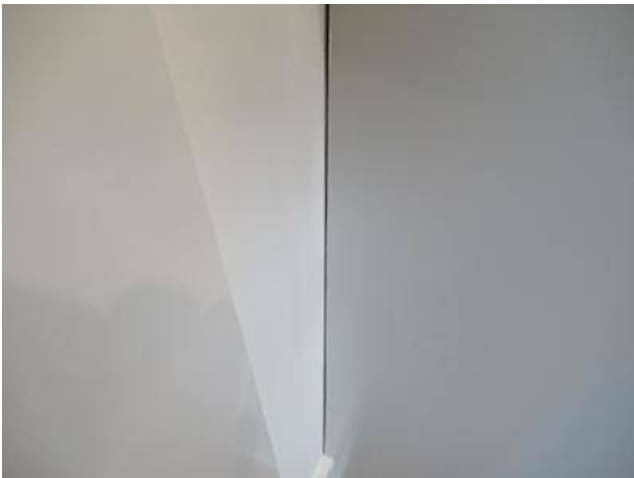
71) 🛠️ The cabinet scribes or trim pieces between the cabinets and the walls, are missing in one or more areas of the kitchen. Recommend having the builder evaluate and make any necessary repairs.

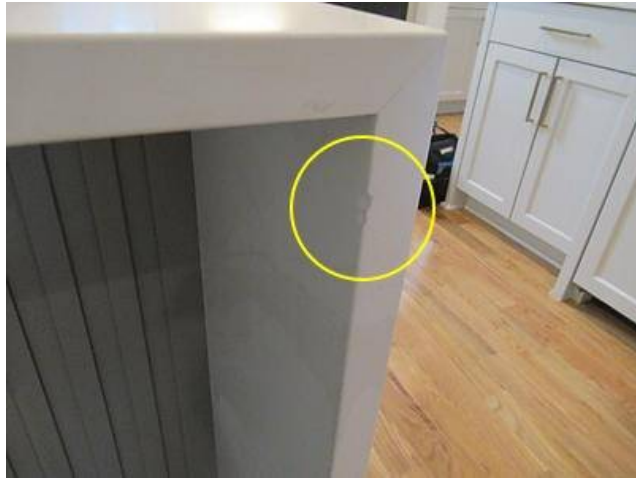
Photo 72-2

There is a chip in the side of the kitchen island. Recommend having the builder evaluate and make any necessary repairs or replacement.

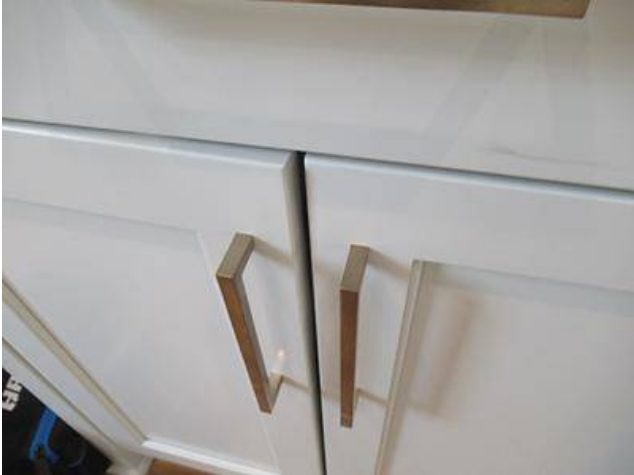
Photo 74-1

74) 🛠️ One or more kitchen cabinet doors need to be adjusted. Recommend having the builder evaluate and make any necessary repairs.

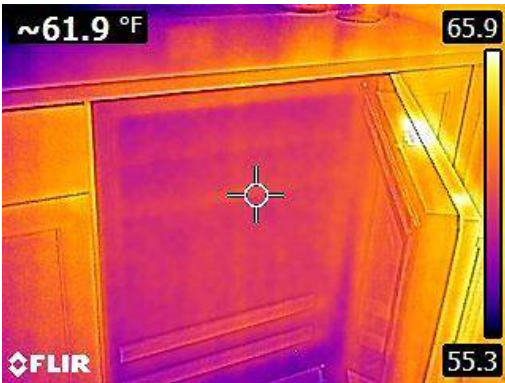
Photo 75-1

75) 🛠️ The small refrigerator in the bar area by the kitchen was not functional at the time of the inspection. Recommend having the builder evaluate and make any necessary repairs.

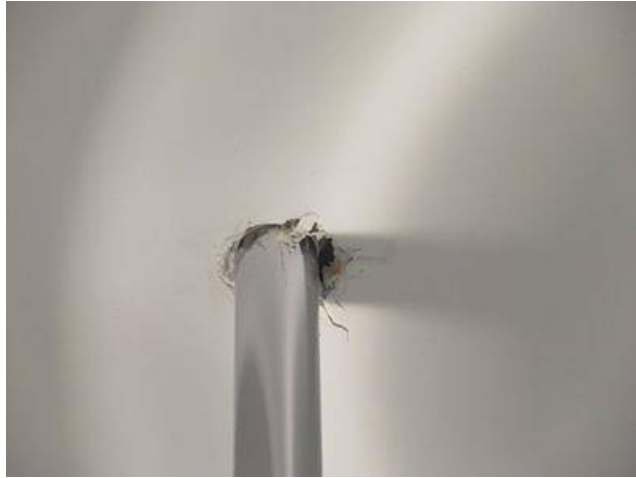
Photo 81-2

The upper showerheads in the master bathroom are missing the stem flanges at the ceiling. Recommend having the builder evaluate and make any necessary repairs.

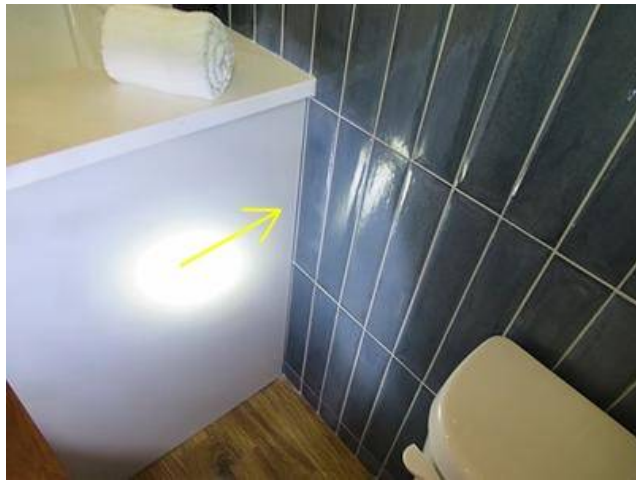
Photo 84-2

The main floor half bathroom cabinet is missing the scribe or trim piece between the cabinet and the wall. Recommend having the builder evaluate and make any necessary repairs.

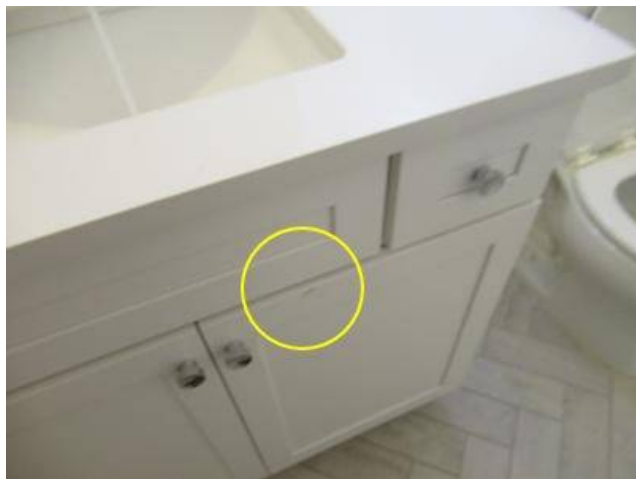
Photo 87-2

87) 🛠️ There is a mark on the cabinet door in the basement bathroom. Recommend having the builder evaluate and make any necessary repairs.

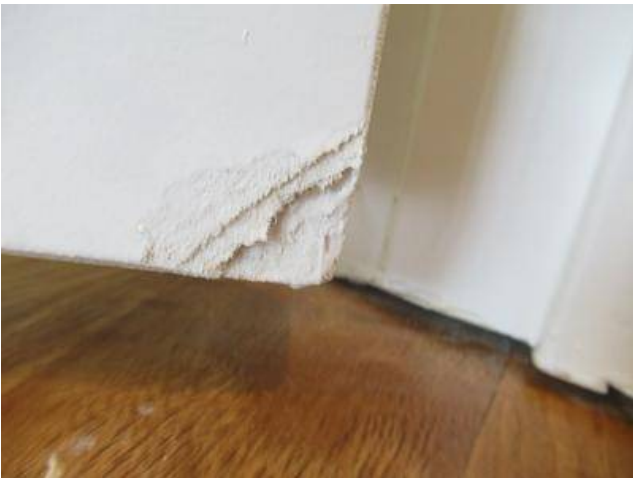
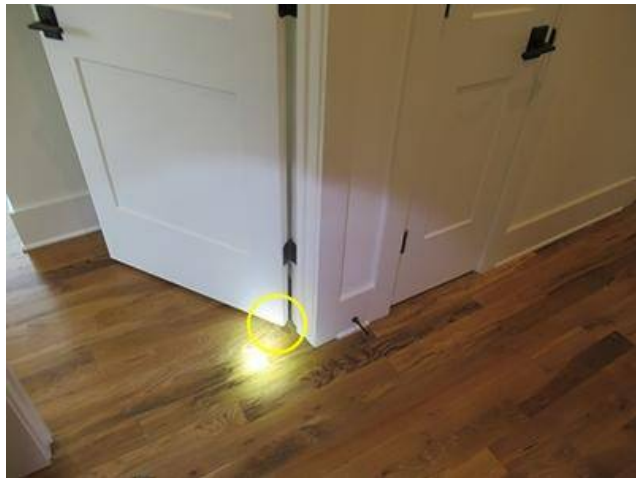
The upstairs front left side bedroom door is damaged at the bottom of the door. Recommend having the builder evaluate and make any necessary repairs or replacement.
