## Open Eye Home Inspections LLC

### Property New Home Final Inspection Report

Client(s): **Sample Report 3**

Inspection date: **Thursday, January 26, 2023**

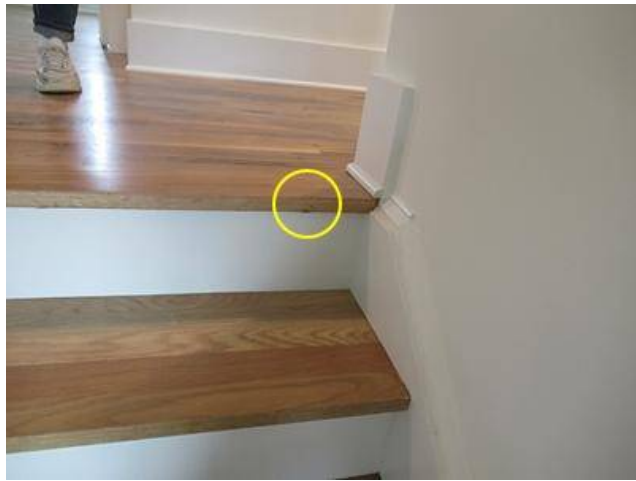
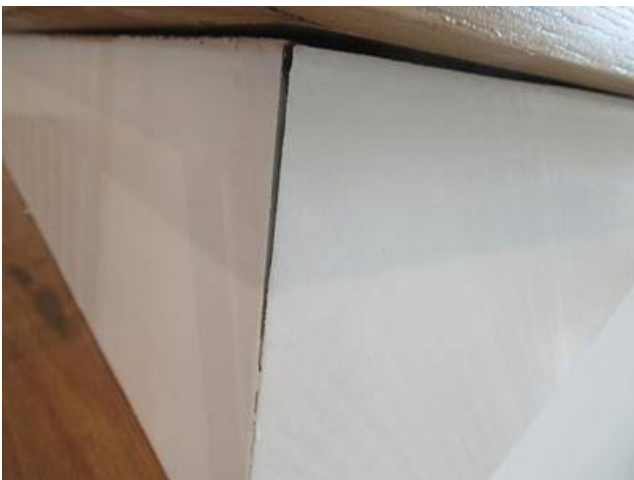
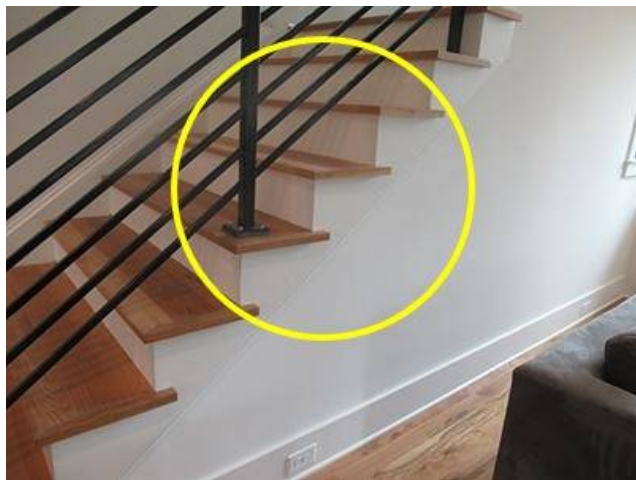
Damage was noticed at the stairs in one or more areas. Recommend having the builder evaluate and make any necessary repairs.

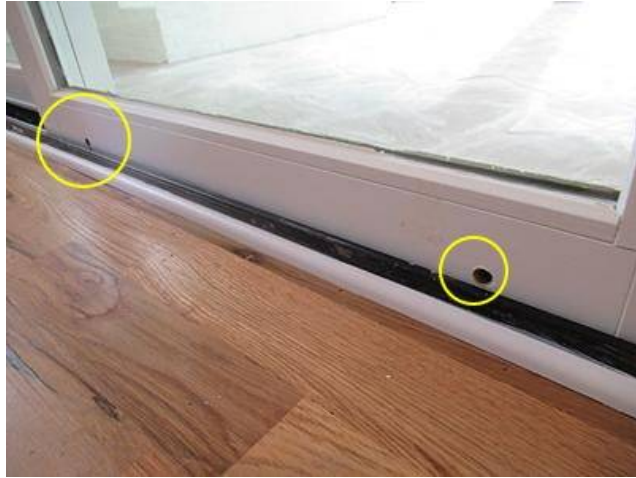
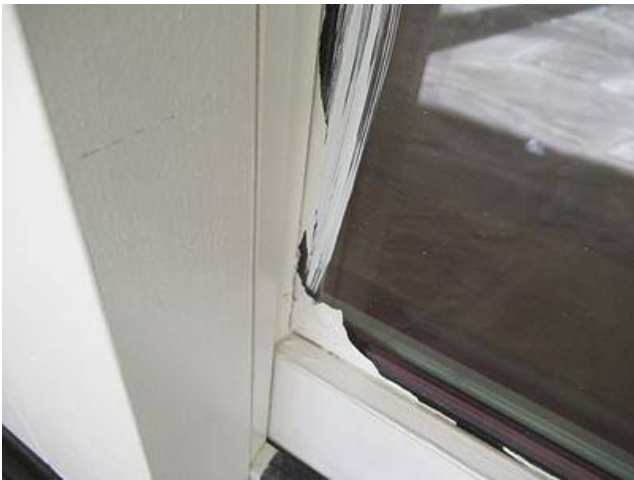
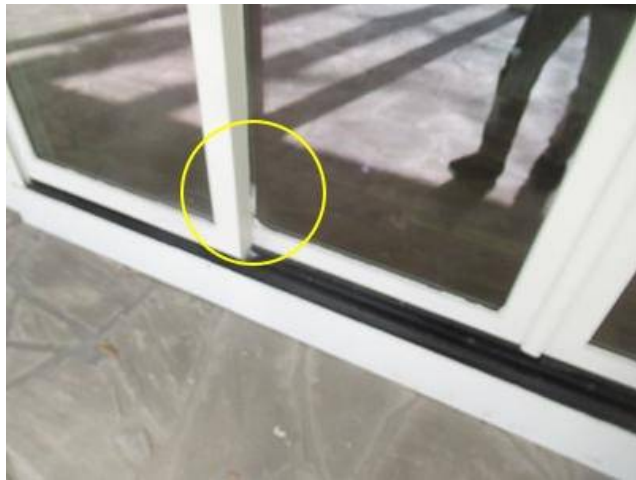
The sliding glass doors are missing the screw dowels that cover the holes at the bottom of the door. In addition, there is paint or sealant on the exterior side of the glass. Recommend having the builder evaluate and make any necessary repairs.

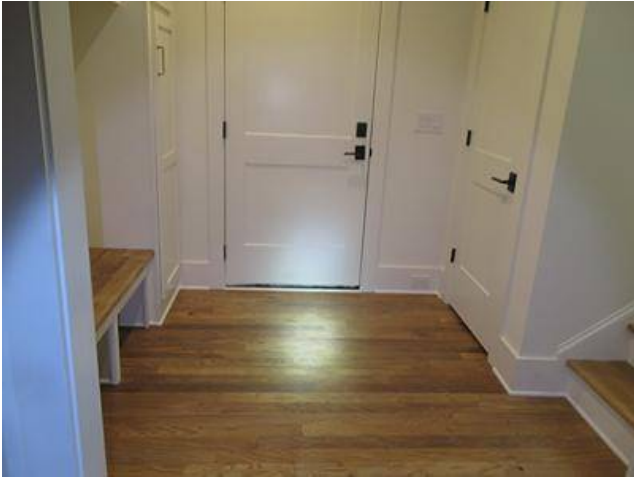
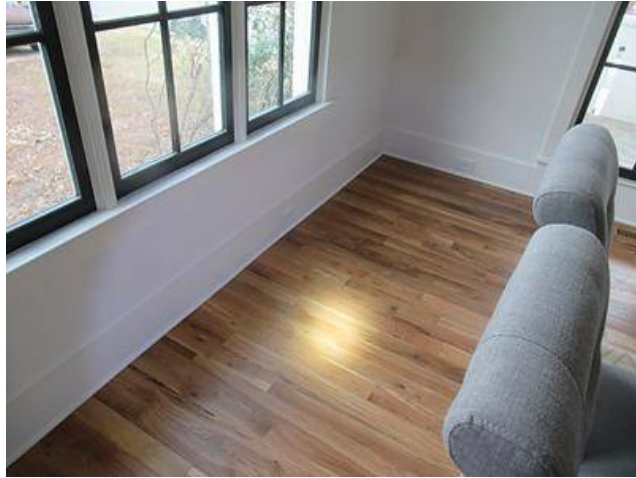
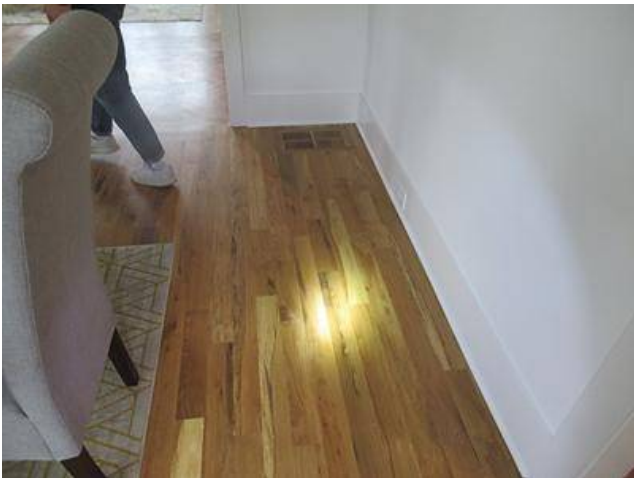
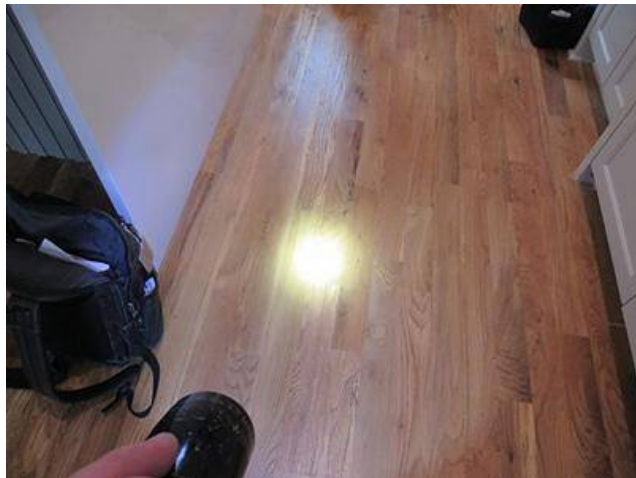
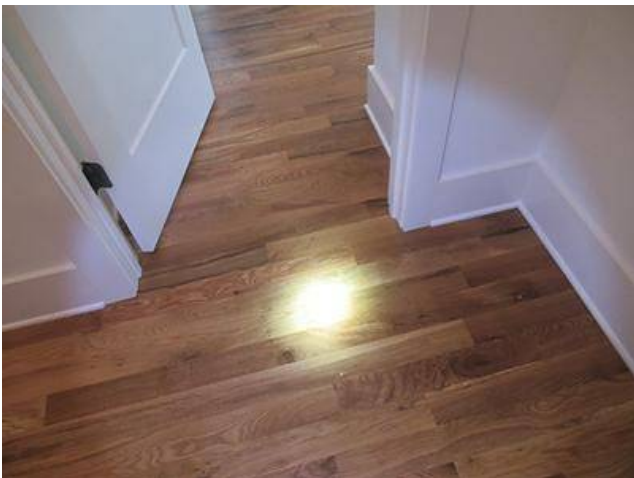
94) 🛠️ The flooring made popping noises in multiple areas throughout the house. Recommend having the builder evaluate and make any necessary repairs.

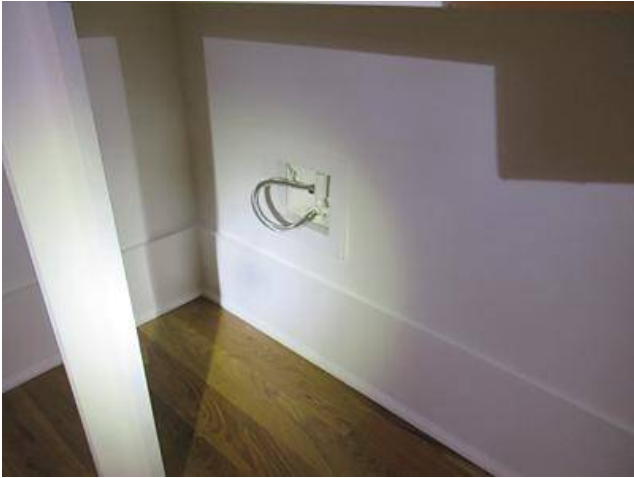
Photo 95-1

95) 🛠️ The water supply line in the pantry was protruding from the cut out area. Leaks may occur if stored items under the shelf come in contact with the water line. Recommend having the builder evaluate and make any necessary repairs.

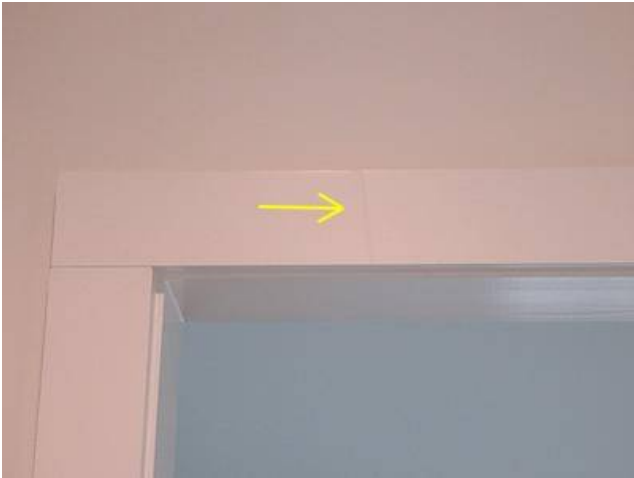
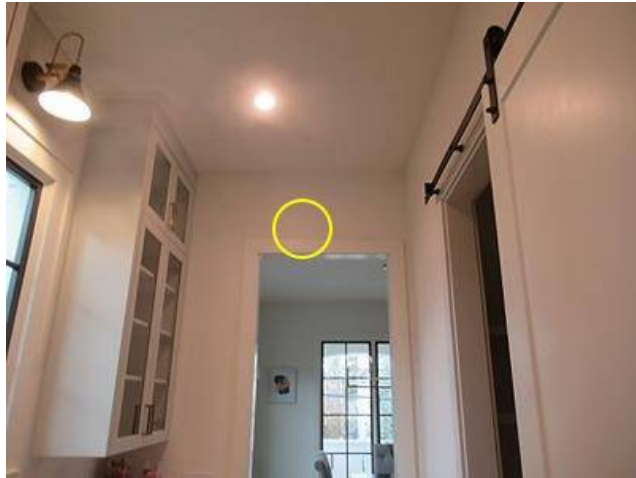
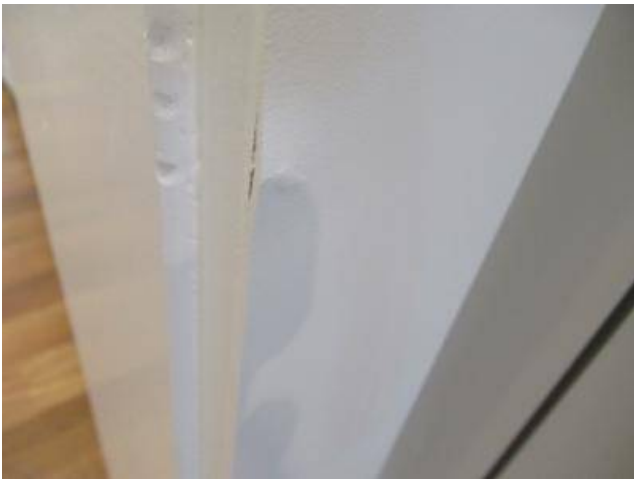
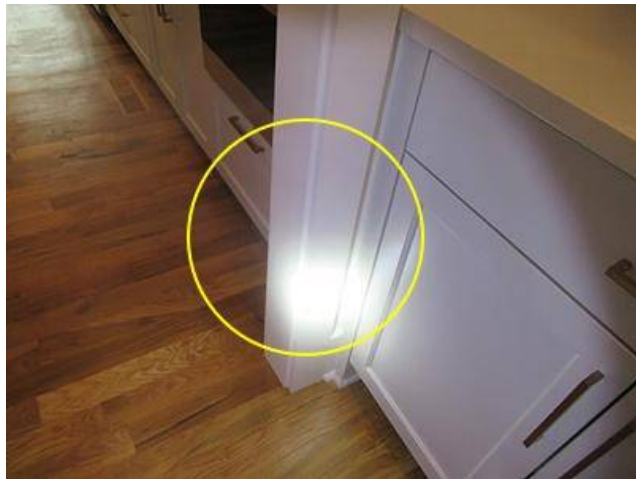
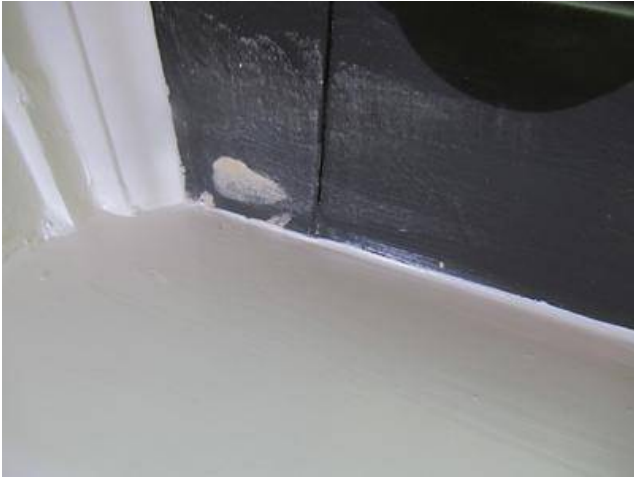
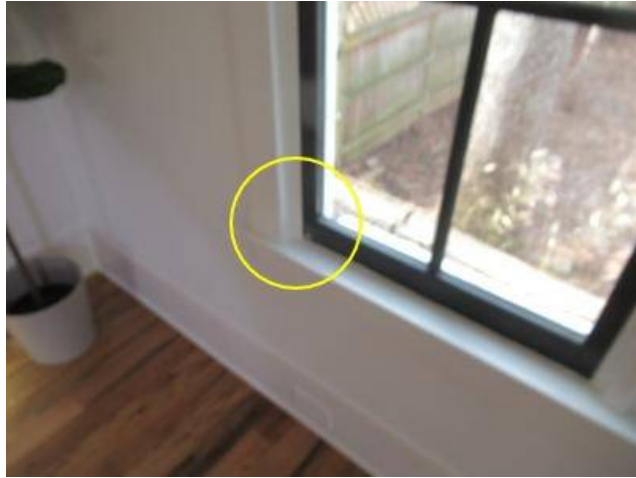
96) 🛠️ Multiple cosmetic concerns were noticed throughout the house. Recommend having the builder evaluate and make any necessary repairs.

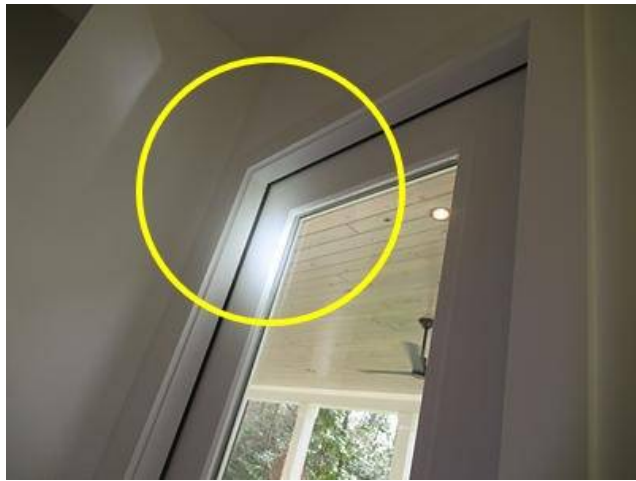
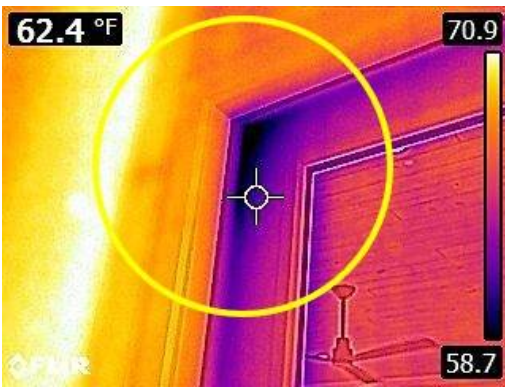
97) 🛠️ The door to the back deck does not make a good seal at the top when closed and latched. The infrared scan shows the energy loss in this area. Recommend having the builder evaluate and make any necessary repairs.

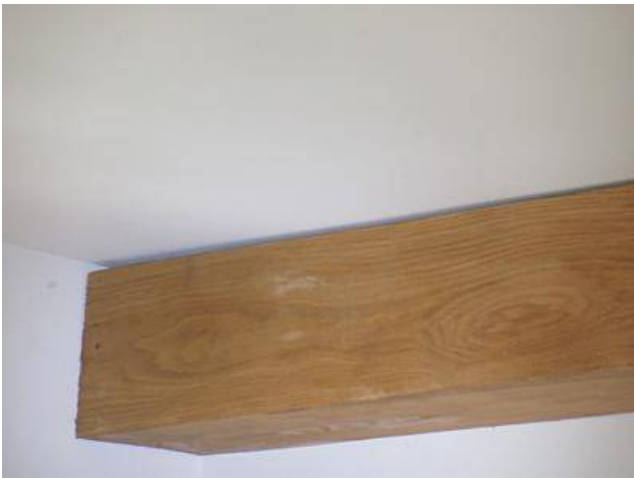
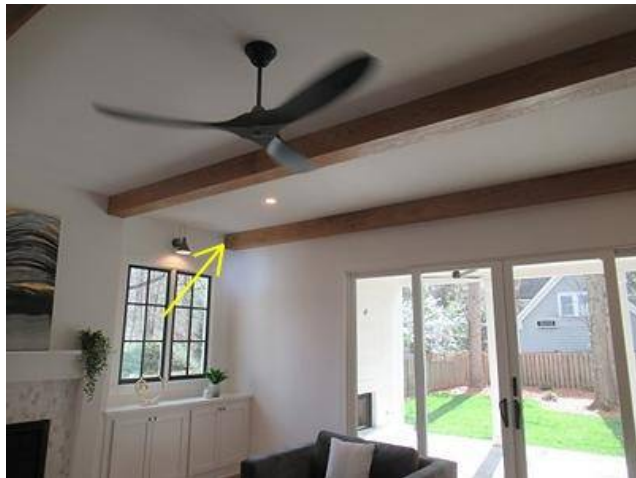
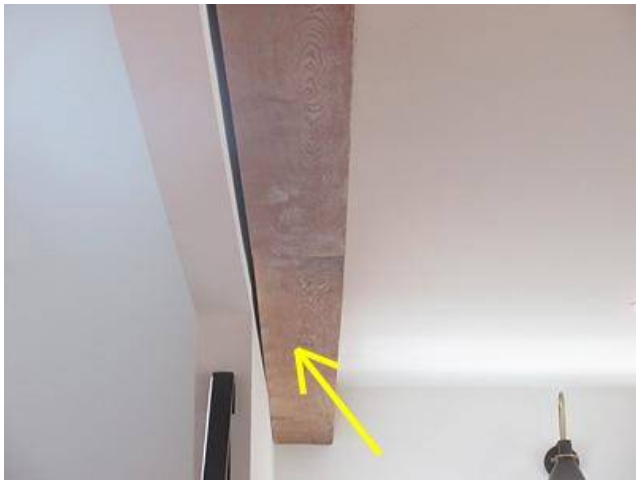
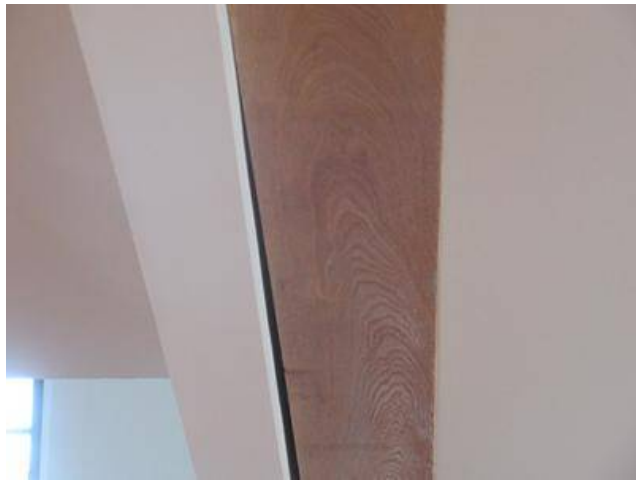
There is a bow in the wall where the beam is installed next to the stairwell. In addition there is a noticeable gap at the end of the on the other side of the family room at the back wall. Recommend having the builder evaluate and make any necessary repairs.

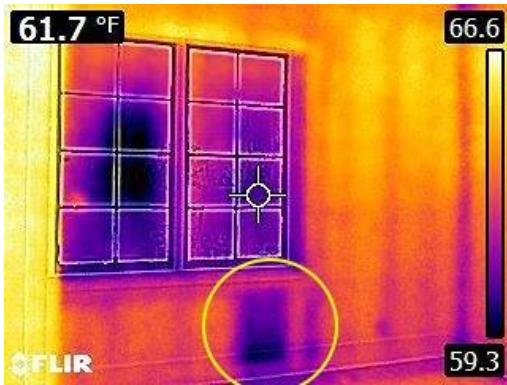
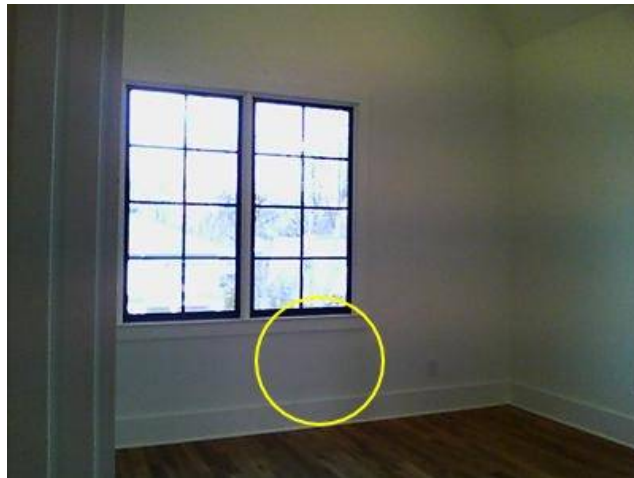
One piece of insulation appears to be missing from the front wall below the window in the upstairs front left side bedroom. Recommend having the builder evaluate and make any necessary repairs.

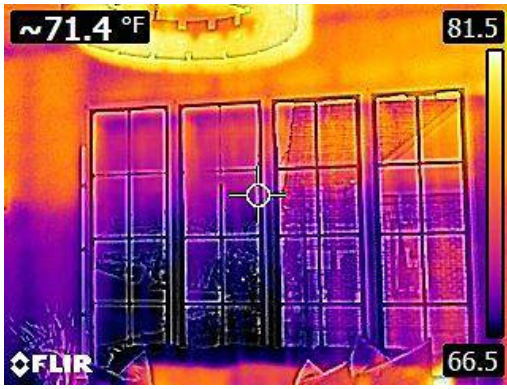
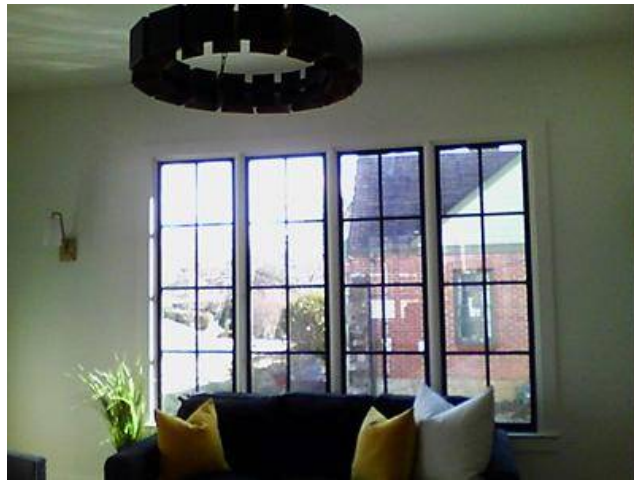
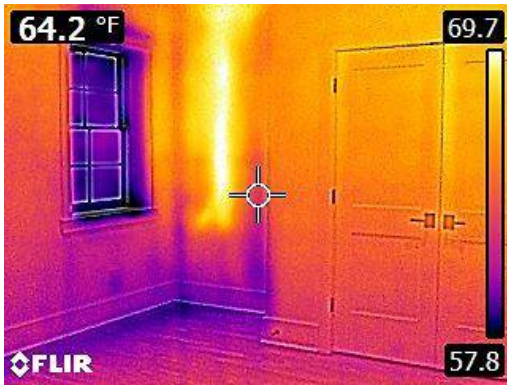
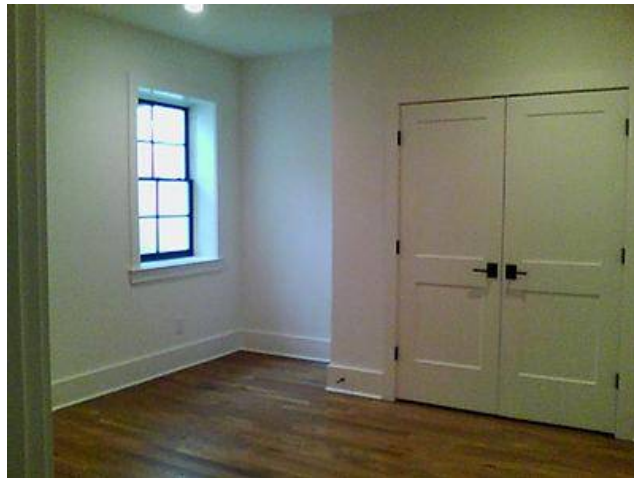
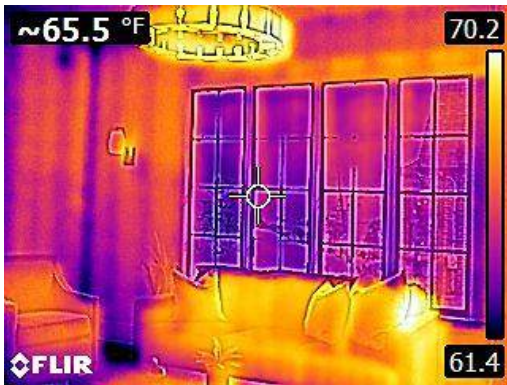
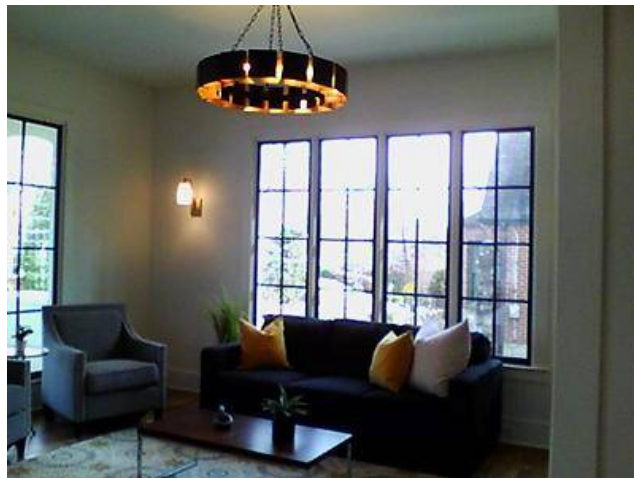
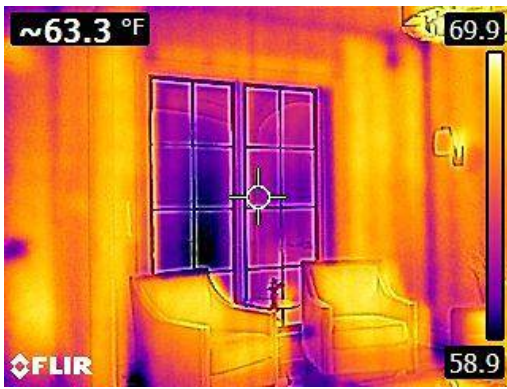
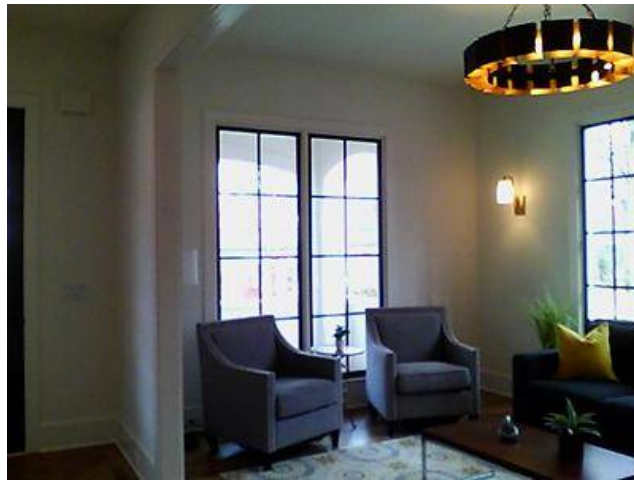
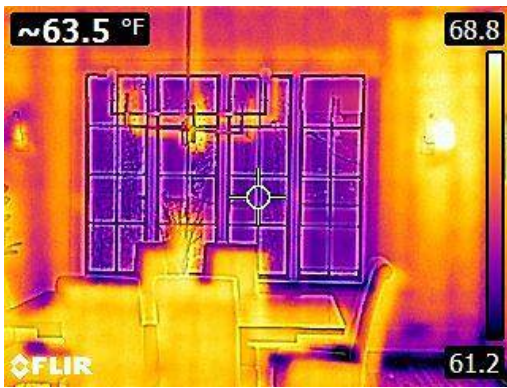
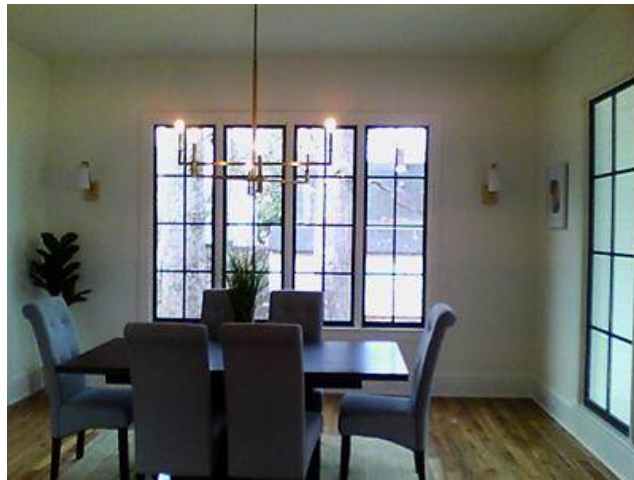
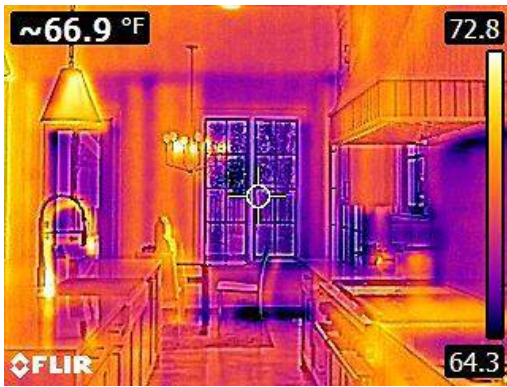
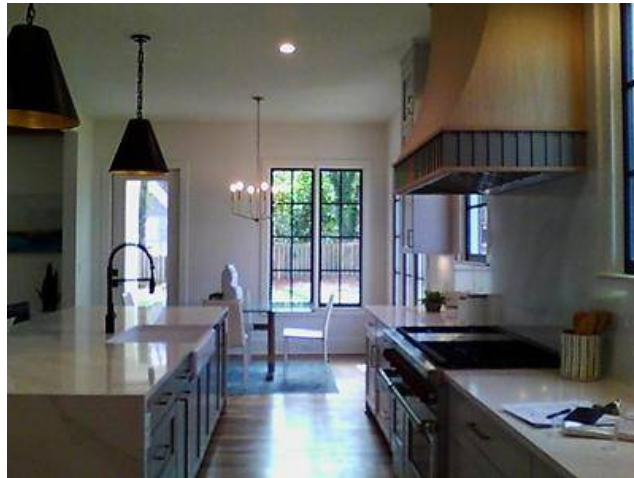
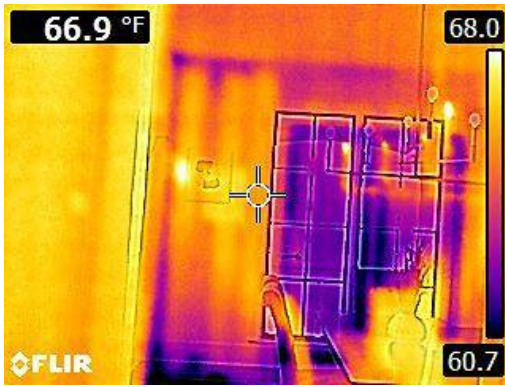
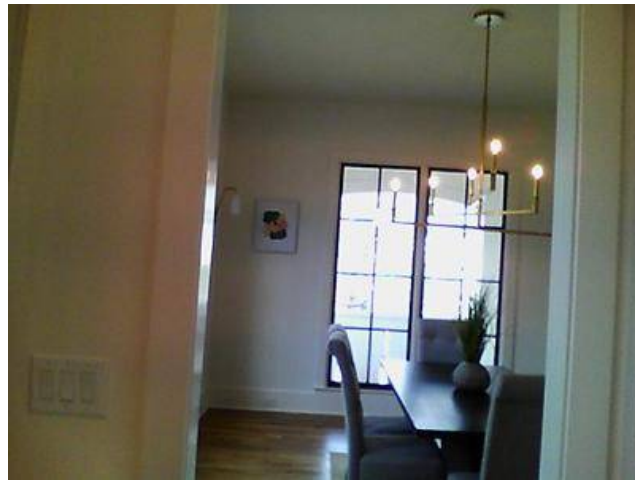
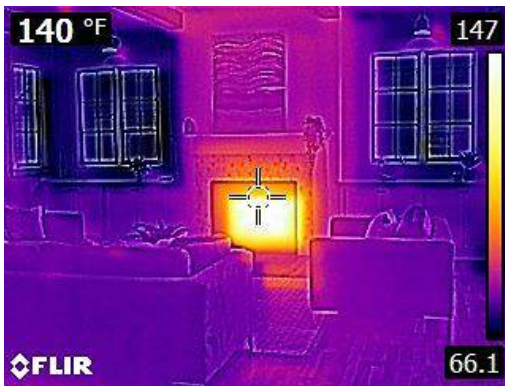
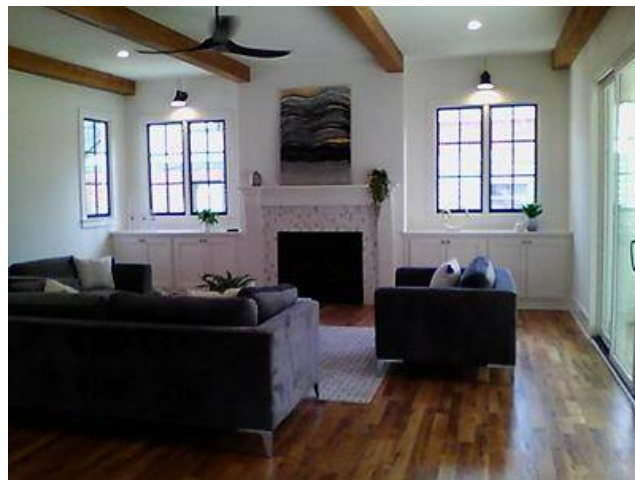
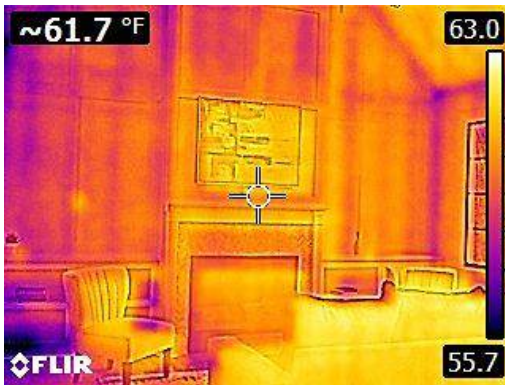
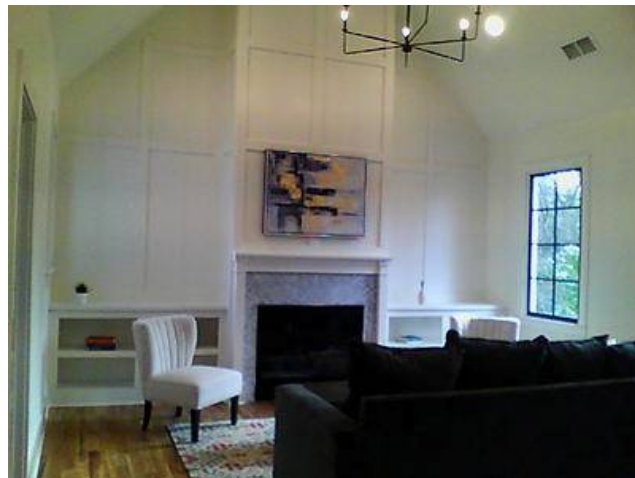
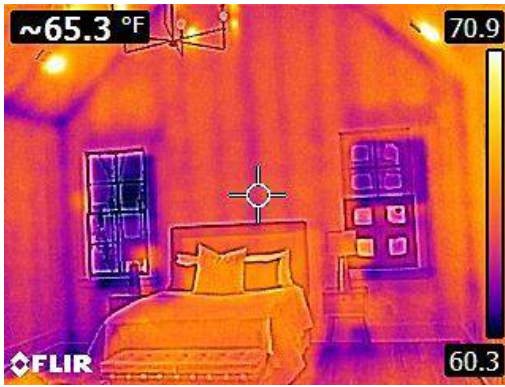
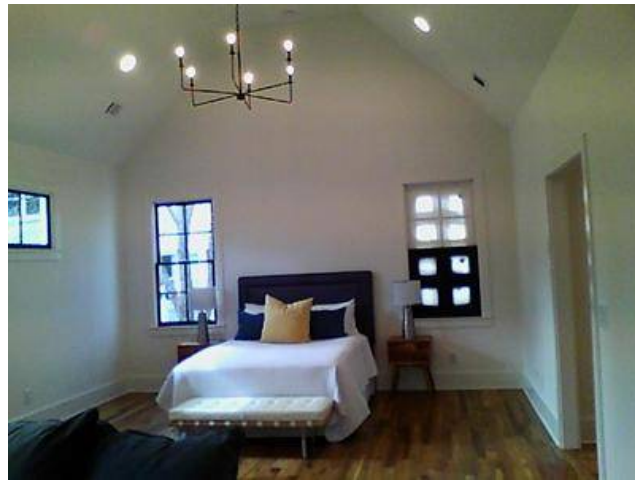
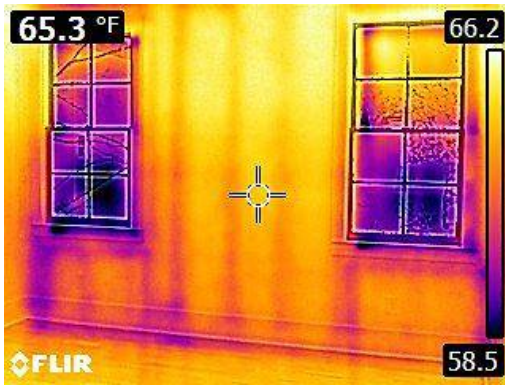
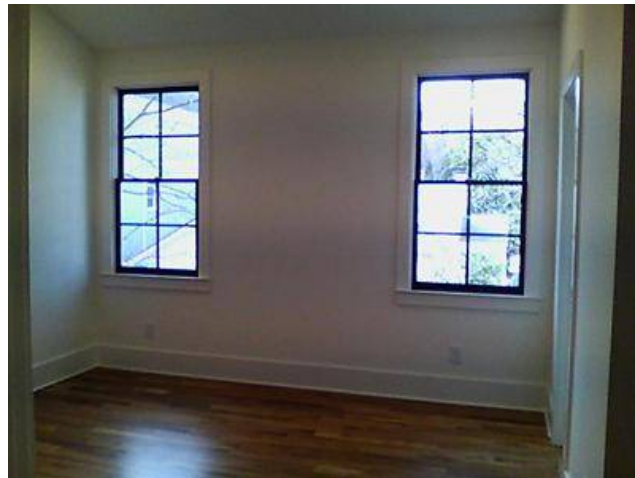
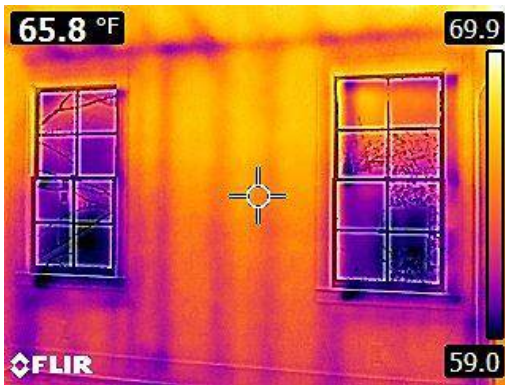
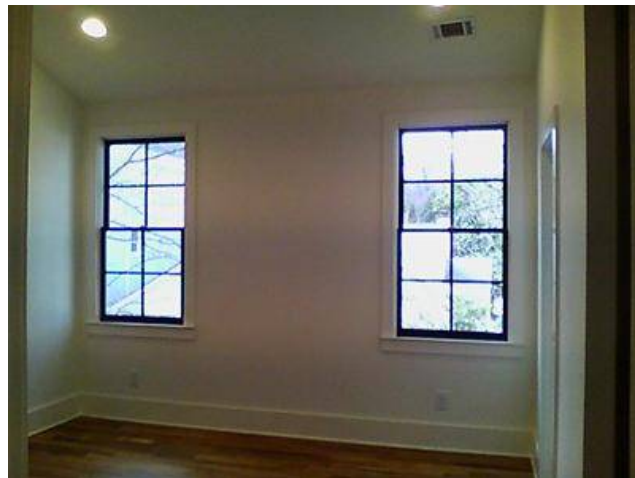
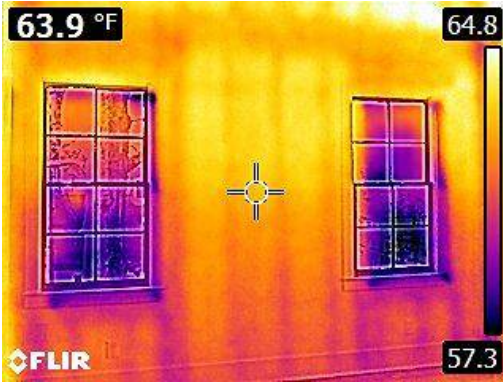
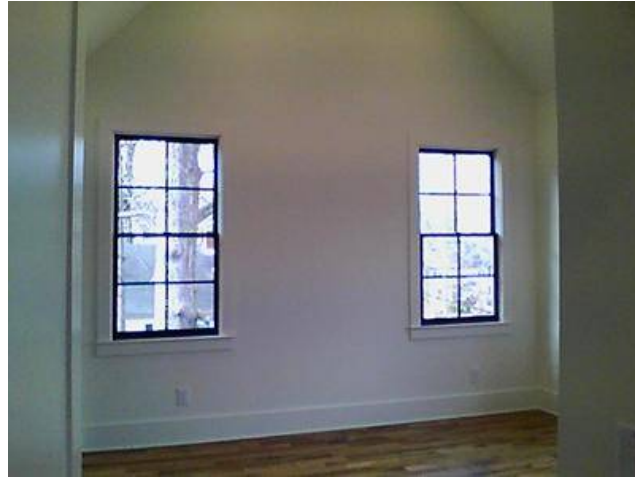
102) **i** The basic infrared scans showed no abnormal anomalies at the time of the inspection other than those mentioned in the report.
